# 755 SAND POINT RD. CARPINTERIA, CA

Appellant: Raemer Crest, LLC & Brilliant Projects, LLC

Law Office of Marc Chytilo  
August 28, 2018

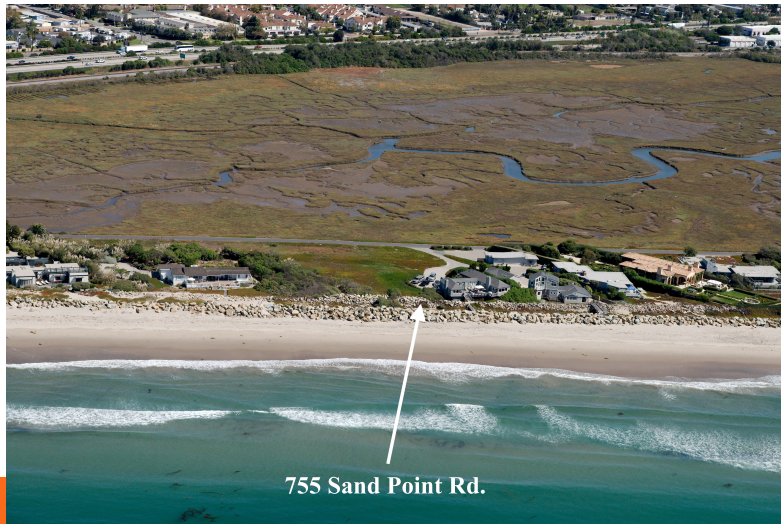
## 2 Rock Revetments, Wetlands & Vulnerability to Flooding from 2 sides

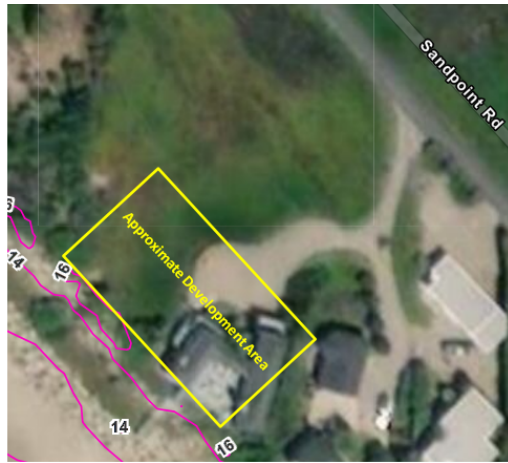
Figure 2 . Air Photo view of the site with water surface elevation contours (courtesy of FEMA) <sup>1</sup>

- a. Extremely vulnerable site – surrounded by water on 3 sides – only ocean waves analyzed
- b. Ignores effect of back-bay water ponding from either tides or creek flow, impacting development from the north
- c. Ignores any discussion of coastal erosion and tsunami inundation
- d. Does not follow FEMA Pacific Coastal Hazard guidelines or look at wave run up with and without existing coastal armoring

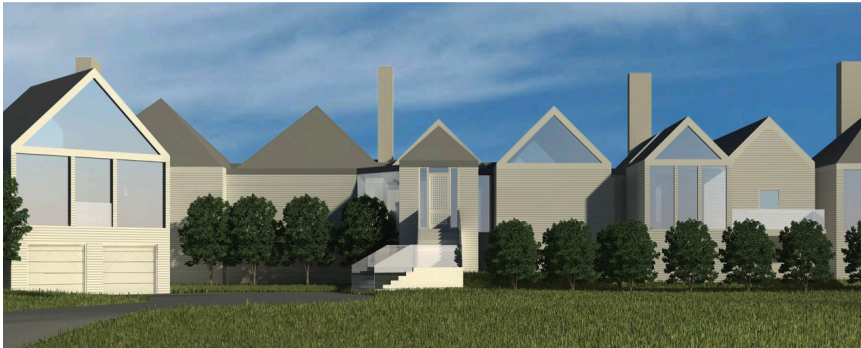
SAND POINT RESIDENCE  
755 SAND POINT ROAD  
CARPINTERIA, CA 93013  
APN 005-460-043  
13CDH-00000-00001  
PLANNING COMMISSION REVISION 02.15.2018

Architect's Rendering Depicting Size and Scale

i. Elevated base floor elevation combined with excessive development requires a Modification to allow unusually steep roofs in excess of 30°.

ii. The development includes four chimneys that are 40' above grade.

iii. The development would be the tallest structure on Sand Point Road, and one of the biggest.

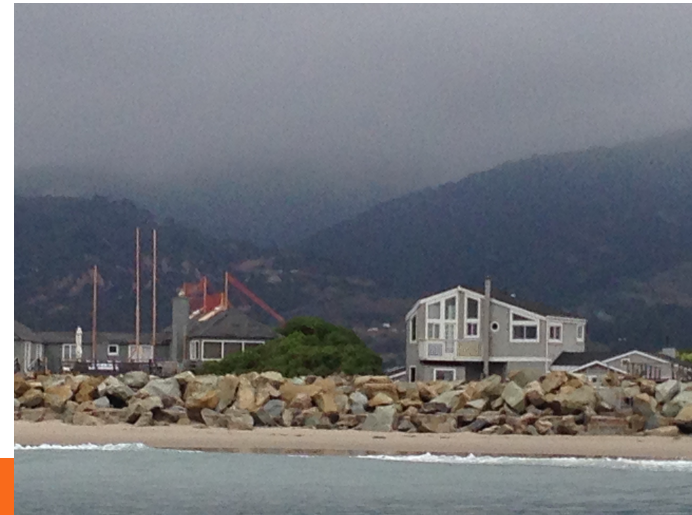
755 Sand Point Rd  
Story Poles As Seen From the Ocean

iii. The views of the mountains from the beach will be significantly obstructed due to the size and design of the development.
