**Santa Barbara County
Flood Control and Water Conservation District**

Carpinteria Valley Watershed Project Operation & Maintenance Plan

June, 2024

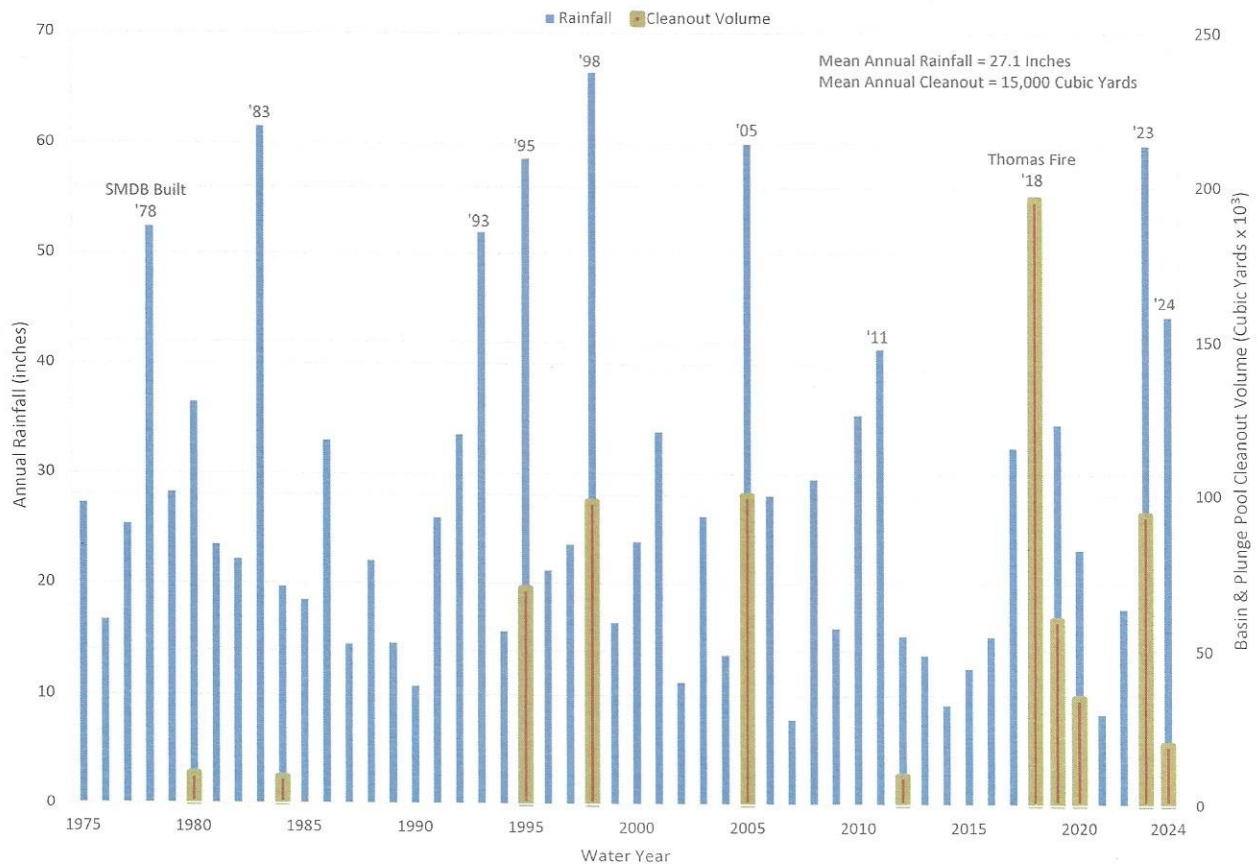
D-1

**O&M History of the Santa Monica Debris Basin
1978 - 2024**

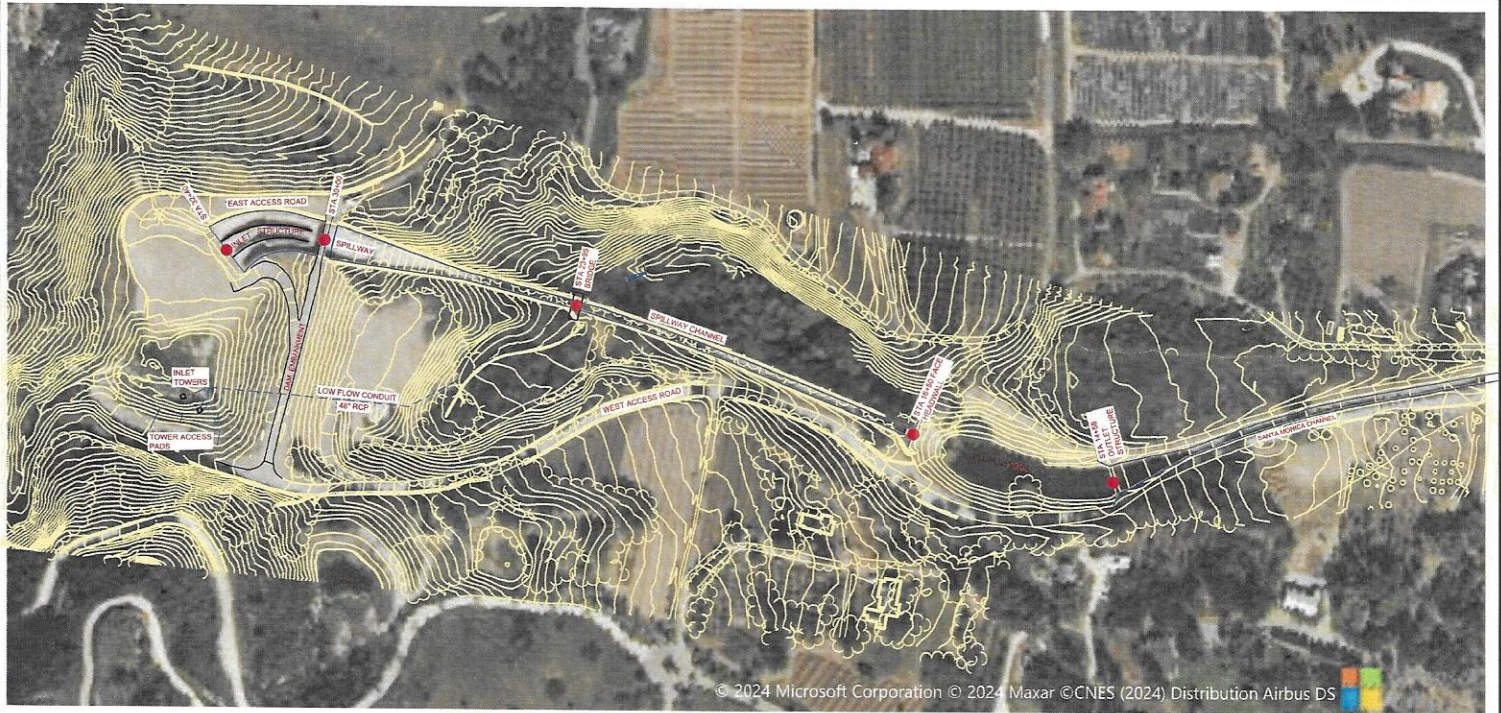
Figure 3

SANTA MONICA CREEK DEBRIS BASIN

Santa Monica Debris Basin is located on Santa Monica Creek, in the foothills about 0.60 mile upstream of Foothill Road. The Santa Monica Debris Basin (SMDB) serves to trap and store debris generated from the Santa Monica Creek watershed, and prevent deposition within the lined channel or on adjacent property below. The 102-foot high earthfill dam has a debris storage capacity of 98 acre-feet (158,000 cubic yards). The basin includes a rock-lined plunge pool located immediately below the embankment, that serves to dissipate high-energy emergency spillway flows before transitioning into the downstream Santa Monica Creek Channel. The plunge pool also serves as a secondary sediment basin, with a temporary storage capacity of 9 acre-feet (15,000 cubic yards). The SMDB is classified as a High Hazard Dam, under the jurisdiction of the State of California Division of Safety of Dams (DSOD), and thereby listed in the National Inventory of Dams (NID) [Appendix A-4].
