SANTA BARBARA COUNTY PLANNING COMMISSION
Staff Report for Myers Bridge Appeal

Hearing Date: August 10, 2016
Staff Report Date: July 21, 2016
Case Nos.: 16APL-00000-00012 & 16LUP-00000-00109
Environmental Document: Notice of Exemption - CEQA Exemption §15270

Hearing on the request of Derek Westen, agent for the property owners Barton and Victoria Myers, to consider Case No. 16APL-00000-00012 [application filed on April 21, 2016] to appeal the Planning and Development Department's denial of a Land Use Permit to allow construction of a secondary access road and new bridge (Case No. 16LUP-00000-00108), in compliance with

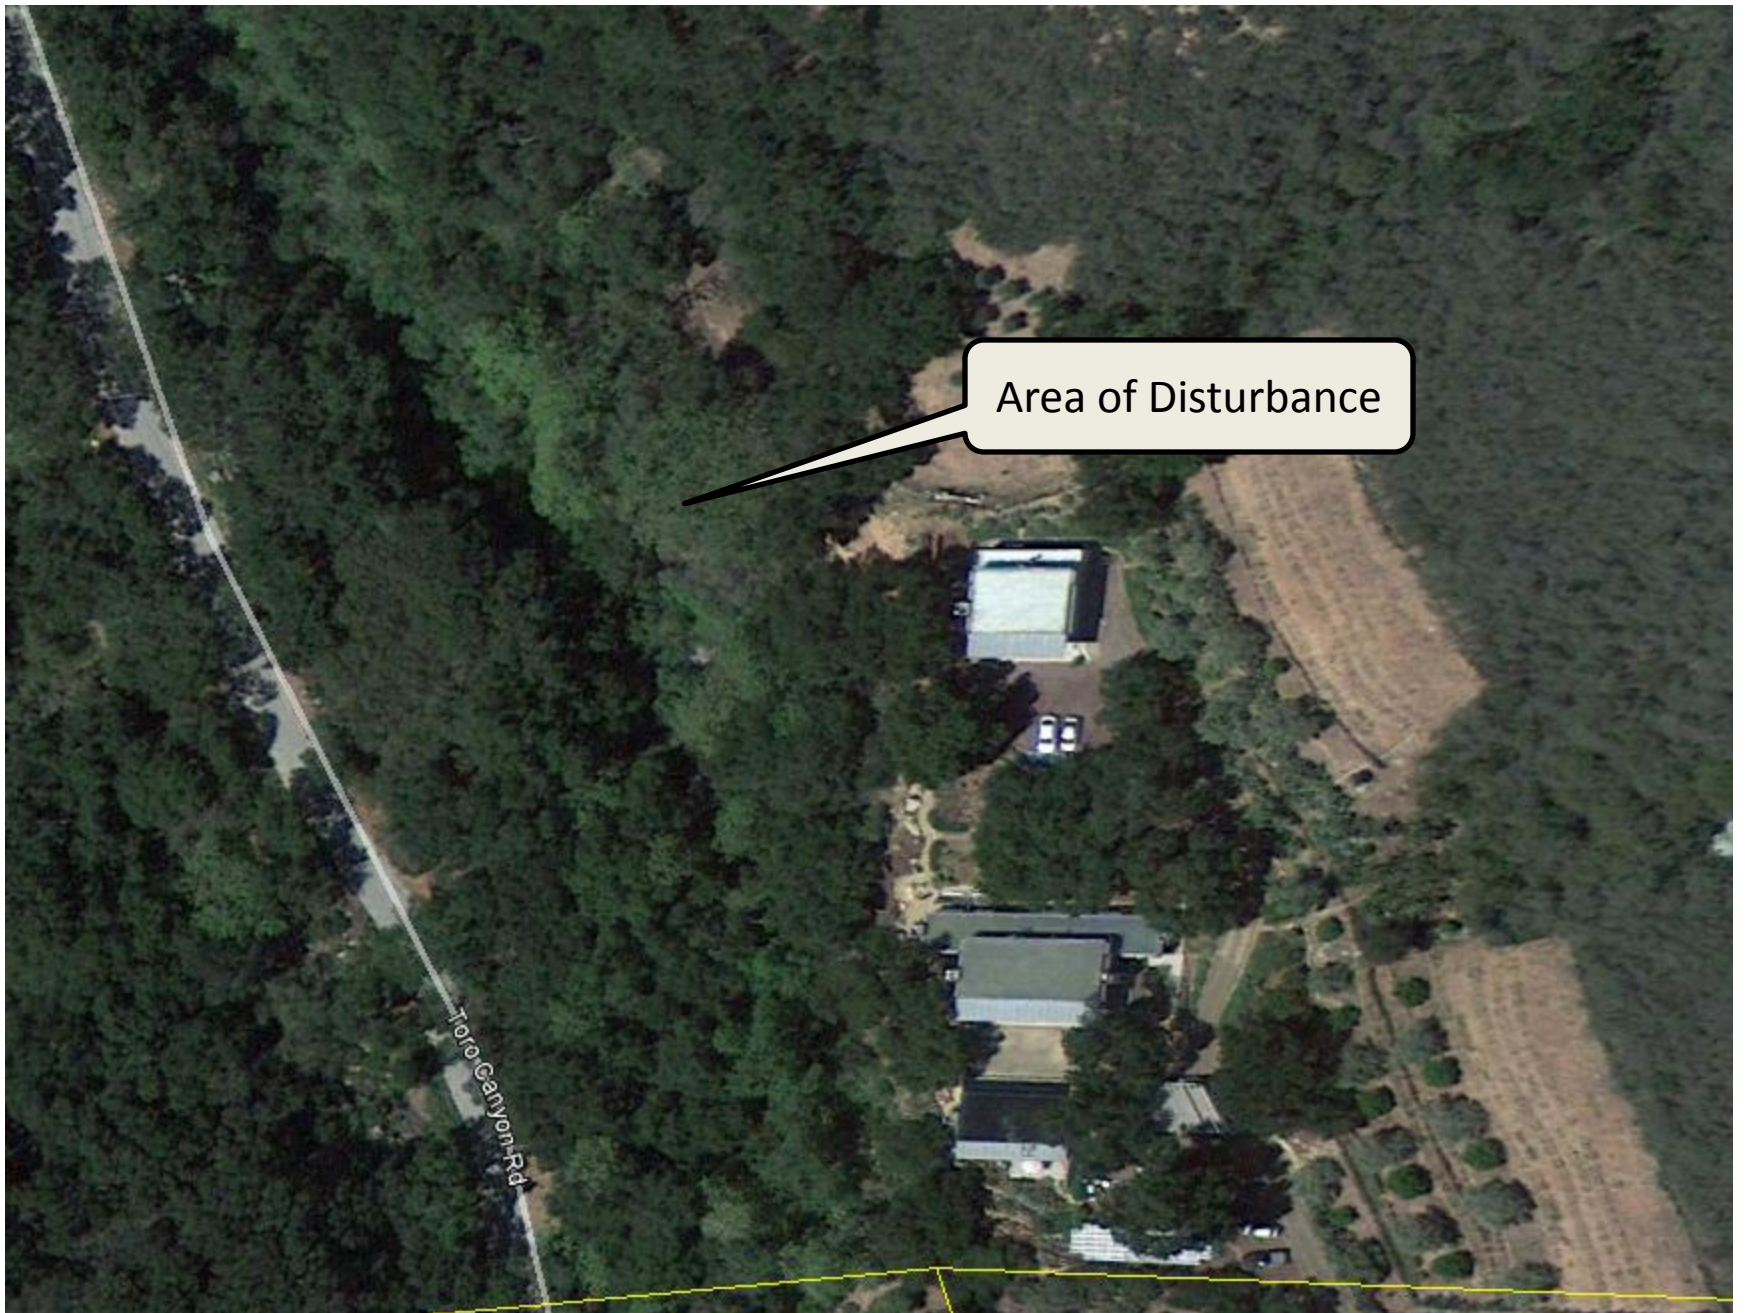
Glenn S. Russell, Ph.D., Director

Dianne Black, Assistant Director

April 13, 2016

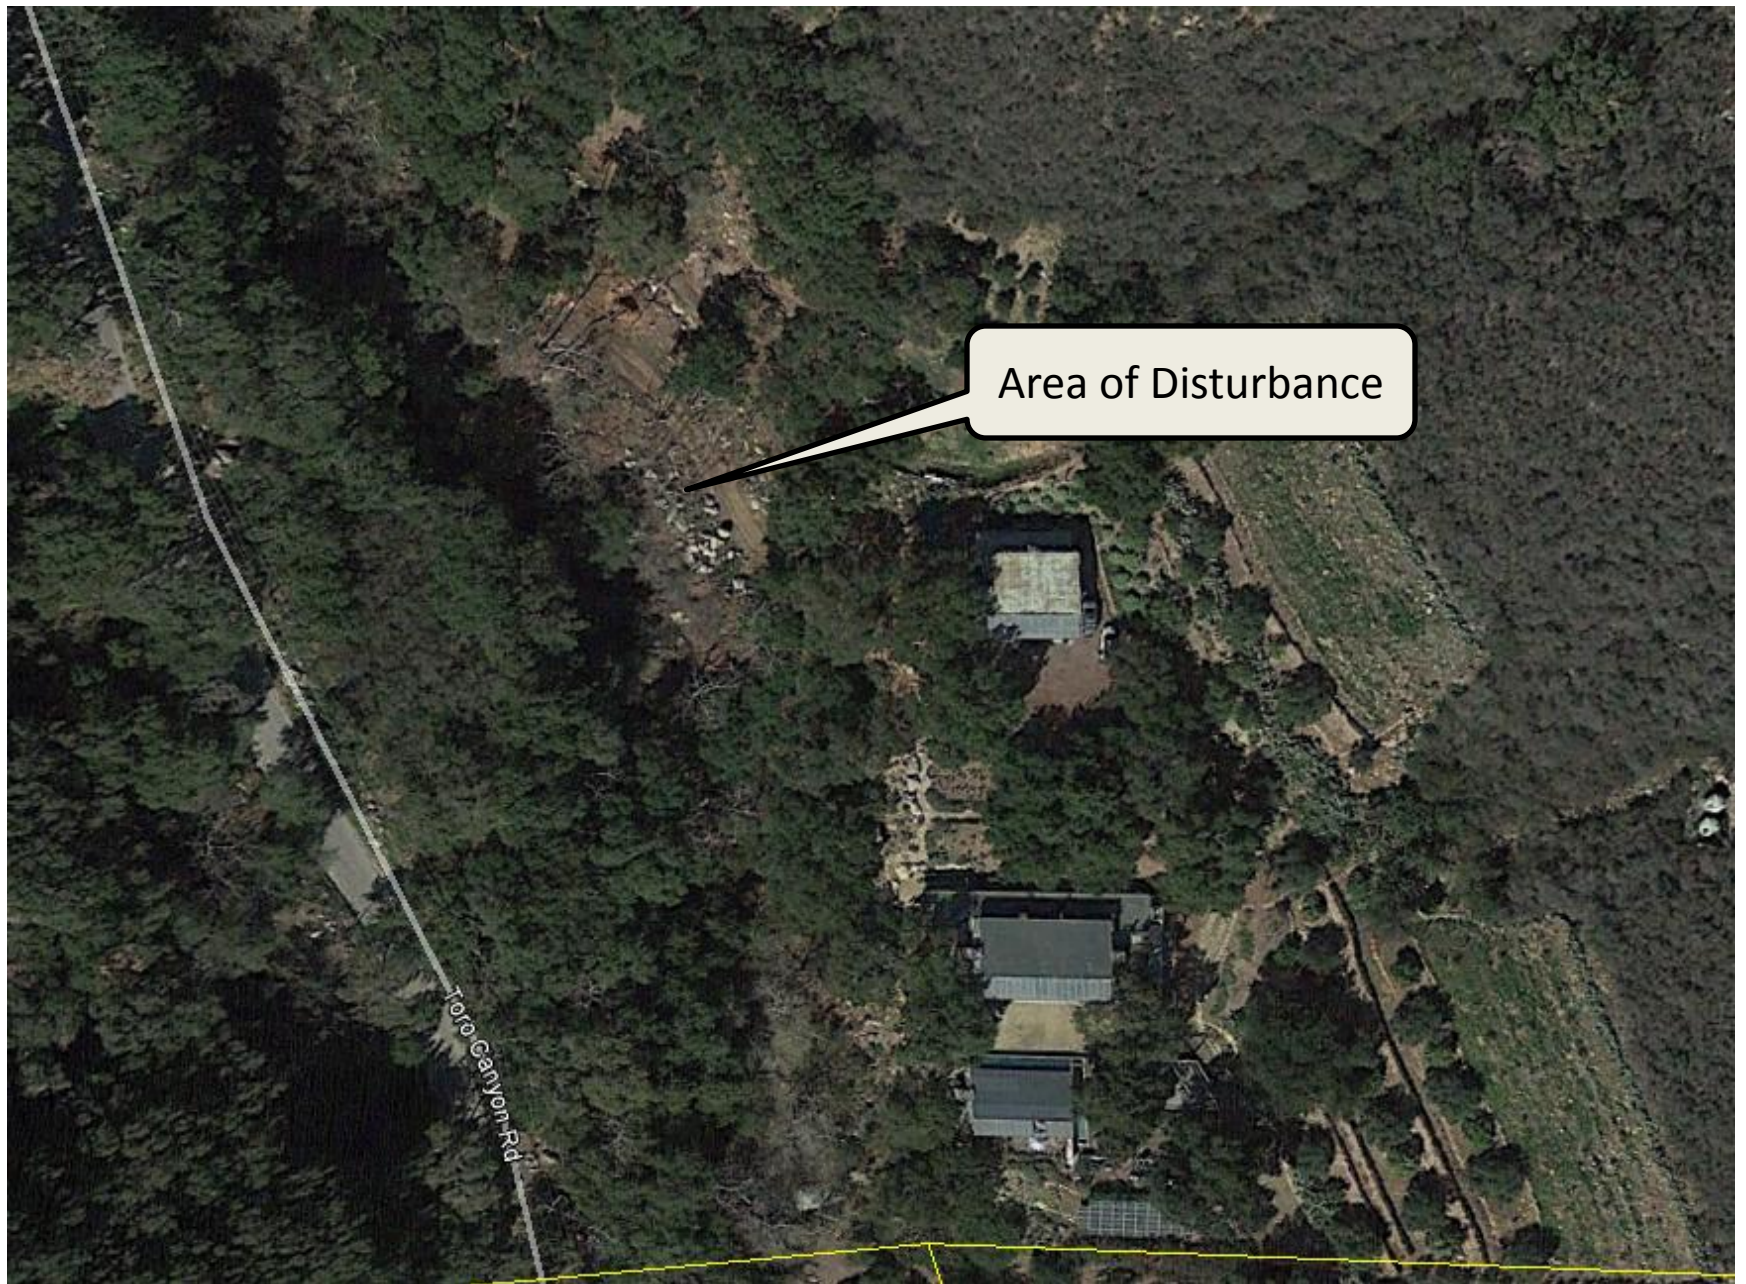
RE: DENIAL LETTER
Myers Bridge
949 Toro Canyon Road
Case No. 16LUP-00000-00109; APN 155-020-004
