Re: Addendum to the Biological Resources Assessment for the Montecito Debris Flow Mitigation Project, Santa Barbara County, California

Proposed Net Locations, Jurisdictional Boundaries, and Sensitive Resources
Montecito Debris Flow Mitigation Project
The Partnership for Resilient Communities (TPRC)
Santa Barbara County, CA

Revised Figure 6e
 December 13, 2018

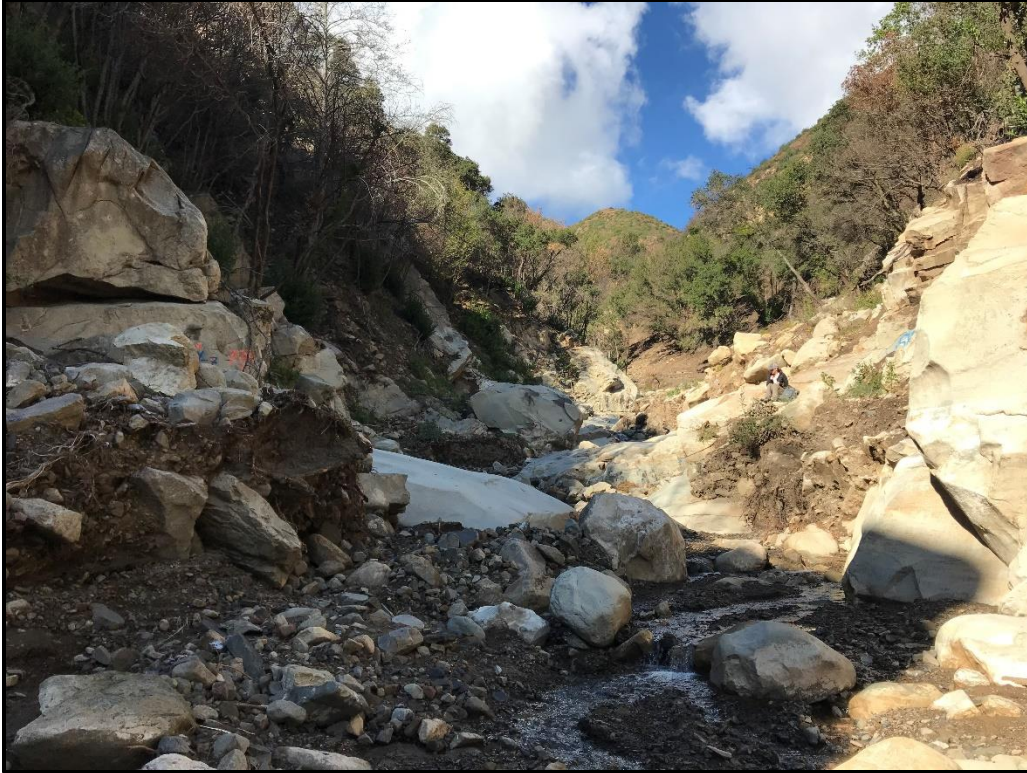
Photo 1 – View of SY-7a net location looking upstream (Aspect: North).

In addition to the removal of the two nets in Hot Springs Creek, one net location in San Ysidro Creek (SY-7) was relocated approximately 190 feet downstream to avoid a public trail crossing in the creek channel. The new net location is now referred to as SY-7a (see attached Site Photographs). Table 1 below provides a description of the net type, site dimensions, and coordinates at SY-7a.

All of the creeks surveyed as part of the Project are perennial, ultimately discharging into the Pacific Ocean, and therefore, are considered jurisdictional Waters of the U.S. under current federal guidance. Recent scour was evident in the San Ysidro Creek channel from storm events on November 27-29, 2018 and December 4-5, 2018. The active flow in the channel was approximately 14 inches to 4 feet wide, and ranged from 2 to 6 inches deep. The channel was approximately 10 to 25 feet wide at the OHWM, which was determined using physical marks on the landscape (e.g., debris racking, topographic breaks in slope, etc.) (see Attachment A – Site Photographs; Revised Figure 6e).

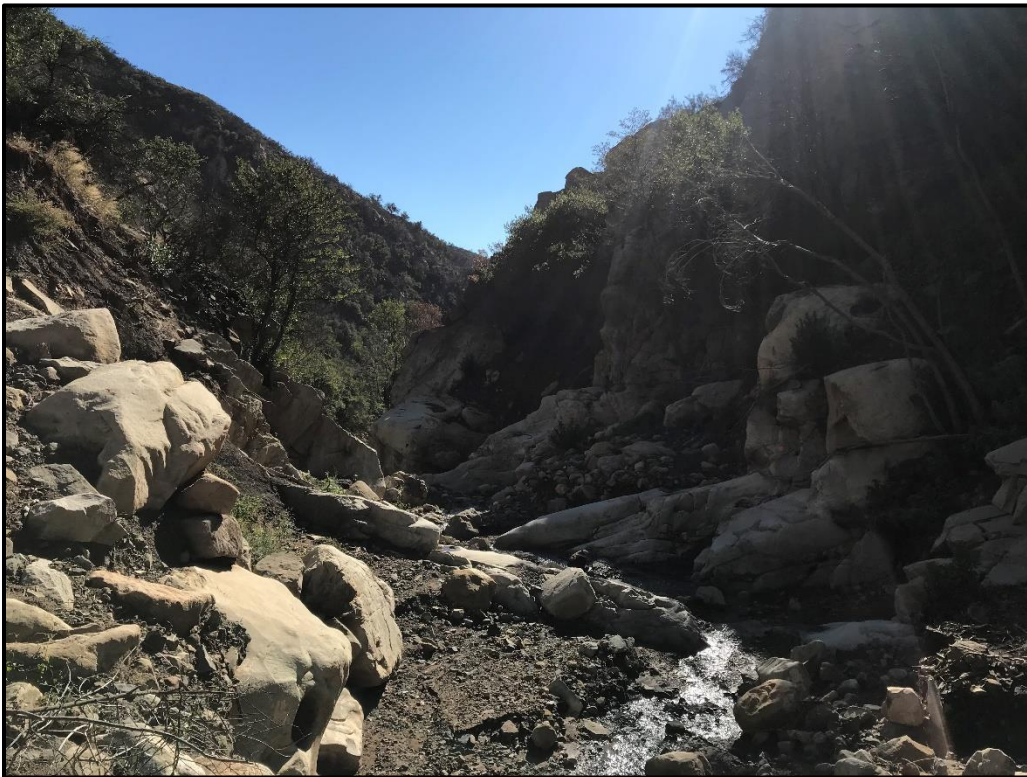
Photo 2 – View of SY-7a net location looking downstream (Aspect: Southeast).

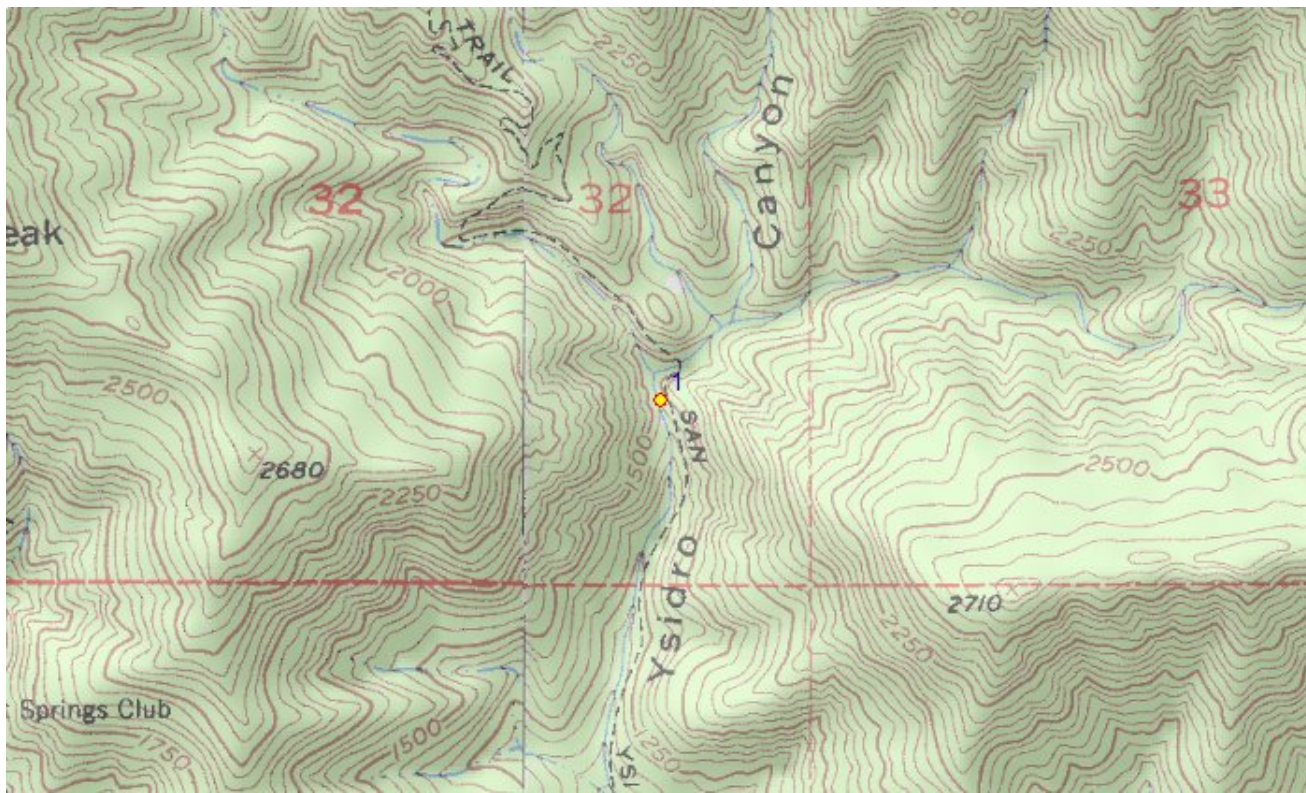
MAP INFORMATION

ID	County	24K Quadrangle	Elev. (ft)	Latitude NAD83	Longitude NAD83	UTM E NAD83	UTM N NAD83	UTM Zone
	Santa Barbara	Carpinteria	1473	34.46820	-119.62287	259090	3817194	11
1	Public Land Survey	Feature Comment						
	S T05N R26W 32

The mapped feature is accurate within: 5 m

Source of mapped feature: iPad/ArcCollector/Arrow 100

Location/directions comments: 4 Plummer's baccharis in 4x4 area (16 sqft) in San Ysidro Canyon
