PHASE 1-2 CULTURAL RESOURCES STUDY
HISTORIC RESOURCES
FUNICULAR
1553 ROBLE DRIVE
HOPE RANCH, CALIFORNIA
APN 63-160-24

FINAL

Prepared by
Alexandra C. Cole
Preservation Planning Associates
519 Fig Avenue
Santa Barbara, CA 93101

July 2001

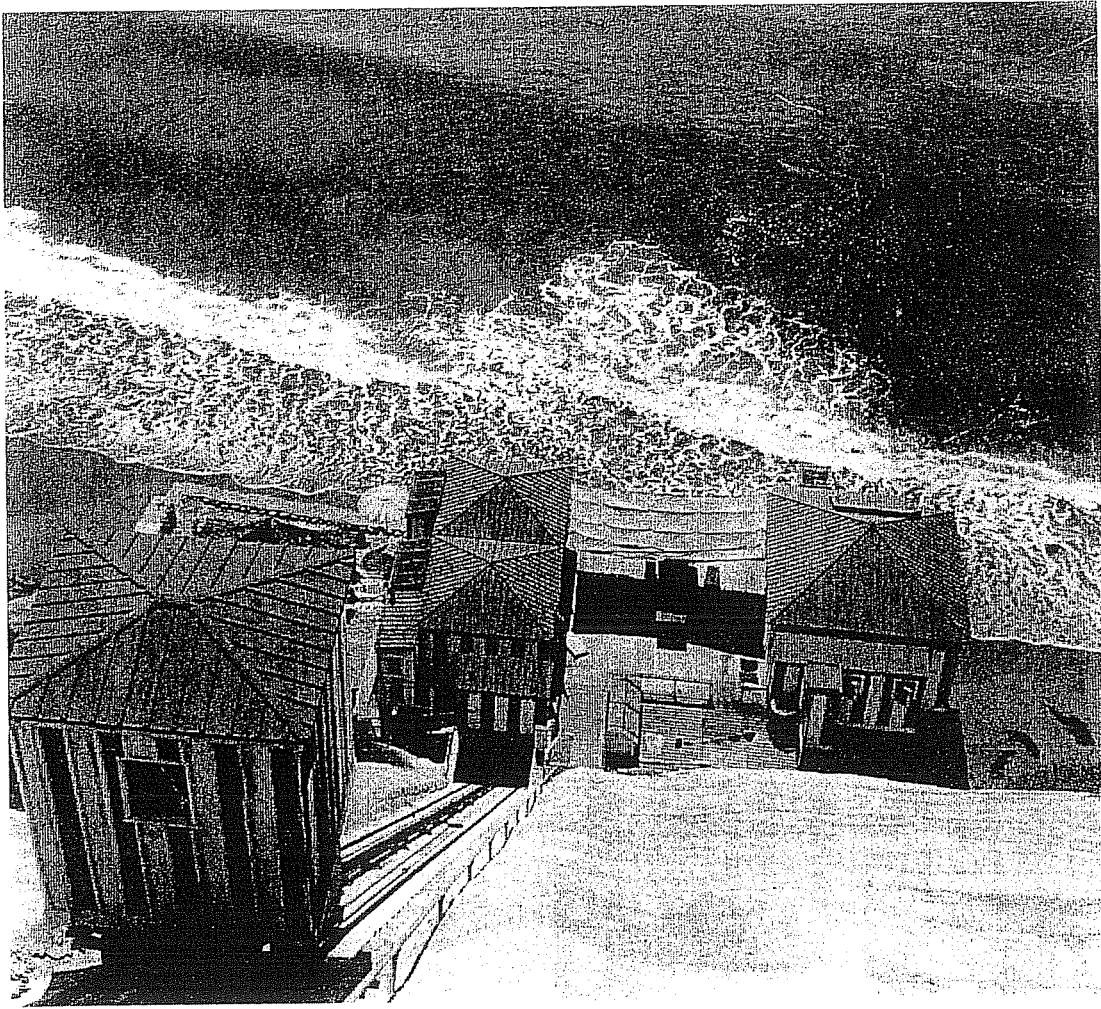
Plate 1. Elevator and beach house c. 1930s. *Courtesy Marc Appleton*

The beach house to be serviced by the elevator was built at the base of the cliff. It consisted of a large platform of reinforced concrete set on eight large cylindrical concrete posts, topped by a wood deck. Three square cabanas sat on this wood deck, a large one to the west and two smaller adjoining ones to the right, separated by a deck open to the sky. Two retractable canvas awnings strung on wires shaded the long picnic table and benches set out on this deck (see Plate 1).

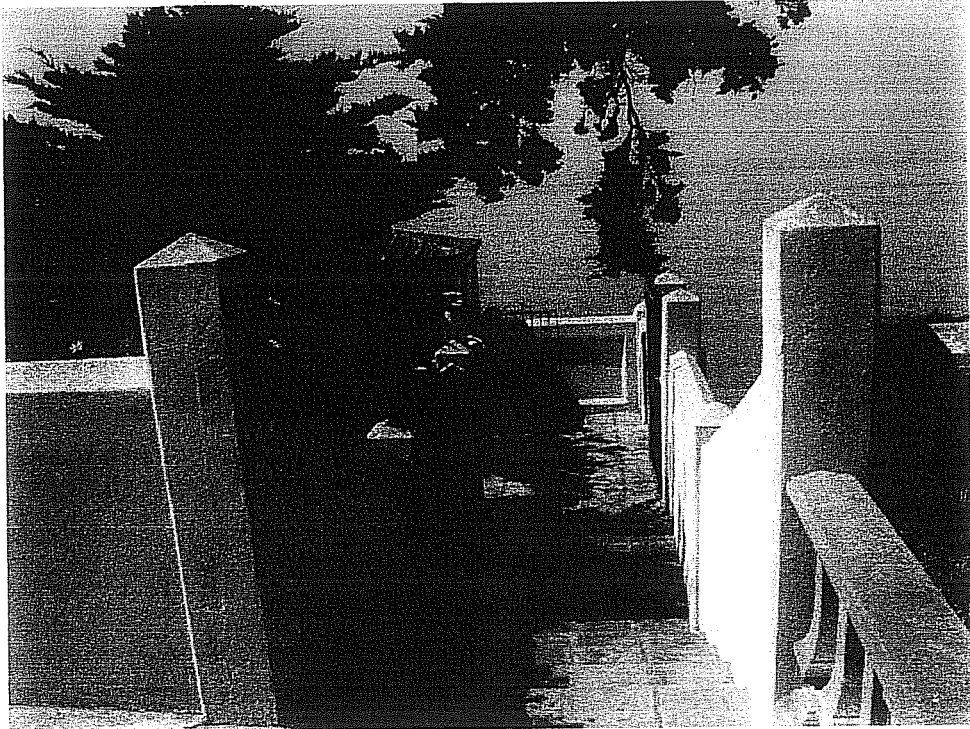
Plate 7. Entrance steps to elevator platform. Facing south. A. C. Cole, July 2001

The elevator is surrounded by a four-foot high concrete wall along the bluff top, punctuated by eight concrete posts with hipped caps (see Plate 6). A flight of red tile steps bisects the wall, leading to a concrete bench and tiled platform, beyond which is the elevator cab (see Plates 7 and 8). A pair of diamond plate industrial doors in the

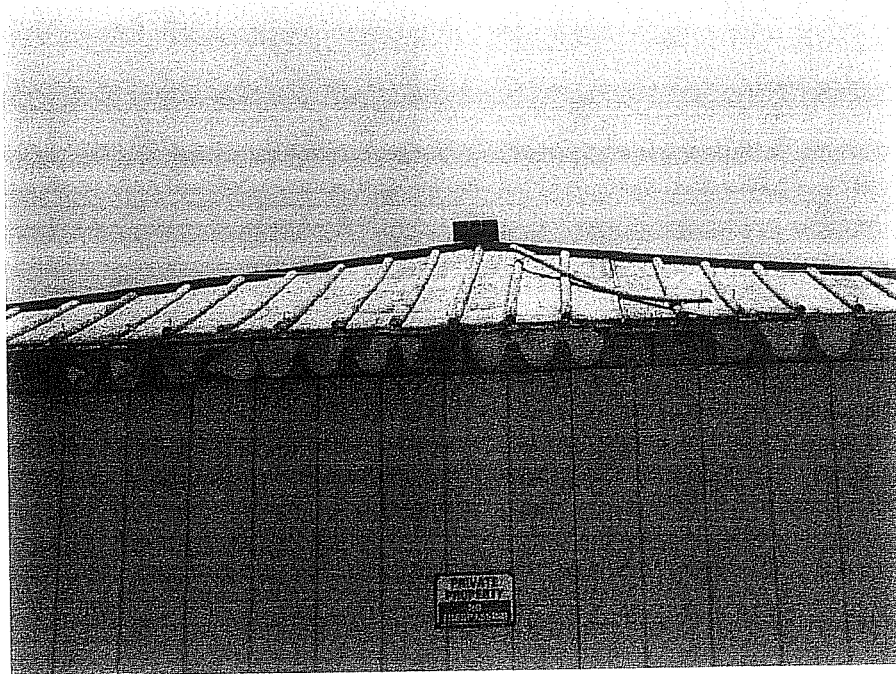
Plate 14. Beach house showing sheet metal scallop detail and original walls beneath protective plywood paneling. Facing east. A. C. Cole, July 2001

1. It is recommended that the applicant undertake an analysis of the original paint scheme of the elevator cab and beach house, through on-site chromochronology, with original colors matched to modern paint chips, to serve as a guide when repainting the stripes.
2. It is recommended that copies of photographs of the system in the 1930s, provided courtesy of Marc Appleton, grandson of the Bryces, with a copy of this report, shall be presented in a binder to the Gledhill Library of the Santa Barbara Historical Society before any alterations take place.
