Project: Coroner's Office

Subject: Ventilation Study in response to, Santa Barbara Civil Grand Jury report titled, ***Sheriff-Coroner's Bureau: The Manner of Death – A Final Diagnosis*** (Published June 21, 2013 on Grand Jury Web Site)

PROJECT: VENTILATION STUDY OF COUNTY CORONER'S OFFICE

DESCRIPTION:  
MAIN BUILDING EXISTING  
CONDITIONS.

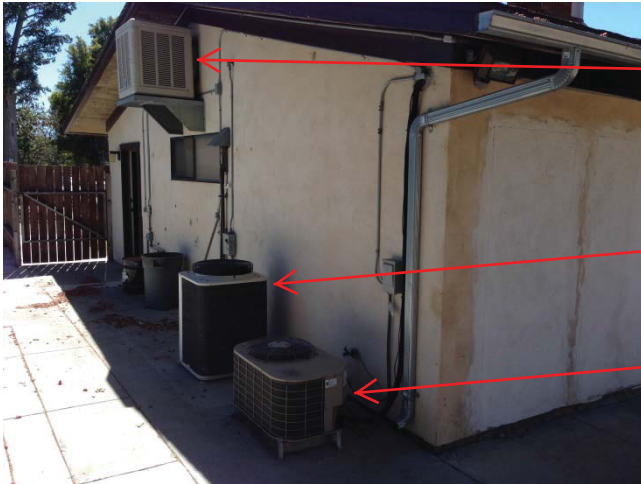
- f. It was also discovered that the makeup air system has been disabled and abandoned in place (Finding 3b). This causes a negative pressure in the lab of -0.29" WC when the doors are closed and exhaust is running. Normal negative pressure should be -0.01" WC.

Lab & Locker  
Room Makeup Air  
Unit, Disabled.

Locker Room A/C  
Condensing Unit.

Office A/C  
Condensing Unit.

1. Replace the makeup air system to provide well filtered and conditioned (heated and cooled) fresh air, properly distributed to provide laminar flow at the autopsy table and full coverage in the lab (Recommendation 5).
2. Replace the rooftop exhaust fan with a vertical discharge fan and high velocity stack (Recommendation 3b).
3. Remove the office A/C supply grille and cap the duct. Office and Lab air systems must be segregated.
4. The size of the window A/C unit is adequate to control the room temperature when the exhaust fan and makeup air systems are off. Conditioned makeup air will control the room temperature when the exhaust system is operating.
5. Add room static pressure gauges to prove negative lab pressure to occupants of the building.

1. Replace the oversized bathroom and shower exhaust fan with appropriately sized fans.
2. Cap off the makeup air ductwork into this space and patch the ceiling.
3. Repair or replace the existing general exhaust fan and interlock with the office FAU fan for continuous operation during occupied hours.

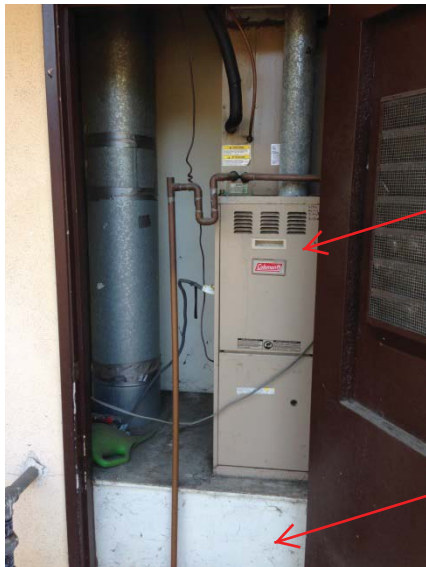
- a. The office area and restrooms are served by a forced air furnace and 3-ton split air conditioner. Ductwork layout is adequate with supply and return air in each major office space.
- b. No fresh air intake causes a negative pressure in relation to the outside and possible back feeding from the lab. Fresh air is required by code.
- c. The restrooms do not have exhaust fans but they do have supply air. When bathroom windows are closed, air will flow from the bathrooms to the office area.

Office A/C Furnace  
and Evaporator.

No Fresh Air  
Intake.

1. Add a fresh air intake to the office system and add exhaust fans to the restrooms.

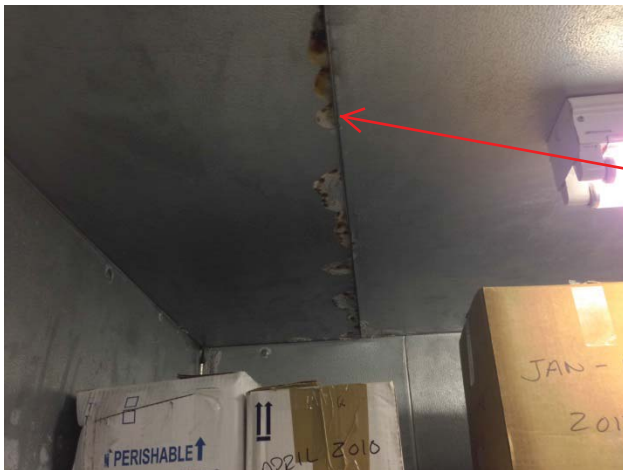
- a. The Cooler mechanical equipment is adequate.
- b. The Walk-in cooler ceiling is corroded and in need of repair.
- c. The ventilation for the compressor mechanical room is not functioning.
- d. The compressor room exhaust fan is not operational.
- e. The compressor is low on refrigerant.

Walk-In Cooler  
Ceiling Corrosion.

1. Repair corroded cooler ceiling.

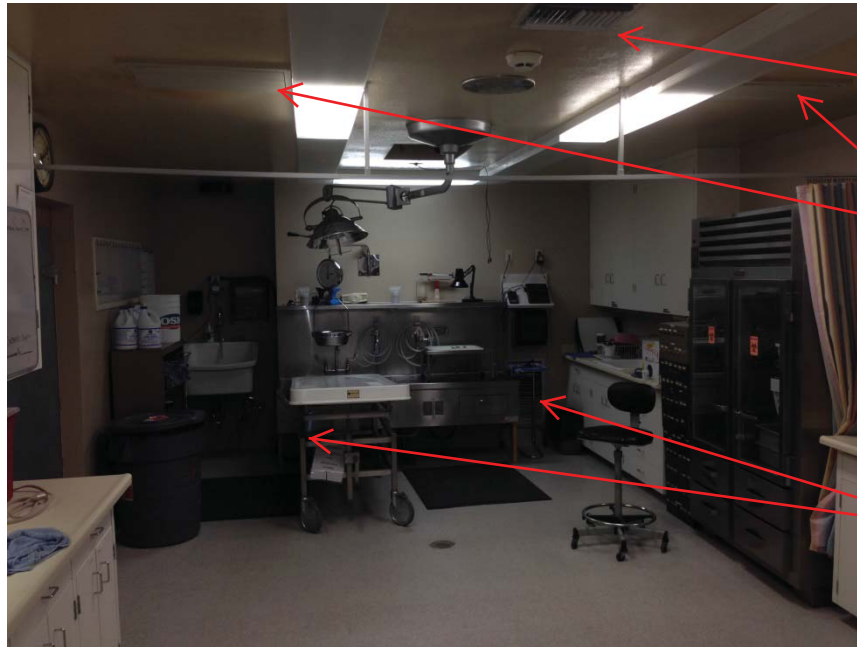
- b. Exhaust vents are low wall as required, but makeup air is not located to provide laminar flow.
- c. Exhaust air flow was tested and the current air flow is approximately 28 air changes per hour (1,560 CFM). More than adequate to meet the air change requirement (Finding 3a).

- g. The lab has a 1.4 ton window air conditioning unit that is inadequate when the exhaust fan is operating.
- h. The office area air conditioning system also serves the lab.

Office A/C Vent  
into Autopsy Lab

Disabled Makeup  
Air Vents.

Low Wall Exhaust  
Vents.

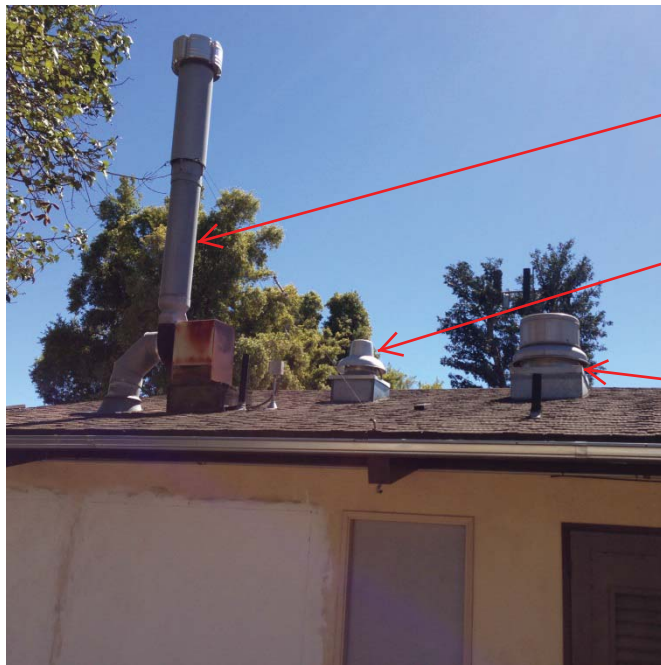
- d. The existing exhaust fan does not discharge air up and away from the building (Finding 3b).
- e. The existing exhaust system has a filter rack for a 20"x 24"x 2", 30% efficient filter. This filter was found collapsed in the duct from lack of service (Finding 3b).

- a. The locker room is served by a 3-ton ductless split air conditioner. This is oversized for this room, however it is working.
- b. There is a small general exhaust fan in the center of the room that is not operational.
- c. The shower and water closet are served by a large exhaust fan that may have once served a fume hood. Air flow is much more than required for these rooms and draws makeup air from the rest of the building when operating.
- d. The disabled makeup air system (Finding 3b) also has duct and grilles serving this room.

Locker Room  
Shower and Toilet  
Exhaust Fan.

Locker Room  
General Exhaust,  
Not Operational.

Autopsy Lab  
Exhaust Fan. Down  
Shot Discharge.

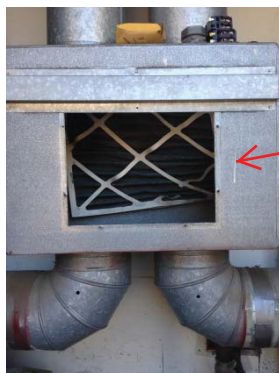
Autopsy Lab  
Exhaust Duct  
Filter.  
Requires Regular  
Replacement.

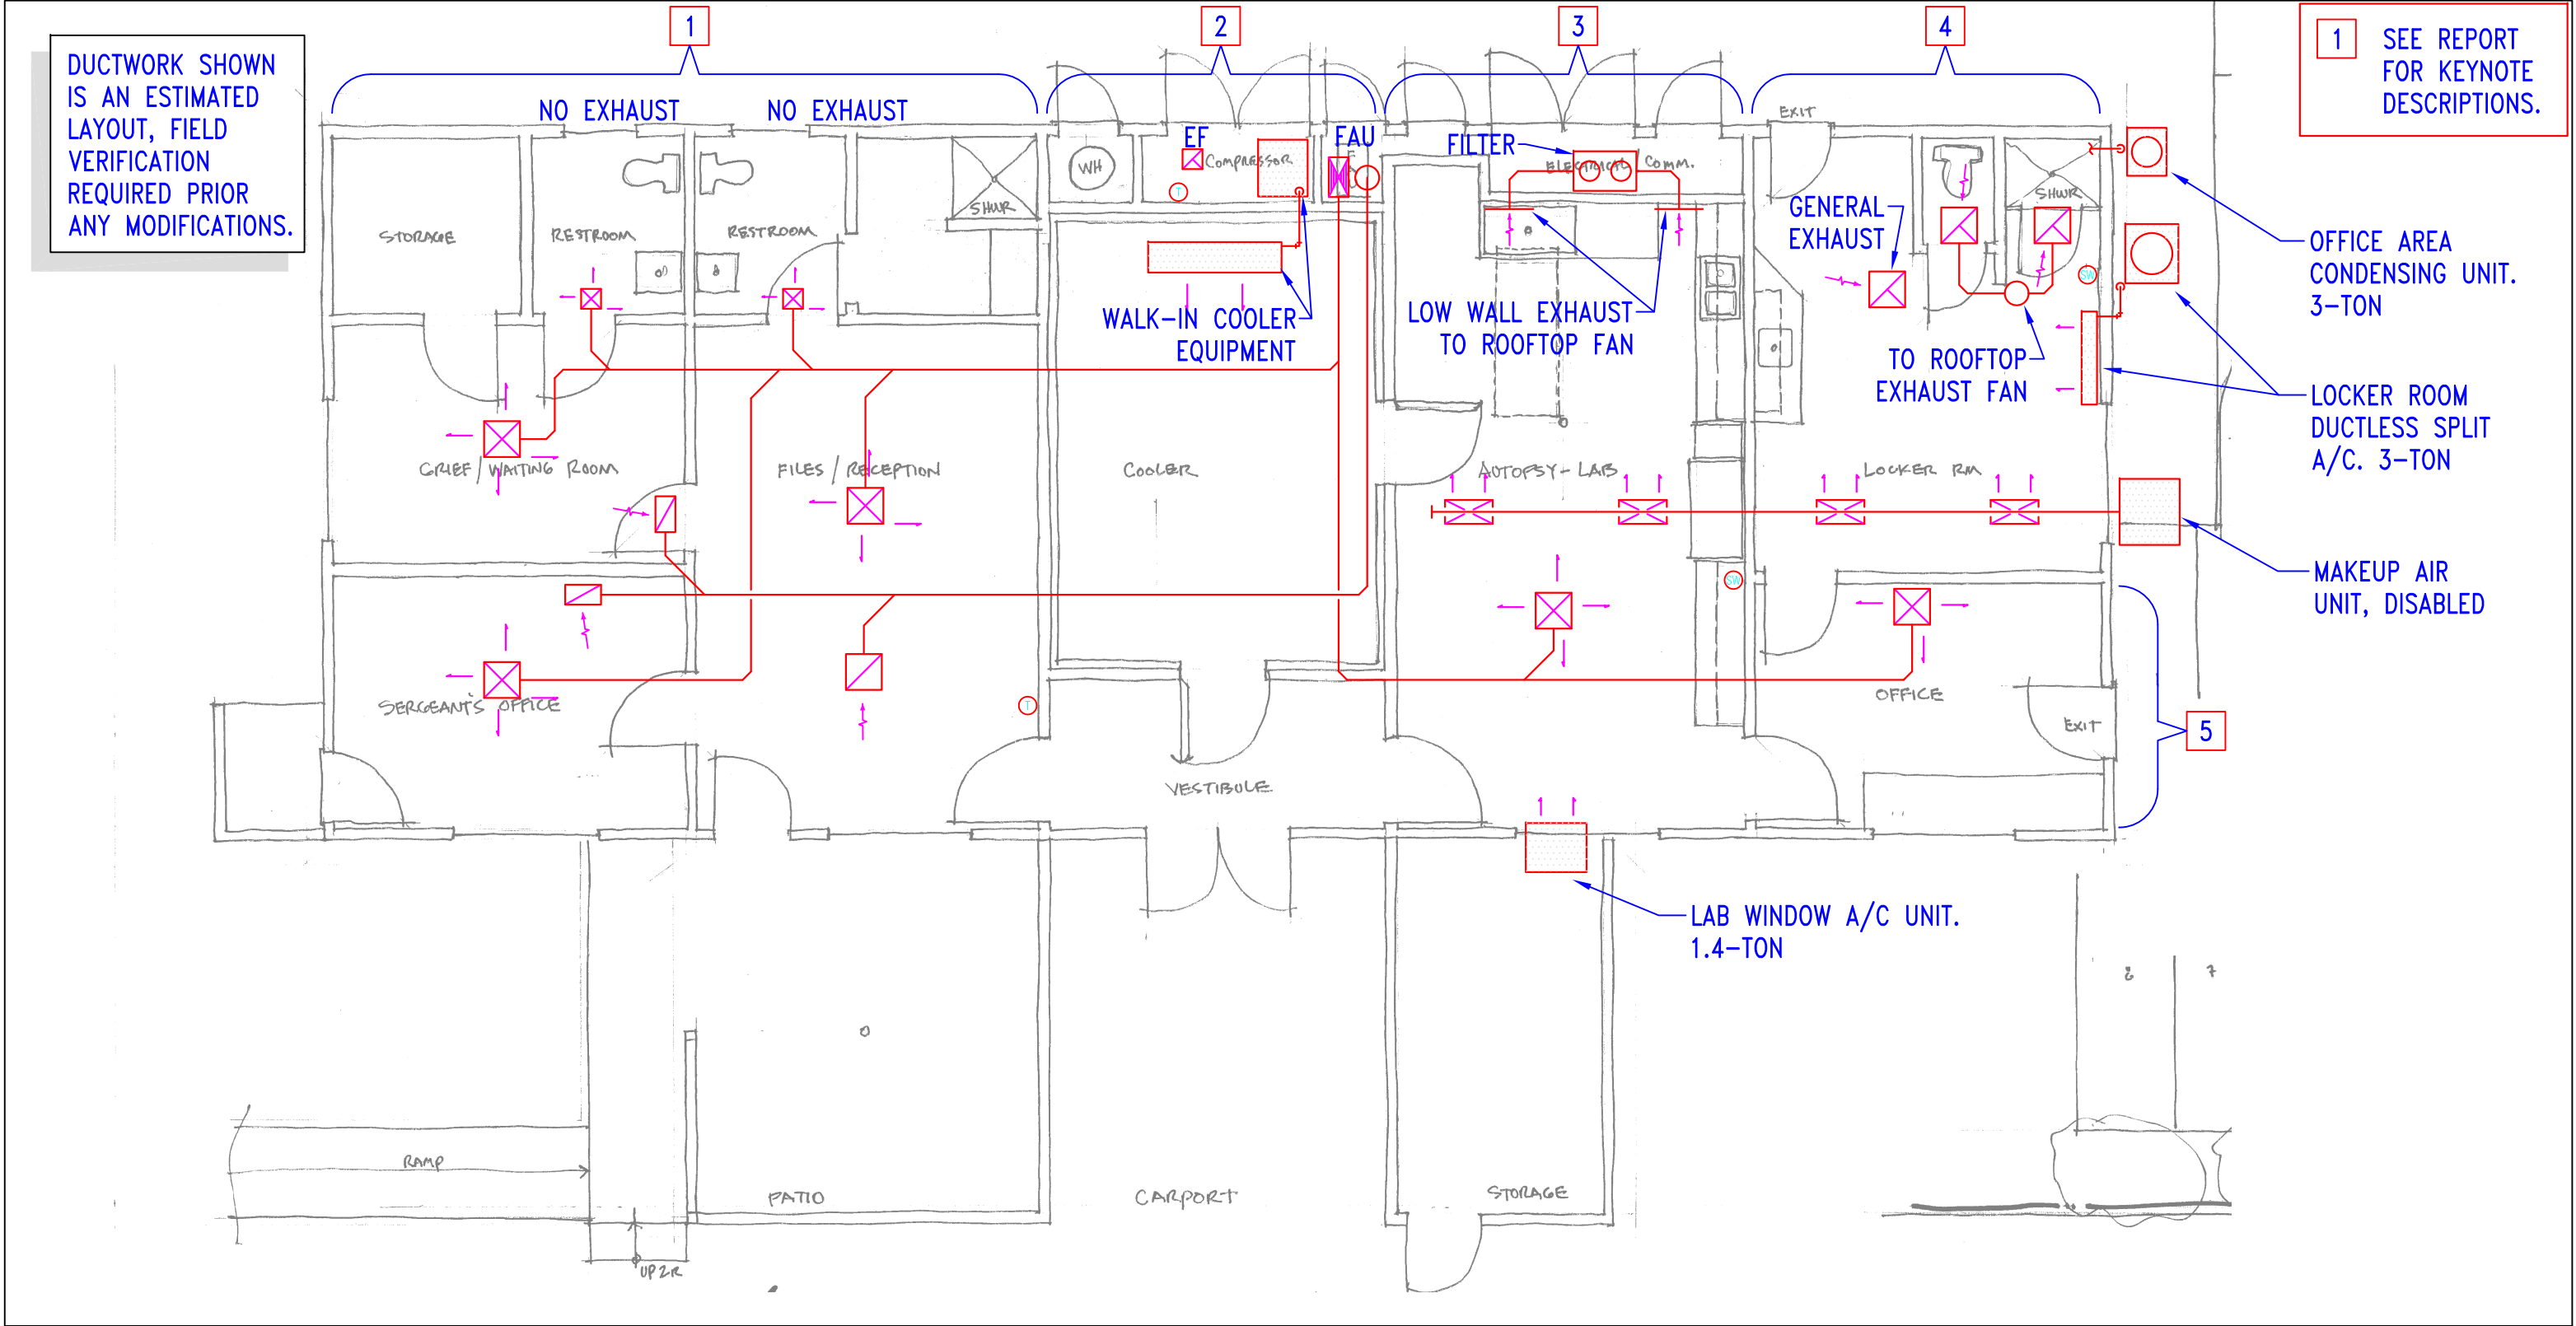
MSK-1

SITE: COUNTY OF SANTA BARBARA CORONER'S OFFICE  
SHEET TITLE: MAIN BUILDING MECHANICAL FLOOR PLAN  
SCALE: NTS  
DRAWN BY: SD  
CHECKED BY: SD
