Appendix 3 – RJM Design Report

Community Parks

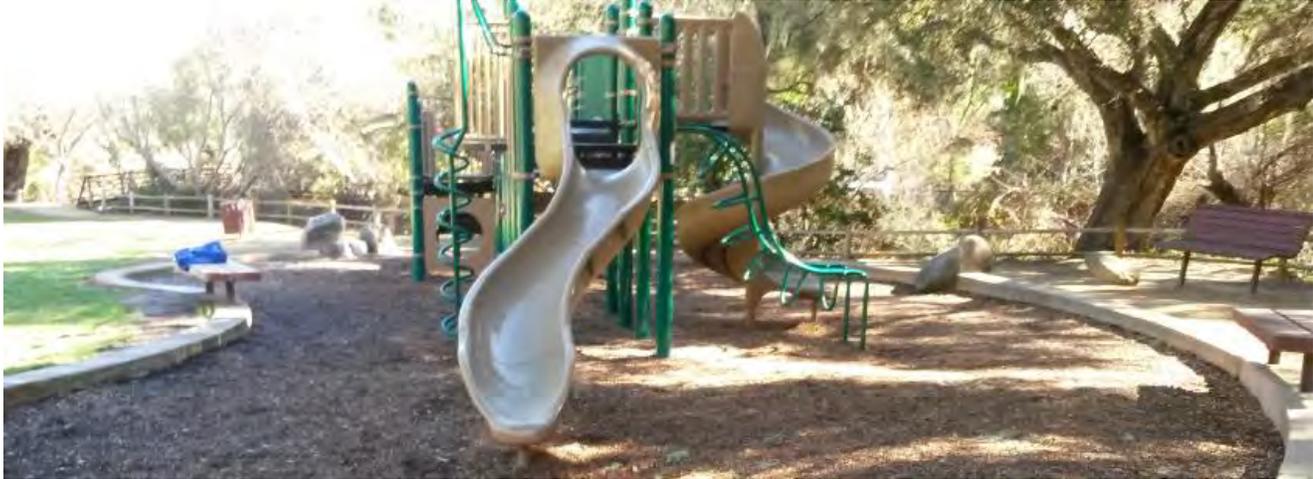
The Miguelito Park Playground Area B does not comply with the California Playground Safety Regulations (CPSR) for the following reasons:

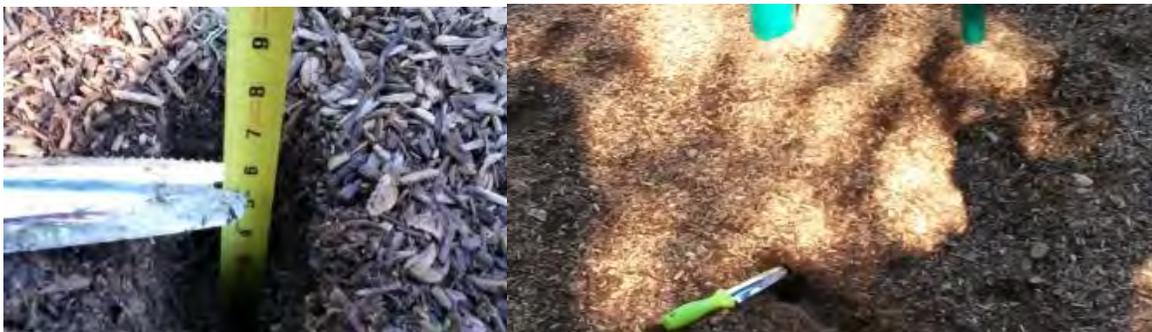
Surfacing

HAZARD: The playground only has 3-6 inches of wood fiber in some areas. California Playground Safety Regulations state that a minimum 9 inches of wood fiber is required. Priority 1 Hazard -Indicates a life-threatening or debilitating injury. Appropriate action is to remove or fix immediately.

Solution: Fill the playground area with wood fiber to 10"-12" to compensate for the rate of compaction which is approximately 1"-2" every year. To prevent fast degradation install filter fabric where the soil meets the wood fiber.

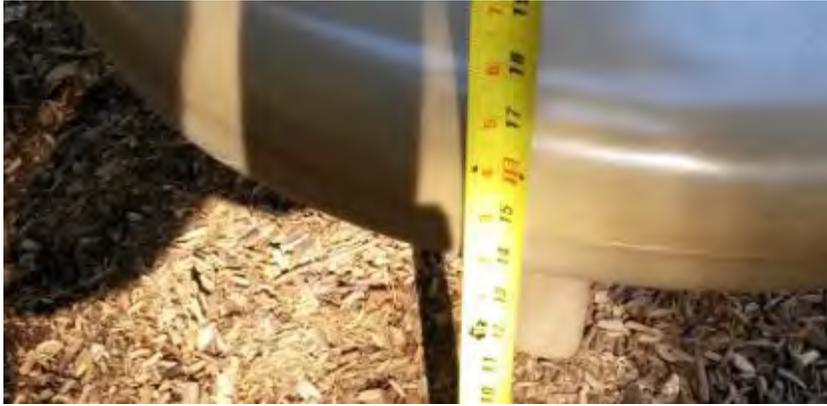
Slide Exit Height

Hazard: The slide exit is 18 inches above the safety surfacing. CPSC requires that the slide exit be no more than 15 inches from the safety surfacing. Priority 2 Hazard - Indicates the possibility of broken bones, stitches, etc. Appropriate action is to schedule to fix or replace as soon as possible.

Solution: Add additional wood fiber to close the gap of at least 3 inches.

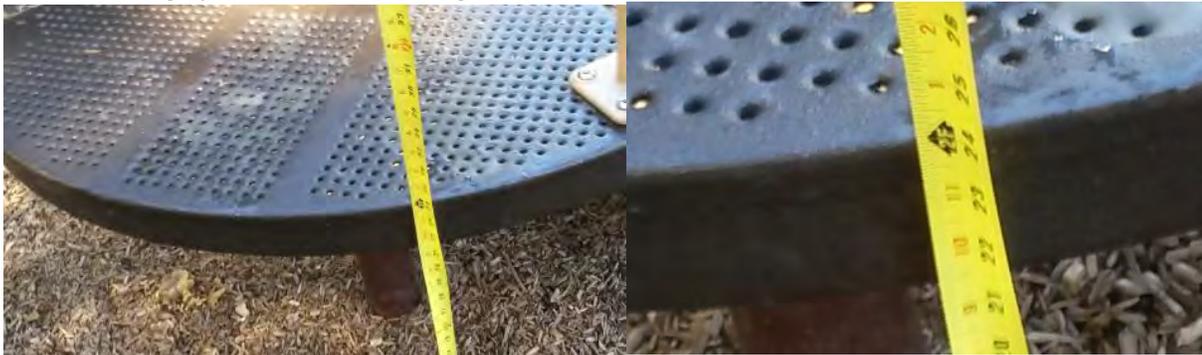
ADA Transfer Station Too High

HAZARD: The ADA transfer station is approximately 24 inches above the safety surfacing. CPSC requires that the ADA Transfer station be from 11 inches (280 mm) to 18 inches (455 mm) height of top surface. - Level of risk: Priority 3 - A priority 3 hazard indicates cuts, scrapes or other minor injuries.

Solution: Bring up the level of surfacing or lower the deck.

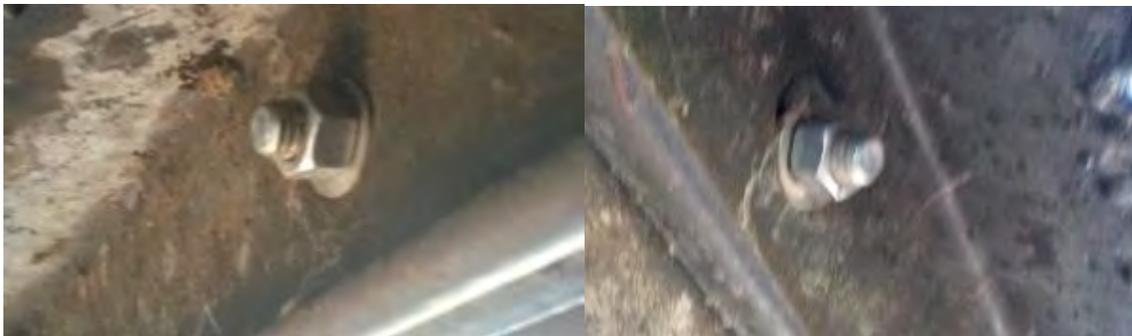
Protrusions

Hazard: There are bolts under the main deck that protrude too far beyond the nut. California Safety Regulations state that the end of a bolt shall not protrude more than 2 threads beyond the nut. - Level of risk: Priority 1 Hazard - Indicates a life-threatening or debilitating injury. Appropriate action is to remove or fix immediately.

Solution: Grind down the bolts and sand to remove sharp edges.

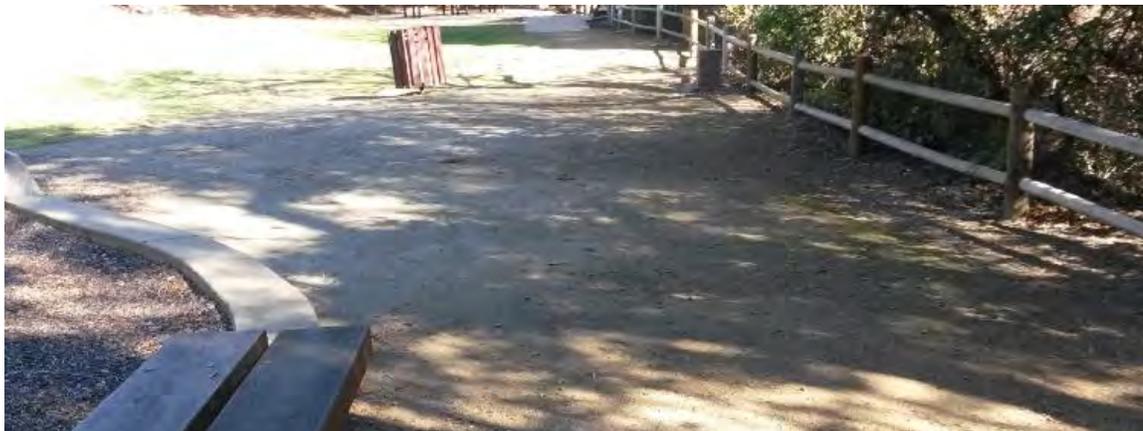
Insufficient Access Route - ADA Compliance

HAZARD: The pathway to the playground is uneven packed earth which can change in consistency when water saturation occurs due to weather. People who have difficulty walking or maintaining balance or who use crutches,

canes, or walkers, and those with restricted gaits are particularly sensitive to slipping and tripping hazards. For such people, a stable and regular surface is necessary for safe walking, particularly on stairs. Wheelchairs can be propelled most easily on surfaces that are hard, stable, and regular. Soft loose sand or gravel, wet clay, and irregular surfaces such as cobblestones can significantly impede wheelchair movement. Priority 3 Hazard - Indicates cuts, scrapes or other minor injuries. Appropriate action is to place on regular maintenance schedule. Solution: Install a proper pathway consisting of a materials like decomposed granite or concrete which is smooth with a gradual slope (1:20) for ADA compliant.

Solution: Install an ADA compliant access ramp to provide a gradual slope entering the playground.

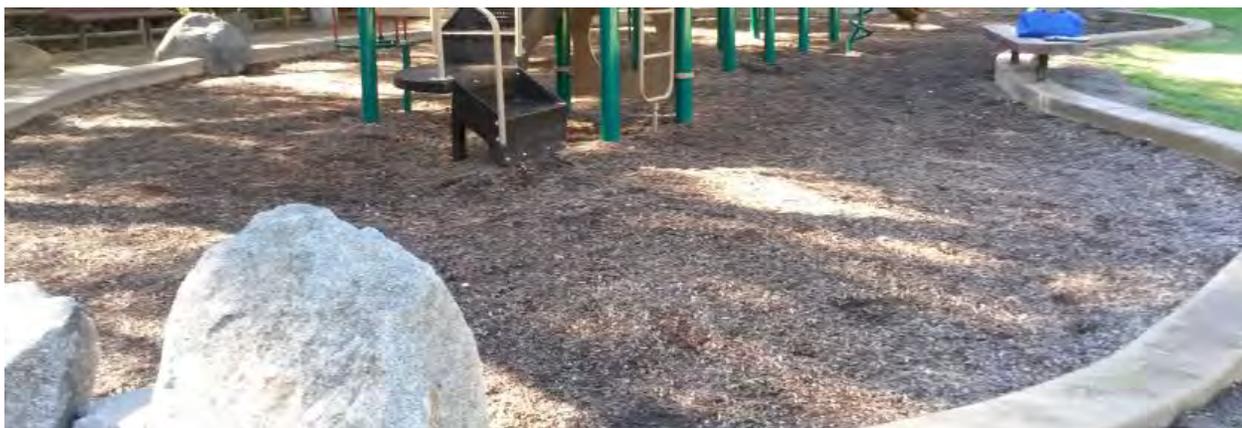
HAZARD: The access route to the playground is surrounded by a curb with no ADA access ramp connecting to the outlying surface. ADA guidelines state that a safe path of travel that is at least 60 inches wide and has a slope that does not exceed a 1:20 ratio is considered accessible. Priority 2 Hazard - Indicates the possibility of broken bones, stitches, etc. Appropriate action is to schedule to fix or replace as soon as possible.

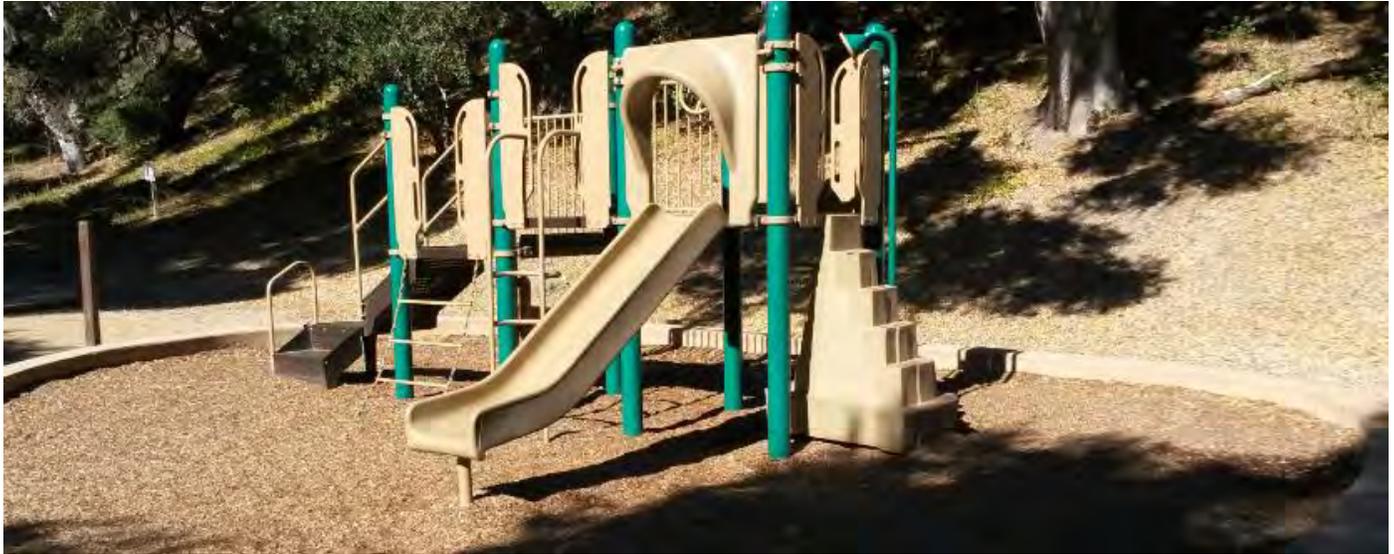
Miguelito Park Playground Area A

Miguelito Park Playground Area B does not comply with the California Playground Safety Regulations (CPSR) for the following reasons:

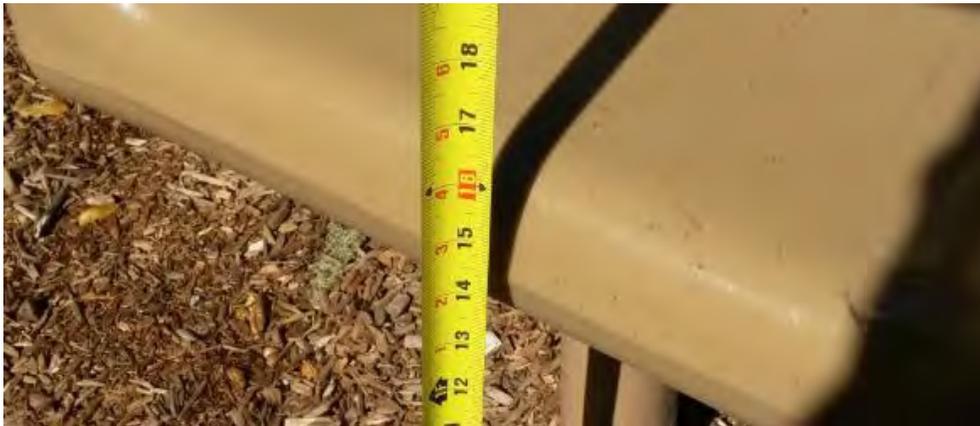
Slide Exit

Hazard: Slide exit is 16 inches above the safety surfacing. CPSC requires that the slide exit be no more than 15 inches from the safety surfacing. Priority 2 Hazard - Indicates the possibility of broken bones, stitches, etc. Appropriate action is to schedule to fix or replace as soon as possible.

Solution: Add additional wood fiber to close the gap of at least 1 inch.

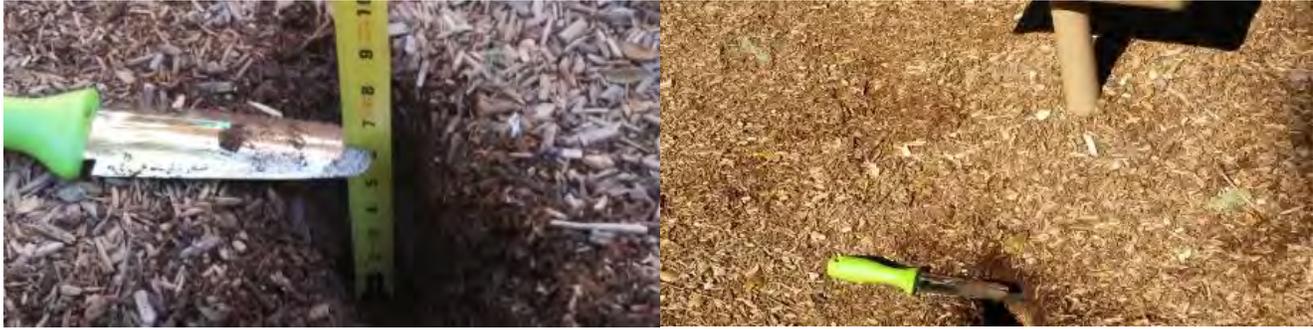
Surfacing

HAZARD: The playground only has 5-6 inches of wood fiber in some areas. California Playground Safety Regulations state that a minimum 9 inches of wood fiber is required. Priority 1 Hazard -Indicates a life-threatening or debilitating injury. Appropriate action is to remove or fix immediately.

Solution: Fill the playground area with wood fiber to 10"-12" to compensate for the rate of compaction which is 1"-2" every year. To prevent fast degradation install filter fabric where the soil meets the wood fiber.

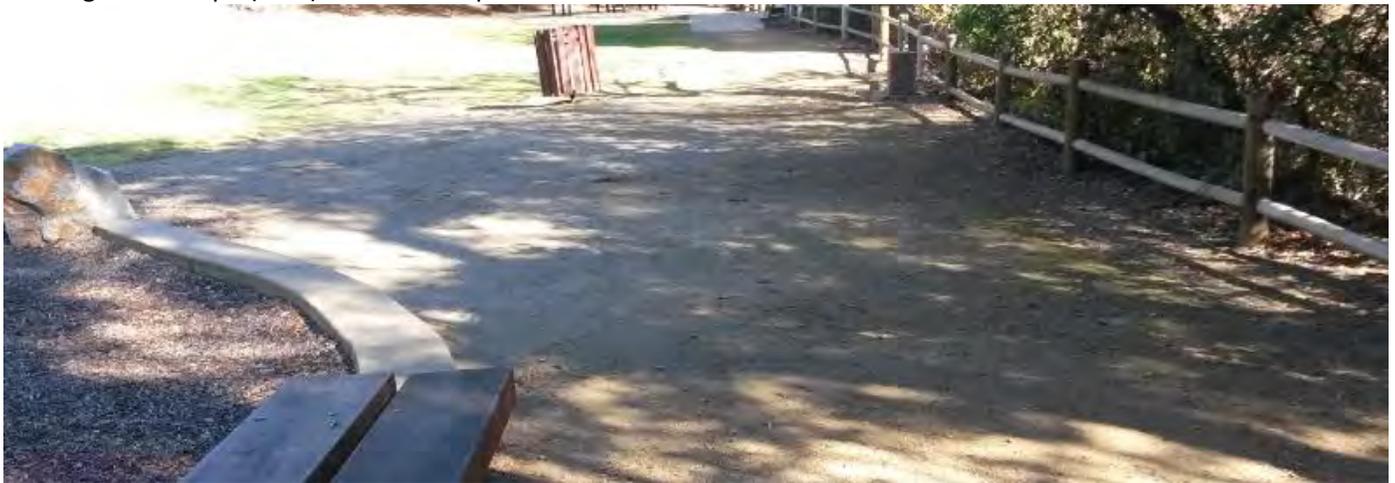
Ground and Floor Surfaces – ADA Compliance

HAZARD: The pathway to the playground is uneven packed earth which can change in consistency when water saturation occurs due to weather. People who have difficulty walking or maintaining balance or who use crutches, canes, or walkers, and those with restricted gaits are particularly sensitive to slipping and tripping hazards. For such people, a stable and regular surface is necessary for safe walking, particularly on stairs. Wheelchairs can be propelled most easily on surfaces that are hard, stable, and regular. Soft loose sand or gravel, wet clay, and irregular surfaces such as cobblestones can significantly impede wheelchair movement. Priority 3 Hazard - Indicates cuts, scrapes or other minor injuries. Appropriate action is to place on regular maintenance schedule.

Solution: Install a proper pathway consisting of a materials like decomposed granite or concrete which is smooth with a gradual slope (1:20) for ADA compliance.

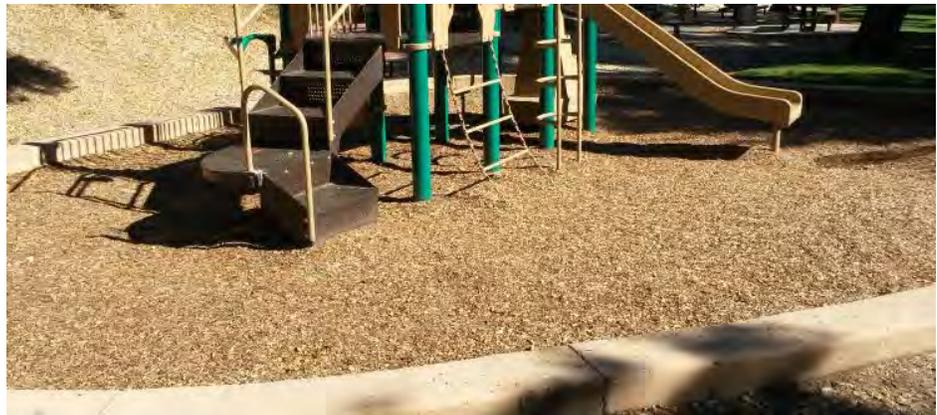
Insufficient Access Route - ADA Compliance

HAZARD: The access route to the playground is surrounded by a curb with no ADA access ramp connecting to the outlying surface. ADA guidelines state that a safe path of travel that is at least 60 inches wide and has a slope that does not exceed a 1:20 ratio is considered accessible. Priority 2 Hazard - Indicates the possibility of broken bones, stitches, etc. Appropriate action is to schedule to fix or replace as soon as possible.

Solution: Install an ADA compliant access ramp to provide a gradual slope entering the playground.

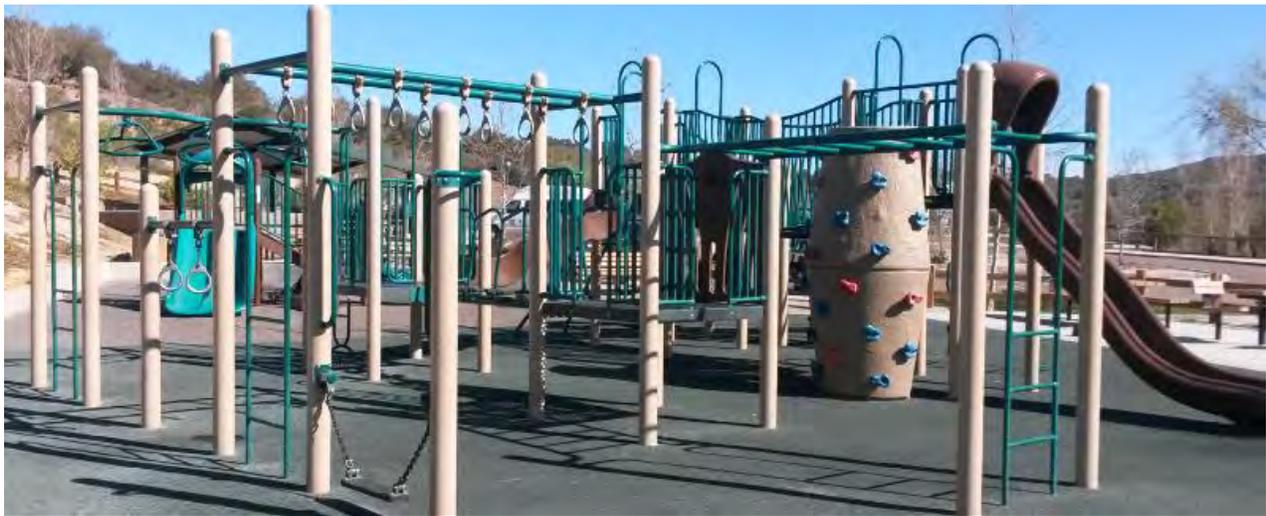
Playground Inspection

The Orcutt Park Playground does not comply with the California Playground Safety Regulations (CPSR) for the following reasons:

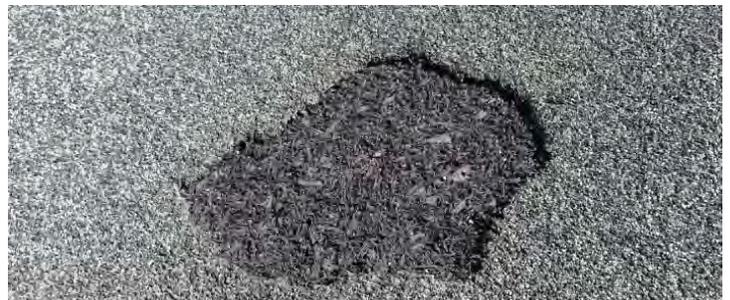
Rubber Surfacing

HAZARD: The poured in place rubber safety surfacing has areas with wear layer missing as shown below. This can cause to area to me less resilient and therefore non-compliant for the fall height requirement. This type of safety surfacing also requires ongoing maintenance otherwise complete replacement will eventually be

necessary due to UV breakdown and hardening. Priority 1 Hazard -Indicates a life-threatening or debilitating injury. Appropriate action is to remove or fix immediately.

Solution: Consult original manufacturer and repair immediately.

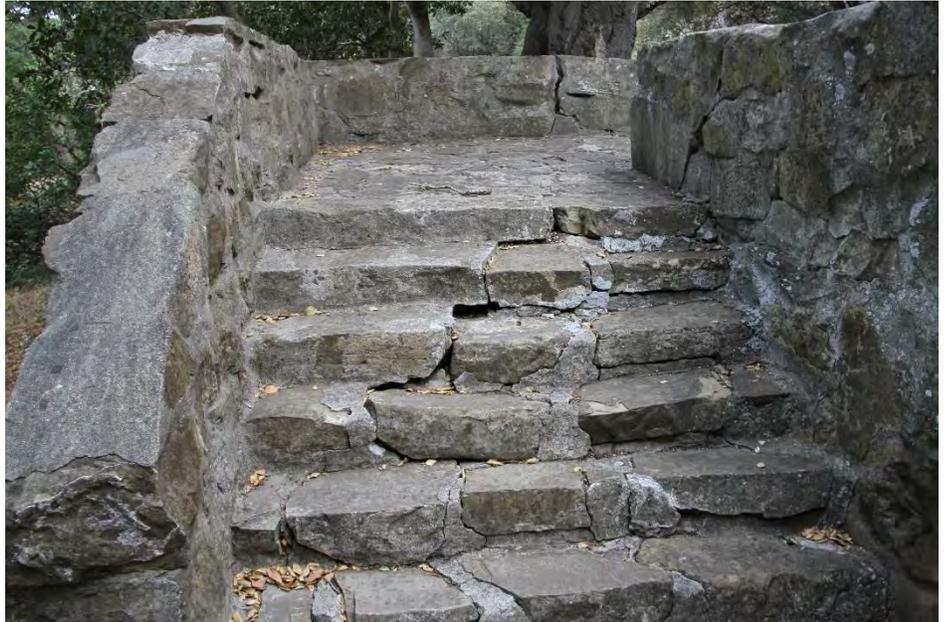
Santa Rosa Park

Park sidewalks included a mixture of asphalt and concrete, were in fair to good condition with several areas of major cracking and uplifting from tree roots. Evidence from newer construction, indicates that the County has adopted a new standard of concrete for all walkways.

Despite the fact that the County regularly inspects sidewalks and repairs raised surfaces by either ramping or “smoothing” raised concrete, this sidewalks and walkways were found to be a significant issue.

- Continue to conduct regular inspections of park sidewalks to identify settlement and or up lifting, exposed edge, and cracks that may pose a safety hazard to park users.
- Much like parking areas, immediately repair damaged asphalt areas by either cold crack fill, hot rubberized crack fill, or cold asphalt patch.
- Develop a planting list of tree species that are acceptable for planting close to sidewalks, as well as identifying species such as liquidambar (*Liquidambar styraciflua*), which has roots that grow near the surface, commonly causing uplift to sidewalks.
- Prior to making repairs to existing walkways the County should evaluate the cost of replacement of the asphalt walkway with concrete.

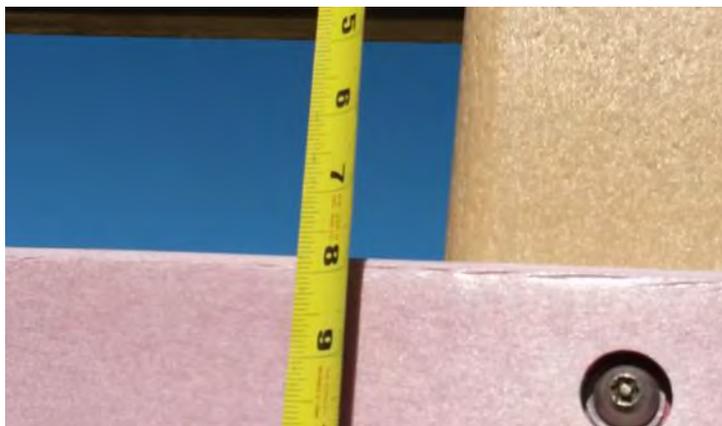
Entrapment – Completely Bounded Opening

HAZARD: There is a gap on the deck connected to the tunnel as shown that does not pass the torso probe test. ASTM regulations state "6.1.1 Completely Bounded-Rigid Openings - A completely bounded rigid opening is accessible when a torso test probe can be inserted into the opening to a depth of 3.5 in. or more when tested in accordance with the test procedure outlined in 6.1.1.1." - Level of risk: Priority 1 Hazard - Indicates a life-threatening or debilitating injury. Appropriate action is to remove or fix immediately.

Solution: Consult the manufacturer for recommended fix.

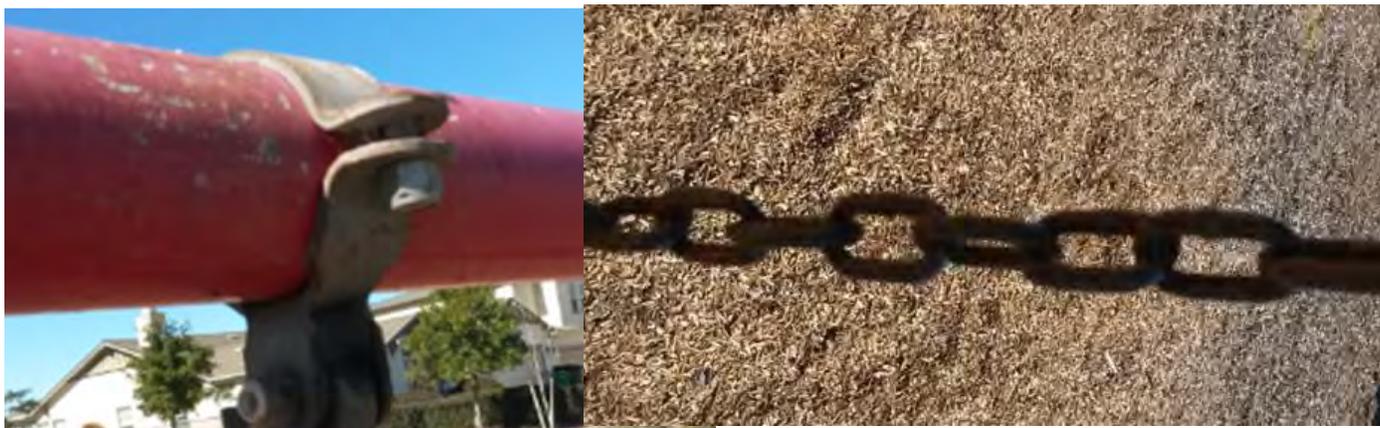
HAZARD: There is paint missing and rust on metals. CPSR state that "Metals subject to structural degradation such as rust or corrosion shall be painted, galvanized, or otherwise treated. Paint and other finishes should be maintained to prevent rusting of exposed metals and to minimize children playing with peeling paint and paint flakes." Priority 3 Hazard - Indicates cuts, scrapes or other minor injuries. Appropriate action is to place on regular maintenance schedule.

Solution: Sand, prime and paint all rusted areas – or replace parts.

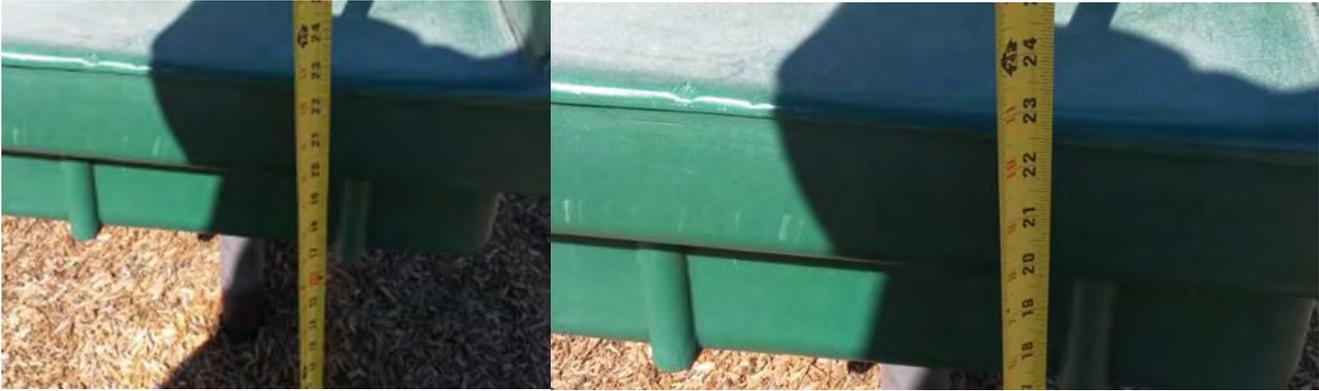
Hazard: Slide exit is 23 inches above the safety surfacing. CPSC requires that the slide exit be no more than 15 inches from the safety surfacing. Priority 2 Hazard - Indicates the possibility of broken bones, stitches, etc. Appropriate action is to schedule to fix or replace as soon as possible.

Solution: Add additional wood fiber to close the gap of at least 8 inches.

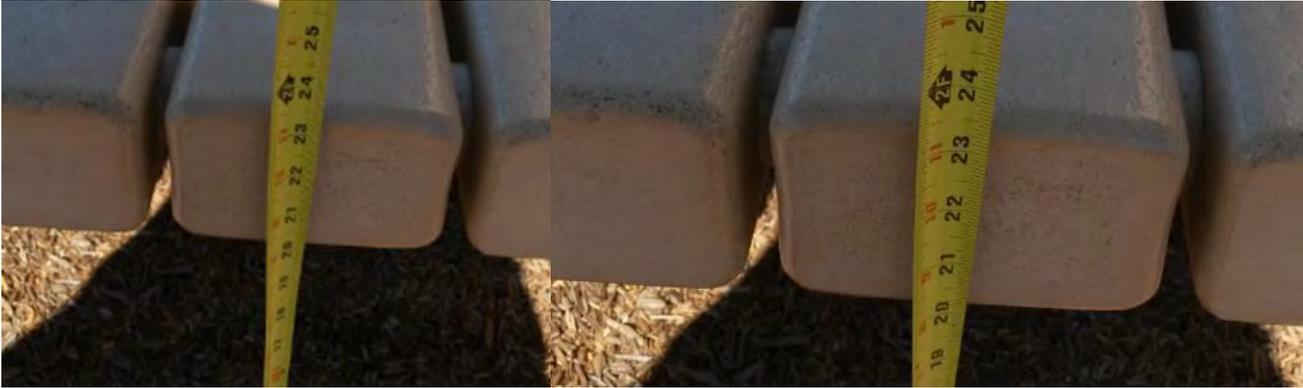
HAZARD: The ADA transfer station is approximately 24 inches above the safety surfacing. CPSC requires that the ADA Transfer station be from 11 inches (280 mm) to 18 inches (455 mm) height of top surface. - Level of risk: Priority 3 - A priority 3 hazard indicates cuts, scrapes or other minor injuries.

Solution: Bring up the level of surfacing or lower the deck.

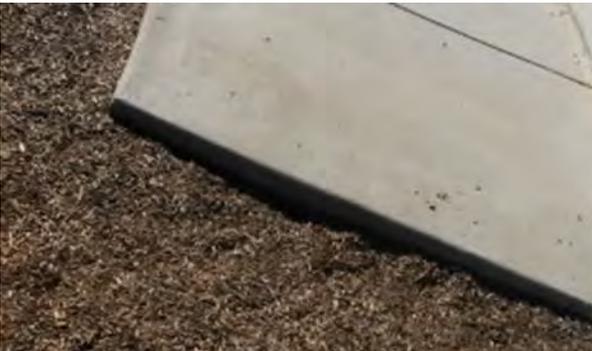
ADA Compliance – Based on Insufficient Access Route

HAZARD: The access route to the playground is surrounded by a curb with the only semi-accessible ramp level with the outlying surface. ADA guidelines state that a safe path of travel that is at least 60 inches wide and has a slope that does not exceed a 1:20 ratio is considered accessible. The ramp is non-compliant in its current state since the wood fiber is below the edge which has caused a trip hazard and not a gradual slope. Priority 2 Hazard - Indicates the possibility of broken bones, stitches, etc. Appropriate action is to schedule to fix or replace as soon as possible.

Solution: Correct the ADA ramp to provide a gradual slope or fill the area with wood fiber constantly to create a level transition that is ADA compliant.

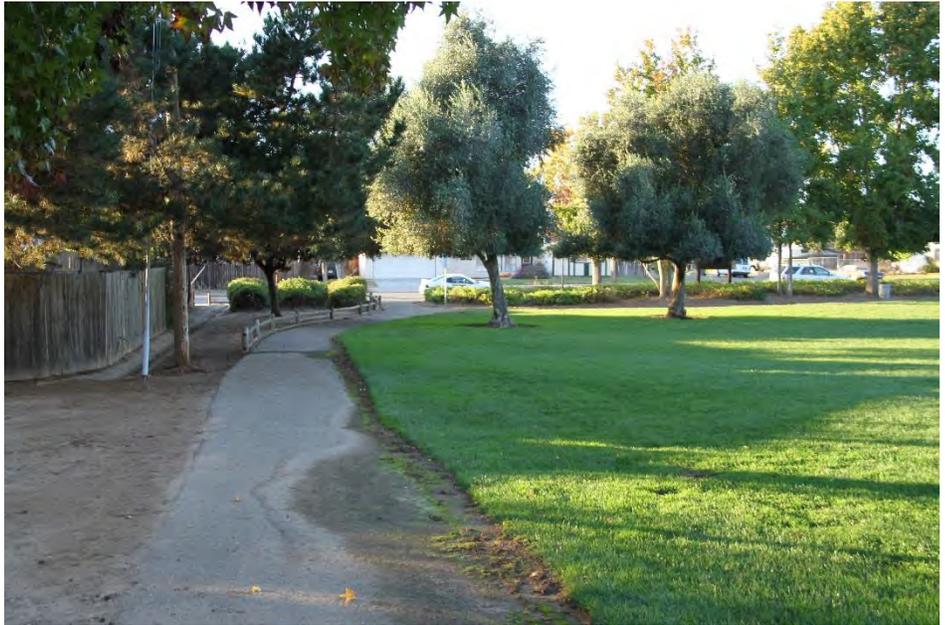
Small Neighborhood Park in good condition featuring asphalt walkway, fencing, turf, and playground. Turf was in good condition without significant evidence of gophers. Walkway and fencing needing repair.

- Add recycling container adjacent to trash can.
- Improve signage to identify park location.
- Prior to making repairs to existing walkway the County should evaluate the cost of replacement of the asphalt walkway with concrete or utilization of decomposed granite.
- Repair fencing as needed.
- Several shrub beds have no plantings. Plant with California natives.

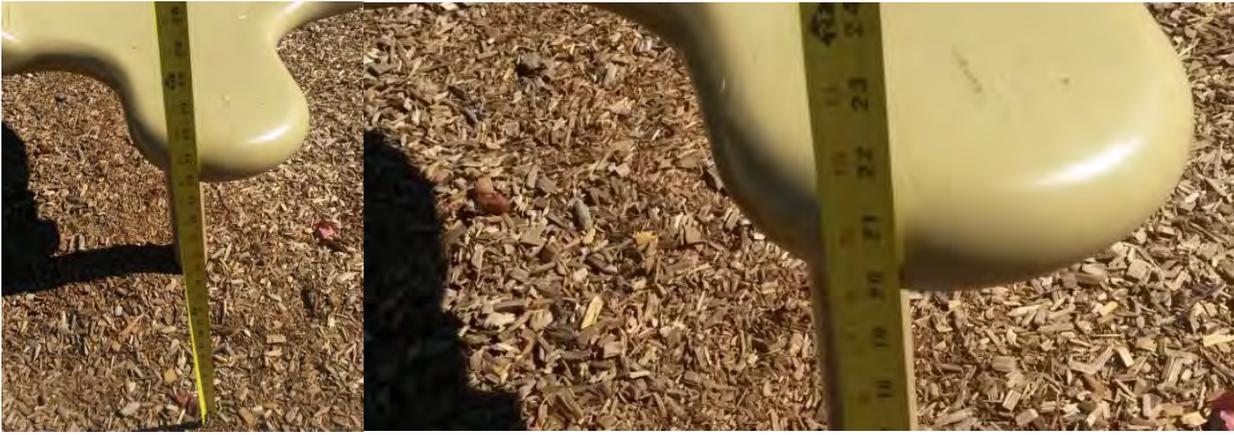
Hazard: Slide exit is 22 inches above the safety surfacing. CPSC requires that the slide exit be no more than 15 inches from the safety surfacing. Priority 2 Hazard - Indicates the possibility of broken bones, stitches, etc. Appropriate action is to schedule to fix or replace as soon as possible.

Solution: Add additional wood fiber to close the gap of at least 7 inches.

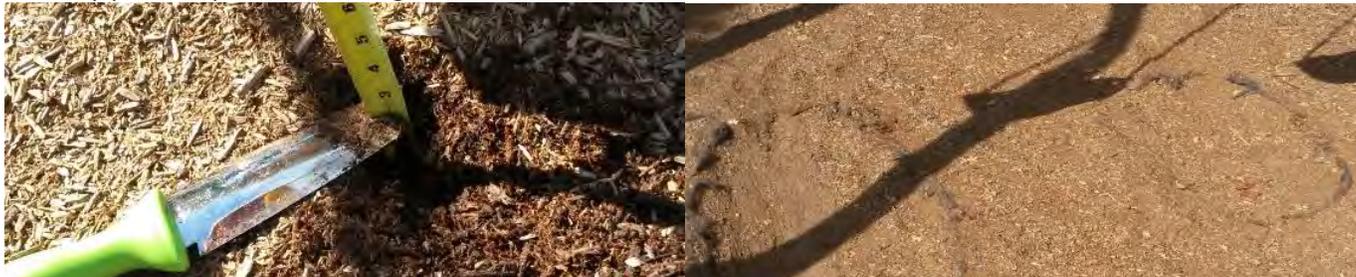
Surfacing

HAZARD: The playground only has 1-2 inches of wood fiber in some areas. California Playground Safety Regulations state that a minimum 9 inches of wood fiber is required. Priority 1 Hazard -Indicates a life-threatening or debilitating injury. Appropriate action is to remove or fix immediately.

Solution: Fill the playground area with wood fiber to 10"-12" to compensate for the rate of compaction which is 1"-2" every year. To prevent fast degradation install filter fabric where the soil meets the wood fiber.

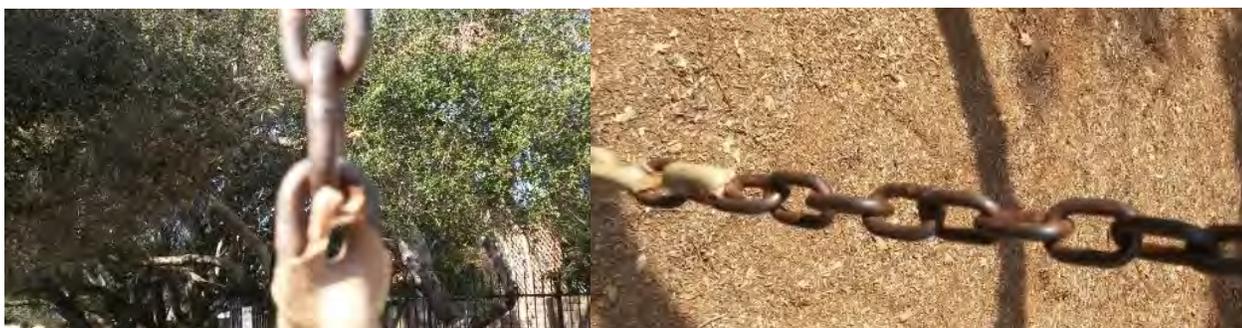
Rust and Corrosion

HAZARD: There is paint missing and rust on metals. CPSR state that “Metals subject to structural degradation such as rust or corrosion shall be painted, galvanized, or otherwise treated. Paint and other finishes should be maintained to prevent rusting of exposed metals and to minimize children playing with peeling paint and paint flakes.” Priority 3 Hazard - Indicates cuts, scrapes or other minor injuries. Appropriate action is to place on regular maintenance schedule.

Solution: Sand, prime and paint all rusted areas – or replace parts.

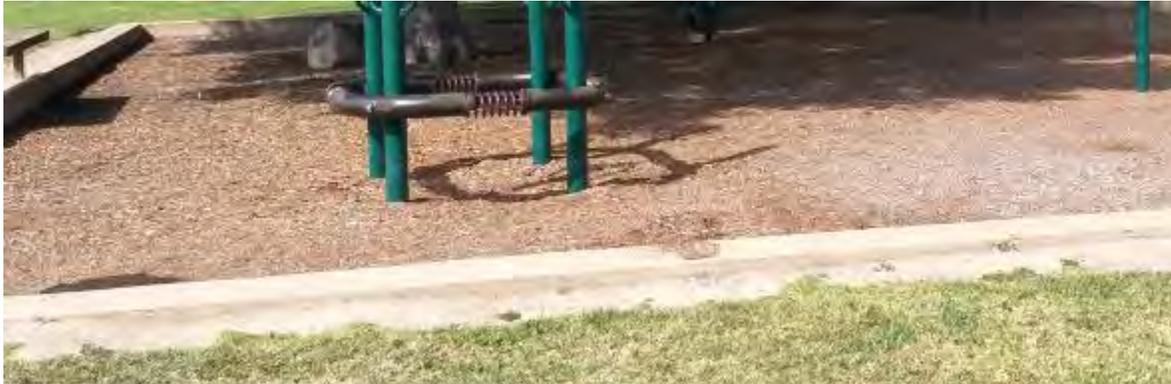
HAZARD: The access route to the playground is surrounded by a curb with no ADA access ramp connecting to the outlying surface. ADA guidelines state that a safe path of travel that is at least 60 inches wide and has a slope that does not exceed a 1:20 ratio is considered accessible. Priority 2 Hazard - Indicates the possibility of broken bones, stitches, etc. Appropriate action is to schedule to fix or replace as soon as possible.

Solution: Install an ADA compliant access ramp to provide a gradual slope entering the playground.

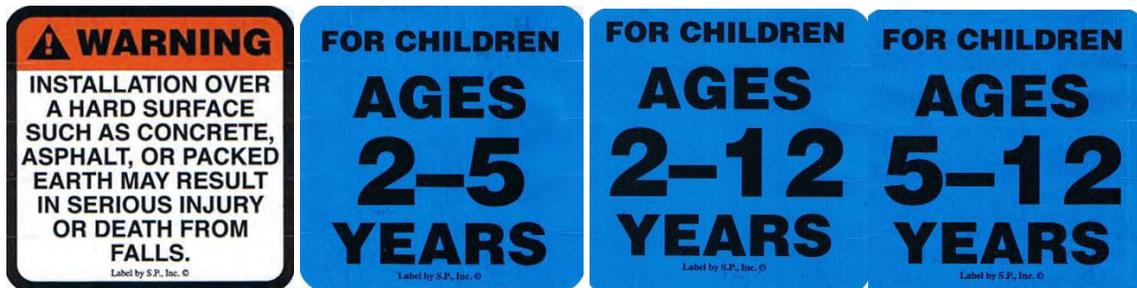
Safety-Signs and Label

HAZARD: There are no signs or labels which state the age group that this is intended for as required by CPSR. Labels are also required that state “WARNING: Installation over a hard surface such as concrete, asphalt, or packed earth could result in serious injury or death from falls.” Priority 3 Hazard - Indicates cuts, scrapes or other minor injuries. Appropriate action is to place on regular maintenance schedule.

Solution: Purchase Labels from original manufacturer and place on structure.

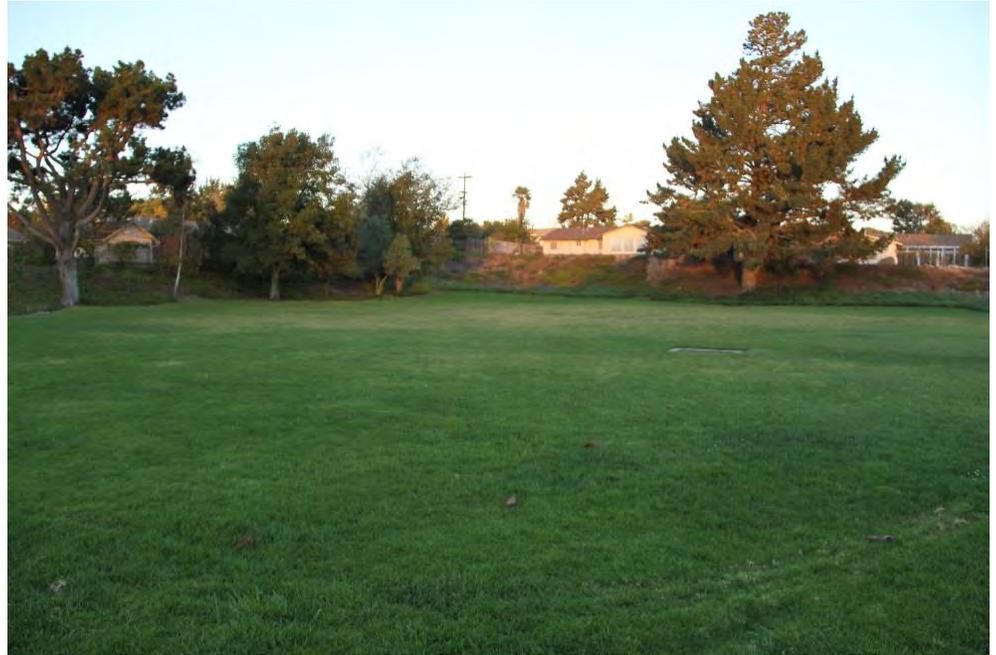
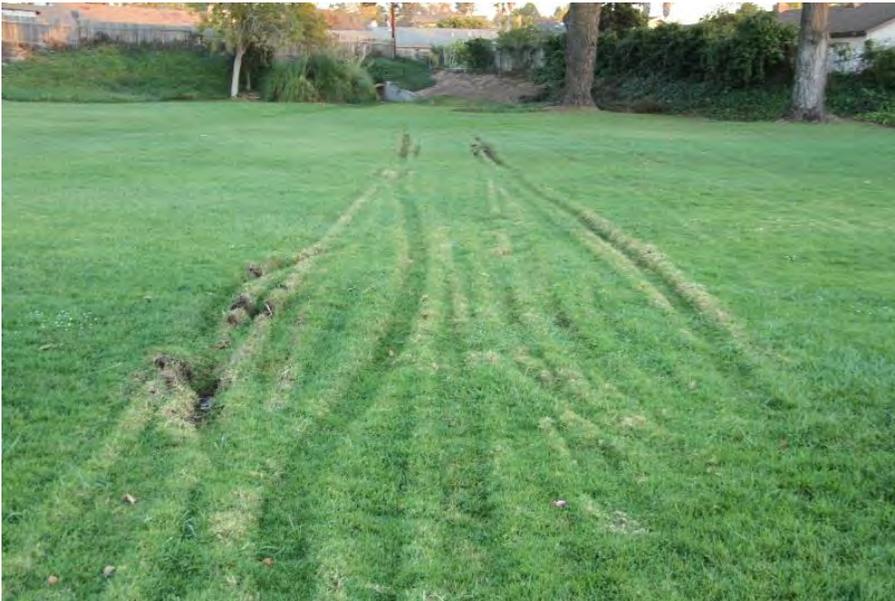
Small facility consisting of turf and trees with limited development of playground bench and drinking fountain. Park is located at the end of street with the playground hidden from view. Turf in need of renovation, suffering from over-watering, gophers, and vehicles driving across wet ground resulting in tire tracks. Trees in need of thinning and structural pruning.

- Add recycling container adjacent to trash can.
- Improve signage to identify park location.
- Increase efforts at gopher eradication and/or control.
- Evaluate irrigation system and correct water application level to the park.
- Upgrade existing turf.
- Schedule trees for pruning and thinning.

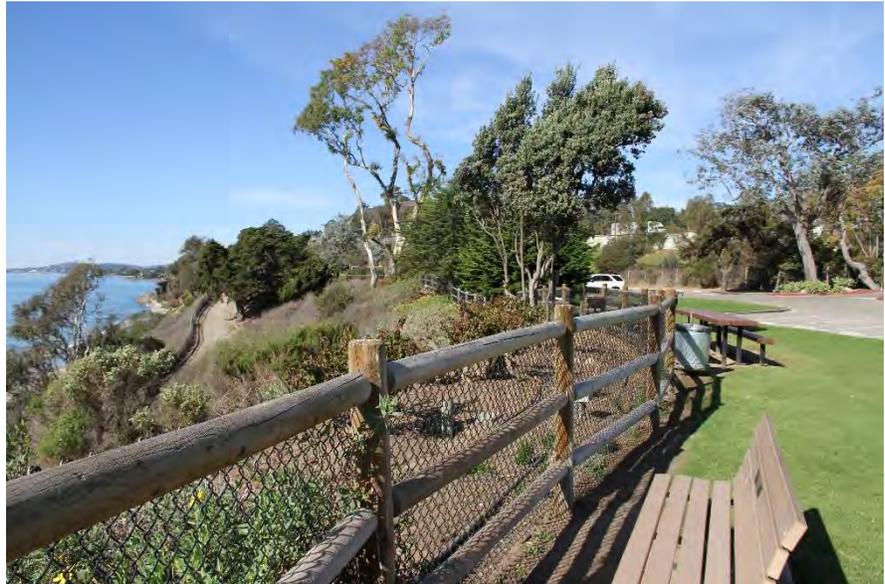
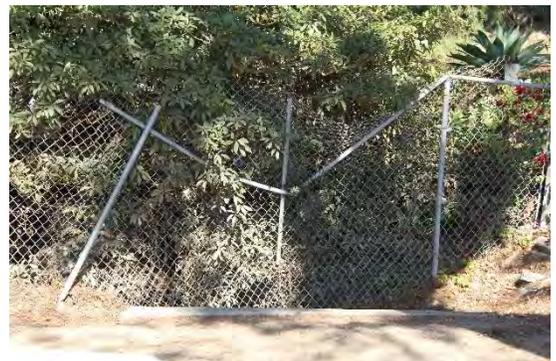
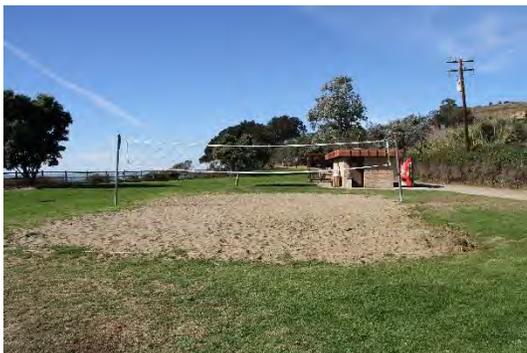
Fully developed neighborhood park including, playground (pour in place safety surface), parking, restroom, group picnic areas and coastal accessway to the beach. Restrooms in need of renovation and fencing along bluff needs repair.

- Add recycling container adjacent to trash can.
- Increase efforts at gopher eradication and/or control.
- Evaluate irrigation system and correct water application level to the park.
- Upgrade existing turf.
- Schedule trees for pruning and thinning.
- Drainage issues along the bluff resulting in erosion. Correct directional flow of run-off.
- Repair damaged chain link fencing.
- Upgrade sand volleyball court.

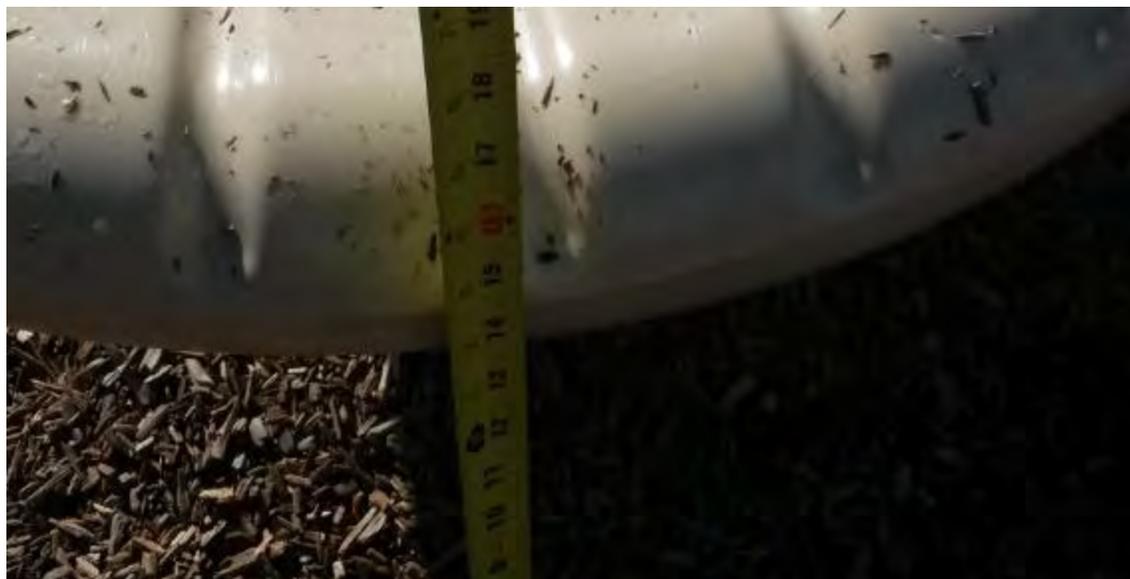
Hazard: Slide exit is 18 inches above the safety surfacing. CPSC requires that the slide exit be no more than 15 inches from the safety surfacing. Priority 2 Hazard - Indicates the possibility of broken bones, stitches, etc. Appropriate action is to schedule to fix or replace as soon as possible.

Solution: Add additional wood fiber to close the gap of at least 3 inches.

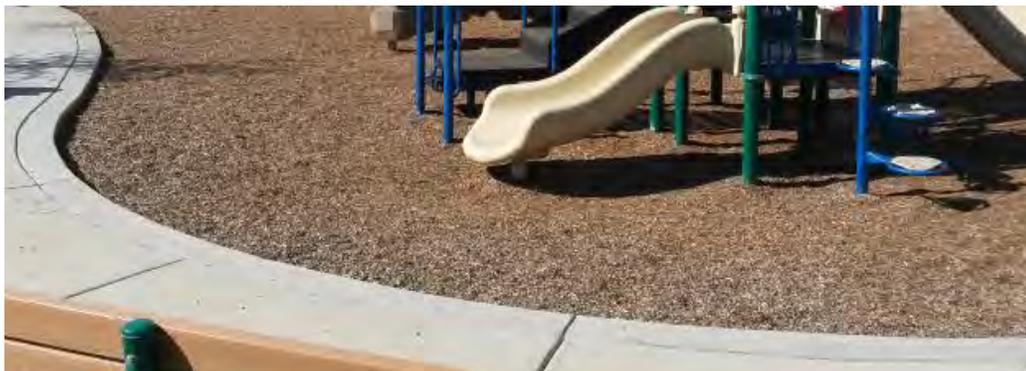
Insufficient Access Route - ADA Compliance

HAZARD: The access route to the playground is surrounded by a curb with no ADA access ramp connecting to the outlying surface. ADA guidelines state that a safe path of travel that is at least 60 inches wide and has a slope that does not exceed a 1:20 ratio is considered accessible. Priority 2 Hazard - Indicates the possibility of broken bones, stitches, etc. Appropriate action is to schedule to fix or replace as soon as possible.

Solution: Either bring up the level of wood fiber flush with the curb and maintain it or install an ADA compliant access ramp to provide a gradual slope entering the playground.

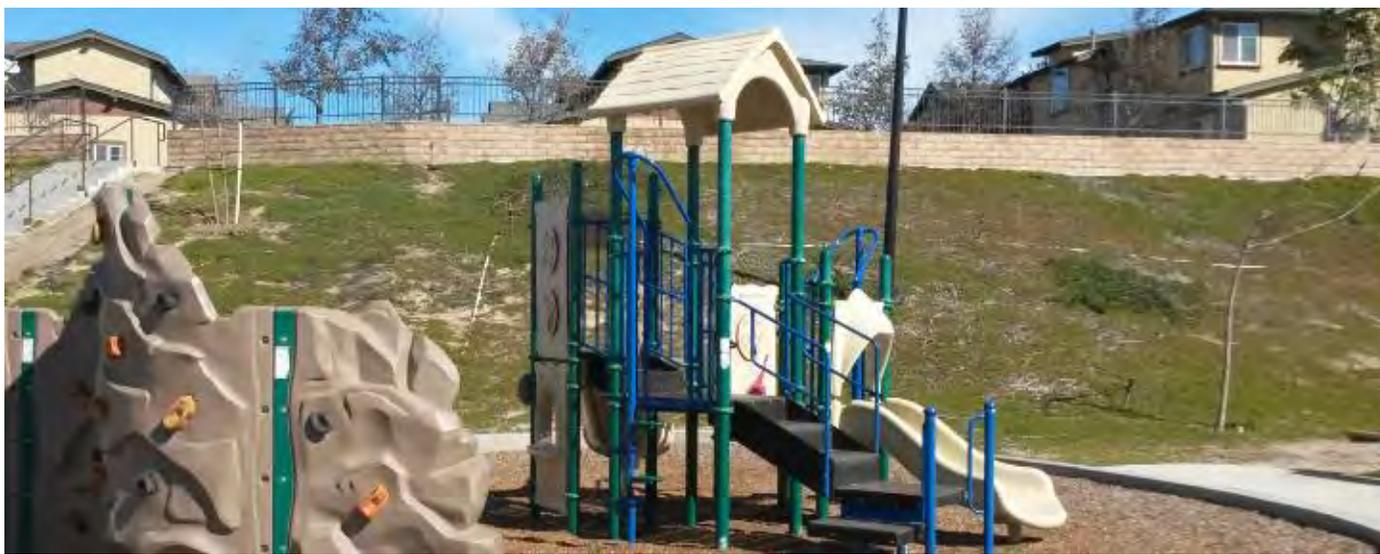
Providence Landing Park Playground Area B

HAZARD: The playground only has 1-2 inches of wood fiber in some areas. California Playground Safety Regulations state that a minimum 9 inches of wood fiber is required. Priority 1 Hazard -Indicates a life-threatening or debilitating injury. Appropriate action is to remove or fix immediately.

Solution: Fill the playground area with wood fiber to 10"-12" to compensate for the rate of compaction which is 1"-2" every year. To prevent fast degradation install filter fabric where the soil meets the wood fiber.

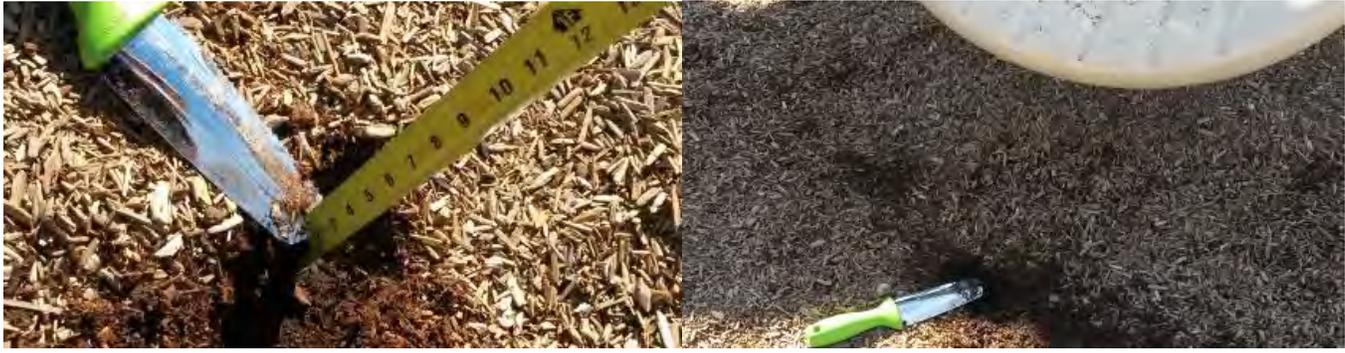
ADA Transfer Station Too High

HAZARD: The ADA transfer station is approximately 19 inches above the safety surfacing. CPSC requires that the ADA Transfer station be from 11 inches (280 mm) to 18 inches (455 mm) height of top surface. - Level of risk: Priority 3 - A priority 3 hazard indicates cuts, scrapes or other minor injuries.

Solution: Bring up the level of surfacing or lower the deck.

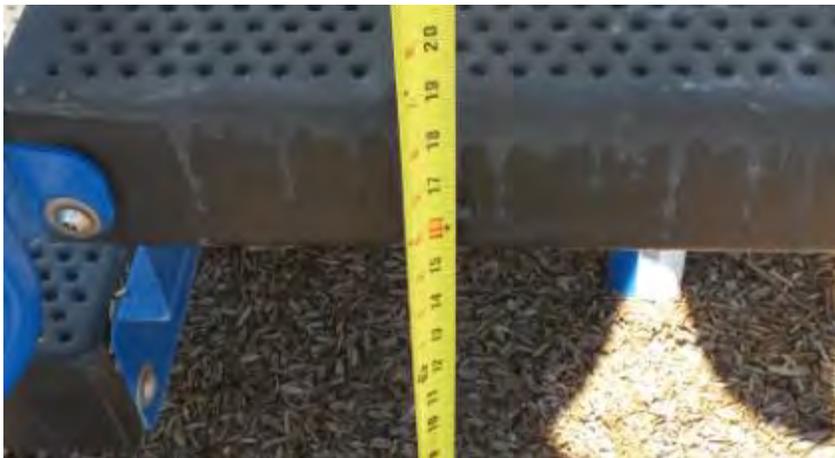
Hazard: Slide exit is 17 inches above the safety surfacing. CPSC requires that the slide exit be no more than 15 inches from the safety surfacing. Priority 2 Hazard - Indicates the possibility of broken bones, stitches, etc. Appropriate action is to schedule to fix or replace as soon as possible.

Solution: Add additional wood fiber to close the gap of at least 2 inches.

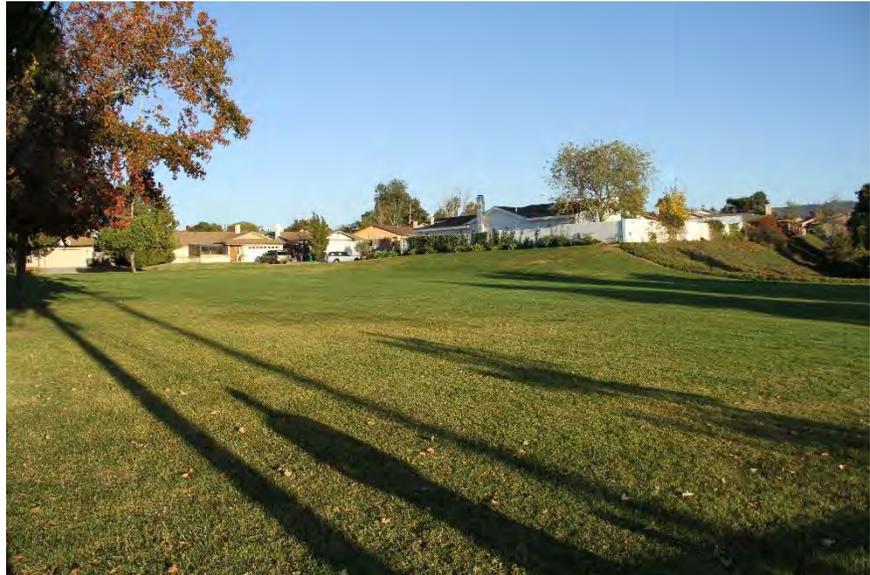
Well maintained neighborhood park located within subdivision with large open turf area, fencing, and large trees around perimeter of the park. Steep concrete ramp into park. Large trees in need of structural pruning.

- Remove concrete ramp and replace with steps into park.
- Improve signage to identify park location.
- Schedule trees for structural pruning and thinning.
