Appendix 3 – RJM Design Report

Community Parks

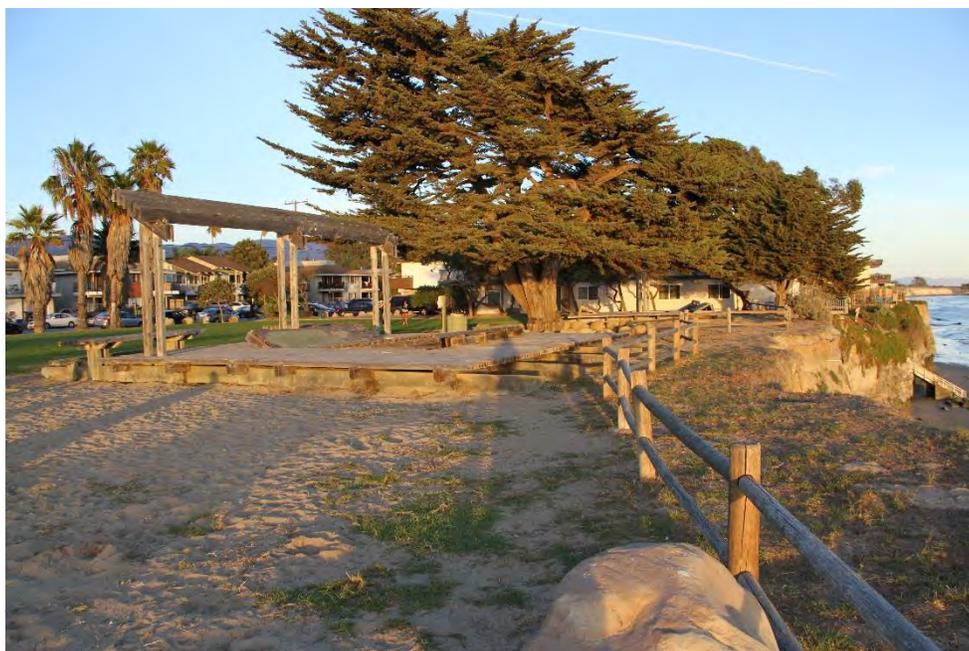
Heavily used facility suffering from deferred maintenance and gopher infestation. Park is utilized as an off-leash park but without amenities generally found at dog parks. Shade structures and wooden structures suffering from wood rot and in need of immediate repair. Turf is in poor condition with gophers and irrigation issues. Fencing along bluff in need of maintenance.

- Add recycling container adjacent to trash can.
- Repair and/or remove wooden structures.
- Repair fencing along bluff.
- Increase efforts at gopher eradication and/or control.
- Provide amenities and fencing for dog park.

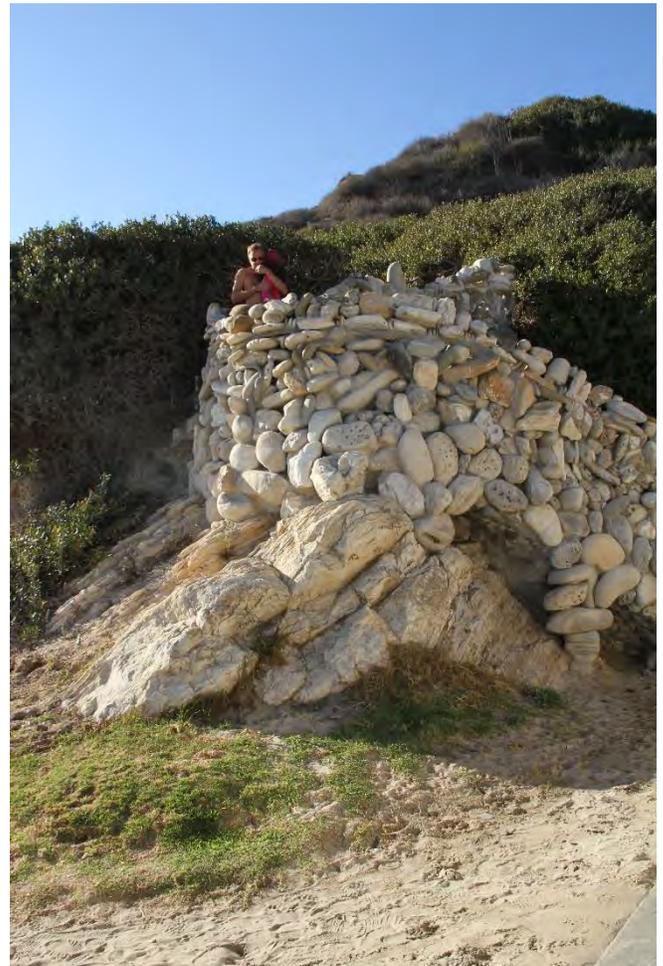
Park sidewalks included a mixture of concrete, asphalt, and decomposed granite were in fair to good condition with some areas of major cracking and uplifting from tree roots. Lights were present along decomposed granite walkway but were not evaluated during the day-time visits.

Examples of a problem area includes failure of rock wall along stairway leading up to beach viewpoint. Additionally the decomposed granite walkway between the lagoon and the parking lot was unsightly and suffering from erosion.

- Continue to conduct regular inspections of park sidewalks to identify settlement and or up lifting, exposed edge, and cracks that may pose a safety hazard to park users.
- Replace and improve decomposed granite walkway with a six foot wide path, adding fencing, entrance ramps, and landscaping between path and parking lot.
- Much like parking areas, immediately repair damaged asphalt areas by either cold crack fill, hot rubberized crack fill, or cold asphalt patch.
- Develop a planting list of tree species that are acceptable for planting close to sidewalks, as well as identifying species such as liquidambar (*Liquidambar styraciflua*), which has roots that grow near the surface, commonly causing uplift to trails and sidewalks.

- Prior to making repairs to existing walkways the County should evaluate the cost of replacement of the asphalt walkway with concrete.
- Evaluate the potential reasons for failure of the rock wall along stairway to beach viewpoint. Schedule repair once this is determined.

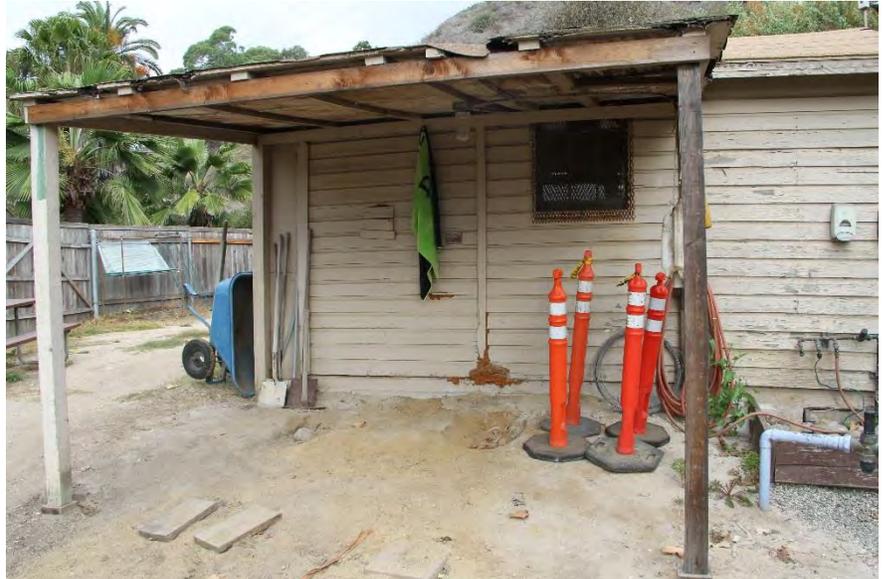
Arroyo Burro features a variety of structures, buildings, and amenities found to be in a variety of conditions, some recently renovated or and/or in good condition, such as the restaurant, others such as the maintenance facility in poor condition and in need of immediate renovation.

The park restroom was clean but in need of renovation. Fencing was generally in good condition and standardized with the use of lodge pole rail fencing.

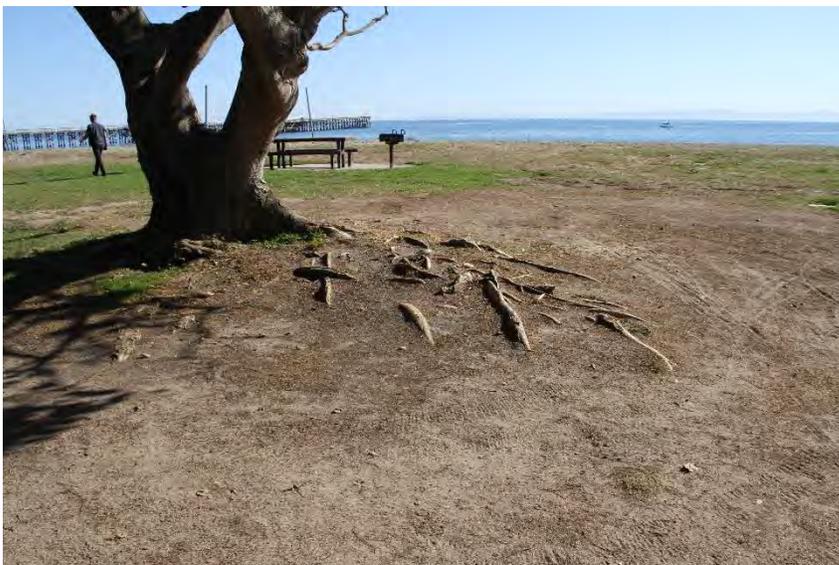
Overall, park roads and parking areas were found to be in fair to good condition. Varying levels of deterioration was evident throughout the park, some directly linked to uplifting from roots, overspray of adjacent turf, and failure to remove organic materials from the asphalt. All parking lots were in need of restriping.

- Regularly inspect for overspray and soil moisture, adjusting watering levels as necessary at all landscaped areas adjacent to paved parking areas, park roads and paved trails.
- Schedule the restriping of parking lots.
- Regularly remove sand and other organic material from parking lots to prevent deterioration.
- All paved parking areas and park roads should be inspected on a regular basis to detect cracks in their surfaces. Cracks should be sealed as early as practical to minimize moisture damage and halt surface deterioration, thus minimizing damage as well as maintenance, repair, and replacement costs.
- Immediately repair damaged areas by either cold crack fill, hot rubberized crack fill, or cold asphalt patch.

- The life expectancy of each paved surface should be estimated and each paved area should be included in the capital improvement reserve budget for (1) periodic sealing and (2) repaving at the end of the usable life of the surface. Deferred maintenance on paved surfaces should be minimized by following these recommended practices to reduce maintenance costs and prolong their usable life.

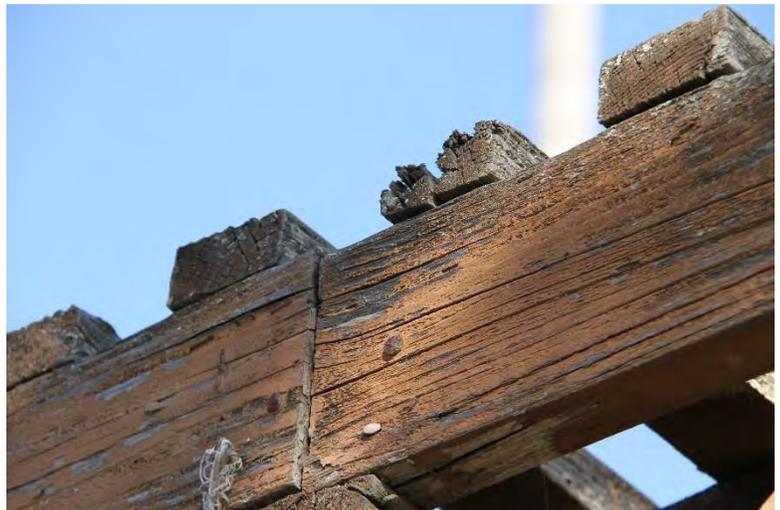
The restrooms, although clean, showed evidence of deferred maintenance needs with roofing issues and older infrastructure inside the facilities. The picnic shelter was also in decline with rotting wood evident. Fencing was generally in good condition and standardized with the use

of lodge pole rail fencing. The pier showed evidence of loose boards. Beach shower run-off ran into pit that was marked with orange cones.

- Vacant ranger residences should be removed and replaced with a paved pad and hook-up facility to accommodate Park Hosts.
- Park buildings should be regularly inspected for vandalism, safety issues and proper operation of equipment.

- Some picnic area concrete pads showed evidence of cracking and need sealing. Further the County through the lifecycle maintenance program should schedule replacement of a limited number of pads each year.

- Graffiti should be immediately painted over or removed and tracked for potential use by local law enforcement agencies.

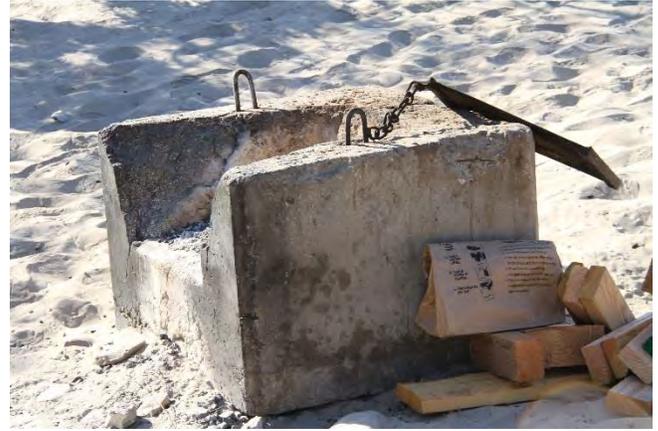
Jalama Beach is a well maintained facility, with intense use, and a wide variety of camping experiences. The campsites, although close together, generally have separation of either vegetation or lodge pole fencing. Many facilities such as restrooms and shower facility should be renovated at the earliest opportunity.

- Evaluate fiscal benefits of adding several new cabins along the southern boundary of the campground. These would be in replacement of existing primitive campsites.
- Facilities with extensive revenue such as Jalama Beach should be operated within an Enterprise Fund budget such that all earned revenue at the facility stays within that facility.
- Replace four fire pits within primitive campsites that are badly deteriorated.

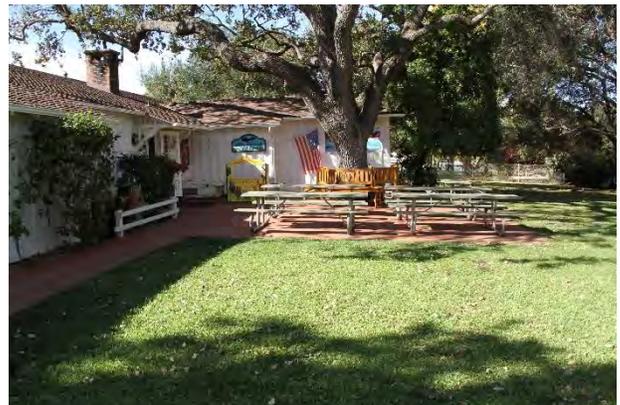
The restrooms and shower facilities, although clean, showed evidence of deferred maintenance needs with roofing issues and dated interior infrastructure needs. Some picnic shelters were in decline with some rot evident. Fencing was generally in good condition and standardized with the use of lodge pole rail fencing.

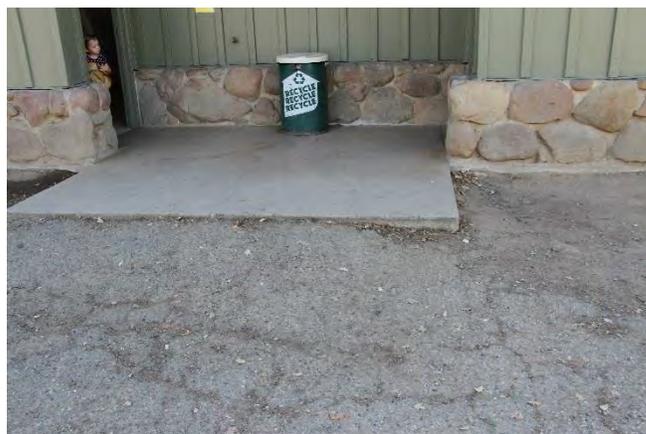
Park sidewalks included a mixture of dirt or paved surfaces, were in fair to good condition with limited areas of cracking and uplifting within paved surfaces. Newer construction such as Harvey’s Cove handicap fishing pier and walkway indicates that the County has adopted a new standard of concrete for all walkways.

- Continue to conduct regular inspections of park sidewalks to identify settlement and or up lifting, exposed edge, and cracks that may pose a safety hazard to park users.
- Much like parking areas, immediately repair damaged asphalt areas by either cold crack fill, hot rubberized crack fill, or cold asphalt patch.
- Develop a planting list of tree species that are acceptable for planting close to sidewalks, as well as identifying species such as liquidambar (*Liquidambar styraciflua*), which has roots that grow near the surface, commonly causing uplift to sidewalks.
- Prior to making repairs to existing walkways the County should evaluate the cost of replacement of the asphalt walkway with concrete.

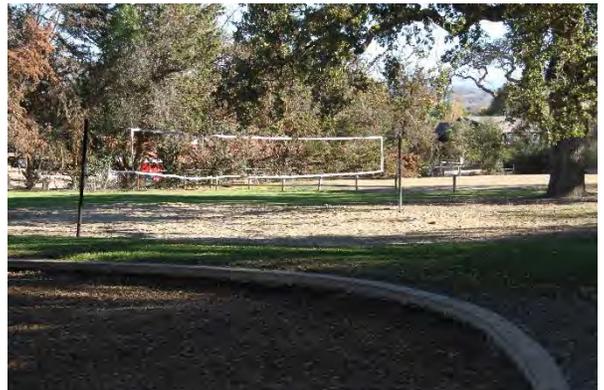
There were limited shrub beds found within the park, mostly near the restroom and parking lots. For the most part these shrub beds appear to have been abandoned and in need of

renovation and upgrade. As a whole, park grounds were found to be free of litter and graffiti with obvious signs of park staff paying immediate attention to grounds clean-up.

- Monitor soil moisture conditions and irrigate turf areas to provide adequate moisture for healthy growth while maintaining a solid and playable surface that is not muddy, spongy or over saturated. This will help to prevent tearing and uprooting of the turf and topsoil.
- Annually (October/November) test soil to assess nutrient deficiencies, following with an application of appropriate fertilizer and/or soil additives to promote healthy root growth. Soil fertility fluctuates throughout the growing season with the quantity and availability of mineral nutrients altered by the addition of fertilizers, sulfur, lime, etc. and the removal from soils as a result of plant growth and development. Soil tests should be taken at various locations dependent on the plant material and its ability to grow in various soil conditions.
- Increase efforts at gopher eradication and/or control.

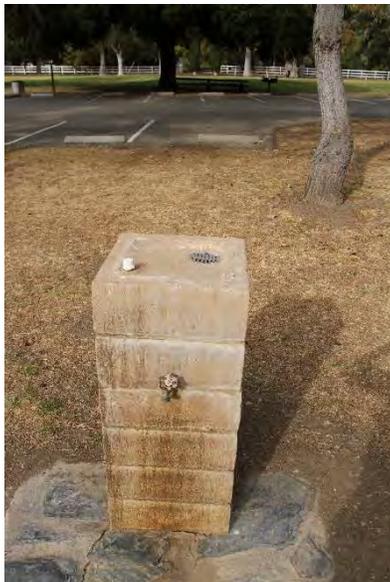
Nojoqui Falls Park includes a restroom, maintenance structures, and host sites. The restrooms, although clean, showed evidence of deferred maintenance needs with roofing issues and older infrastructure inside the facilities. Fencing was generally in good condition and standardized with the use of lodge pole rail fencing.

- Vacant ranger residence should be removed and replaced with a paved pad and hook-up facility to accommodate Park Hosts.
- Capped and non-functional drinking fountains should be repaired immediately.
- Park buildings should be regularly inspected for vandalism, safety issues and proper operation of equipment.
- Restrooms should be upgraded and including conversion to waterless urinals and hands free fixtures.
- Some concrete pads for picnic areas were cracking and should be scheduled for replacement.
- Some picnic area concrete pads showed evidence of cracking and need sealing. Further the County through the lifecycle maintenance program should

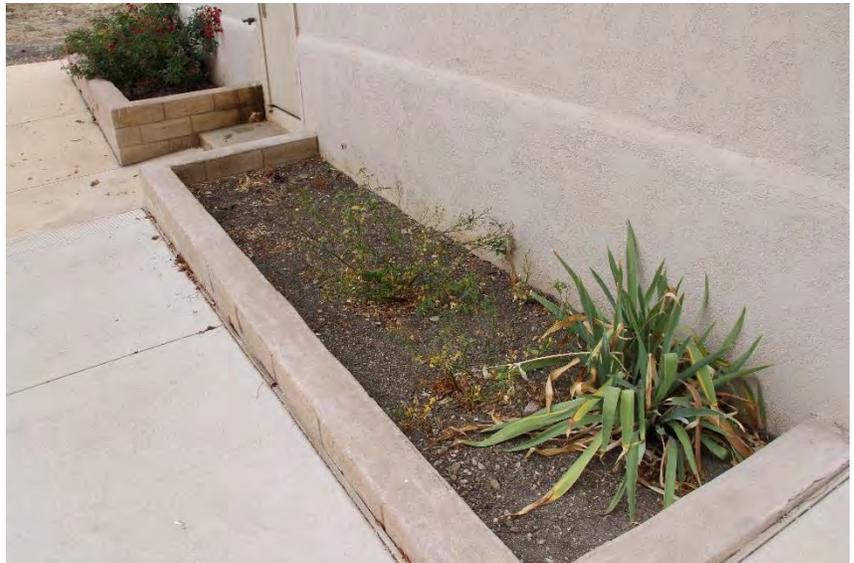
Park landscaping which includes trees and shrub beds were found to be in fair to good condition for tree maintenance while shrub beds revealed the need for improved maintenance. The park includes limited non-native evergreen and deciduous trees which were in need of thinning and structural pruning. Compaction around tree wells was poorly managed with no evidence of bark/mulch around the drip line.

- Pruning should occur on park trees for structural health and thinning. Native species should be pruned only in high use areas of the park. Immediately remove dead trees.
- Bark/mulch should be regularly placed around the drip line to reduce compaction and water evaporation.
- Soils around the roots of trees should be aerated to reduce soil compaction that can smother the roots of some trees.
- Regularly inspect for overflow and soil moisture, adjusting watering levels as necessary at all landscaped areas adjacent to paved parking areas, park roads and paved trails.
- Where necessary, improve conditions or County maintained shrub beds by replanting with California natives and removal of weed growth.

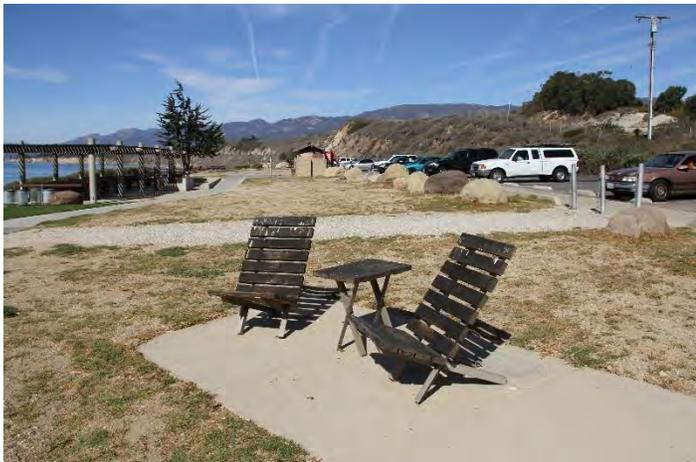
Well known California surfing spot features a number of newer well-maintained facilities, public art, and several poorly maintained aspects including turf and an older restroom facility. Turf areas were in poor condition with extensive gopher and ground squirrel infestation, uneven surface, extensive broadleaf growth and wet/dry areas.

- Monitor soil moisture conditions and irrigate turf areas to provide adequate moisture for healthy growth while maintaining a surface that is not dry, muddy, spongy or over saturated.

- Annually (October/November) test soil to assess nutrient deficiencies, following with an application of appropriate fertilizer and/or soil additives to promote healthy root growth. Soil fertility fluctuates throughout the growing season with the quantity and availability of mineral nutrients altered by the addition of fertilizers, sulfur, lime, etc. and the removal from soils as a result of plant growth and development. Soil tests should be taken at various locations dependent on the plant material and its ability to grow in various soil conditions.
- Increase efforts at gopher and ground squirrel eradication and/or control.

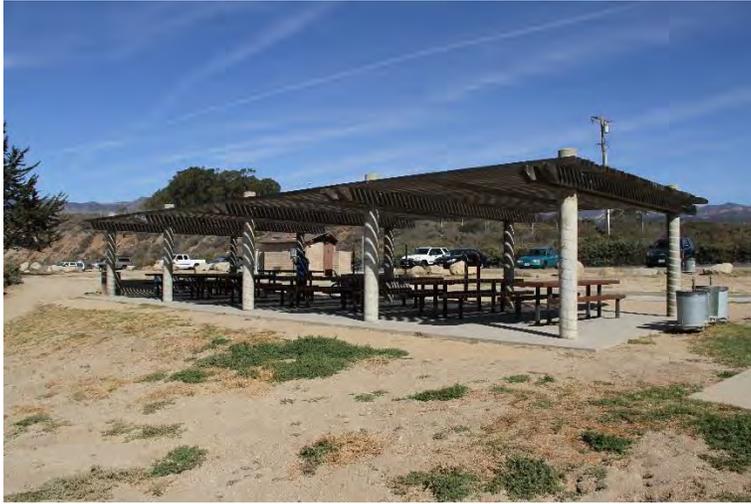
Rincon Beach features a restroom, picnic shelter, and host site. The picnic shelter was in good shape. The host site gave the appearance of long-termed residency. Beach shower facility was present and in good condition.

The restrooms, although clean, were of older design and inadequate for the level of public use at this facility. Fencing was generally in good condition and standardized with the use of lodge pole rail and chain link fencing. Repairs were needed to the chain link section along the bluff.

- Immediately repair chain link fencing along the bluff.
- Reduce the appearance of long-term residency of host site.
- Park buildings should be regularly inspected

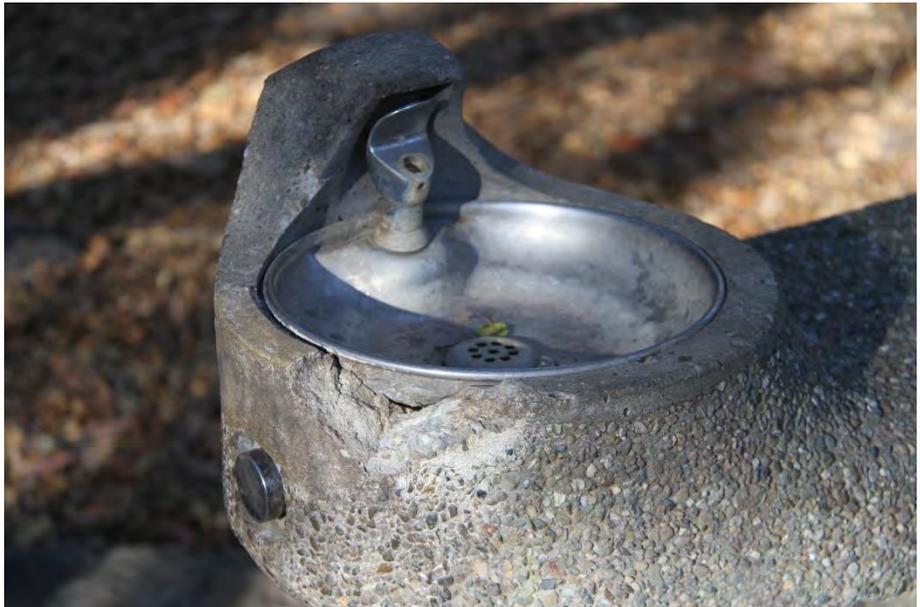
Rocky Nook Park includes a restroom, maintenance structures, and park headquarters. The restrooms were heavily impacted by homeless use of the park and additionally showed evidence of deferred maintenance needs with roofing issues and older infrastructure inside the facilities. Park headquarters, although located in a beautiful setting, were in poor condition with immediate deferred maintenance and circulation needs if facility is to be utilized as Department headquarters.

- Park buildings should be regularly inspected for vandalism, safety issues and proper operation of equipment.
- Restrooms should be upgraded and including conversion to waterless urinals and hands free fixtures.
- Evaluate benefits and costs of upgrading headquarters building vs. removal of facility.

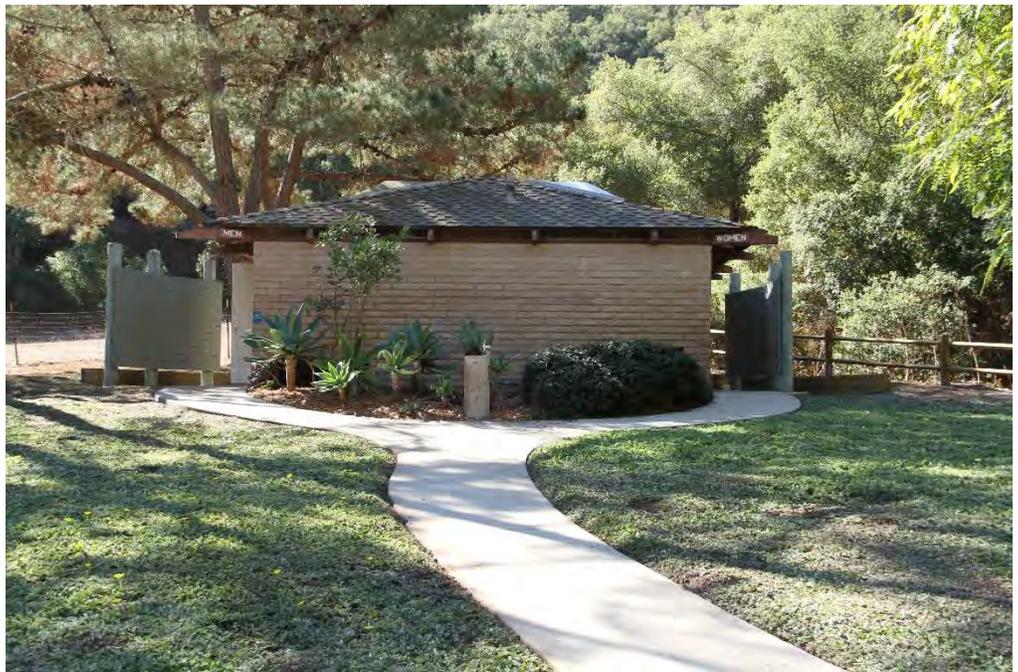
The restrooms were of older design and deferred maintenance needs. Fencing was generally in good condition and standardized with the use of lodge pole rail fencing with evidence of some new installation along the creek.

- Park buildings should be regularly inspected for vandalism, safety issues and proper operation of equipment.
- Restrooms should be upgraded to waterless urinals and hands free fixtures.

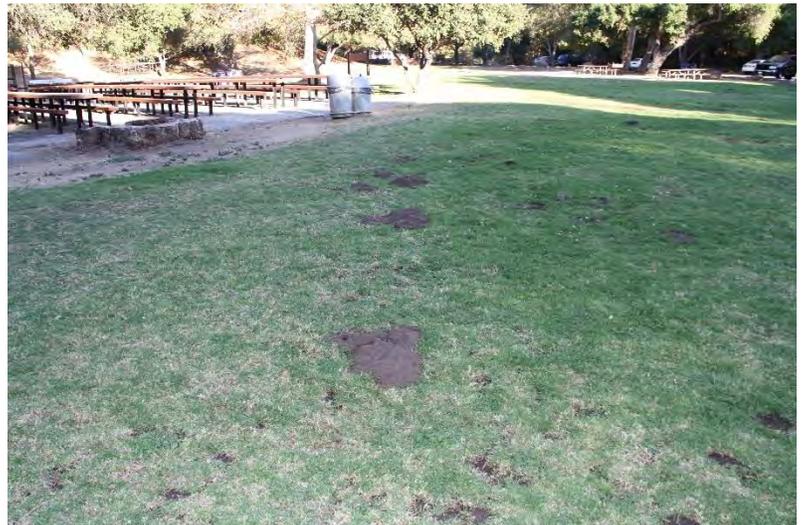
Tucker’s Grove features approximately 10 acres of irrigated turf. The irrigation system appeared to be well-maintained with a limited number of water leaks due to broken or damaged sprinkler heads and lines. Areas within the park along the seasonal creek could be converted from turf to native plantings as part of an overall redesign of the irrigation system.

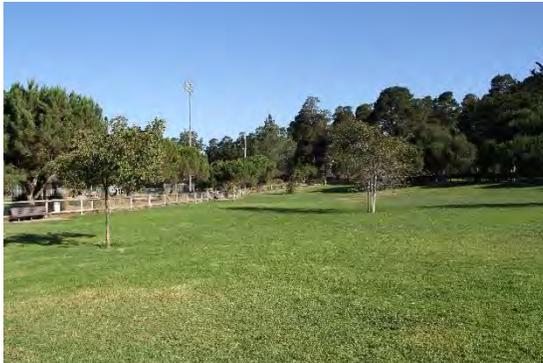
Most sports fields and open turf areas were in good condition with adequate growth mass and limited broadleaf invasion. Several areas, of high intensity use, such as around the ballfields, exhibited poorer conditions with significant bare spots, thinning, and invasion of broadleaves and other weeds. Gopher issues were present throughout the park with significant long-term rutting of the park turf occurring in some areas.

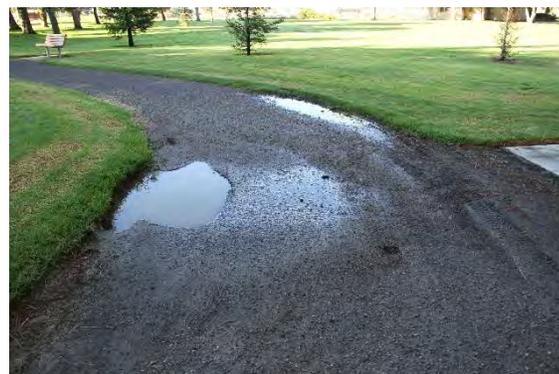
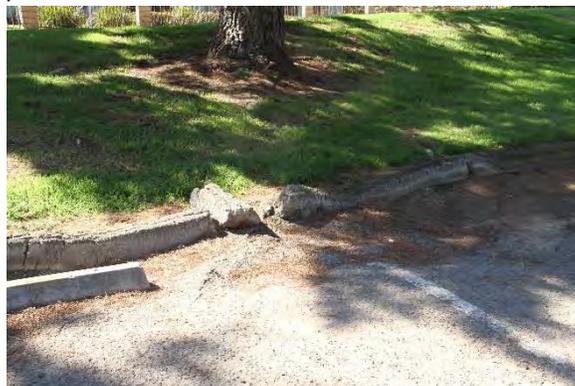
- Parking lot of Goodwin—Overspray from irrigation
- Group Area #7—Dirt parking lot
- Group Area #6—Major deterioration in asphalt parking lot
- Group Area #5—Dirt parking area between road and fence badly torn up
- Group Area #4—Organic material allowed to accumulate on asphalt
- Group Area #8—Dirt parking lot
- Lakeview Terrace—Overspray from irrigation, uplifting from roots, and general failure of asphalt
- Group Area #2—Dirt parking lot
- Group Areas #3 and #9—Dirt parking lot—on slope and in poor condition
- Front parking areas---Asphalt needs resurfacing

Information supplied by the County of Santa Barbara inventories 539,000 square feet of asphalt within Waller Park. This one item alone shows the importance of implementing a lifecycle maintenance plan. If put in place and funded, parking lot resurfacing could be addressed in a timely fashion rather than when the pavement is in serious levels of deterioration. Identified parking spaces counted included 457 regular and 106 handicap spaces.

- Regularly inspect for overspray and soil moisture, adjusting watering levels as necessary at all landscaped areas adjacent to paved parking areas, park roads and paved trails.

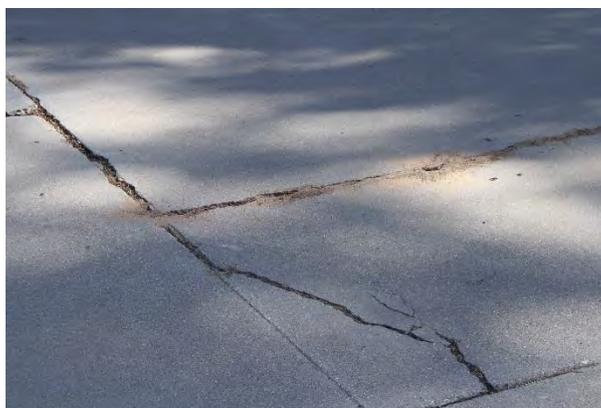
Waller Park includes three sand volleyball courts, one basketball court and four horseshoe pits. The volleyball courts and horseshoe pits were found to be in good condition, well maintained, with volleyball nets present at all courts. The basketball court features a badly cracked concrete surface, heavily rusted backboards and poles, and no basketball nets present.

- The basketball court playing surfaces should be regularly inspected for cracks or other surface damage and promptly repaired when these are detected. When cracks begin to appear in the surface of the courts, moisture can seep below the surface resulting in accelerated deterioration.
- When renovated the basketball court should be maintained on a regular basis. Each court should be scheduled for resurfacing every five to seven years. In addition, one standard color should be utilized throughout County facilities and records of that should be kept by the maintenance staff for small repairs or removal of graffiti.
- As the result of lack of maintenance on the basketball court, this facility is in need of renovation and or replacement.

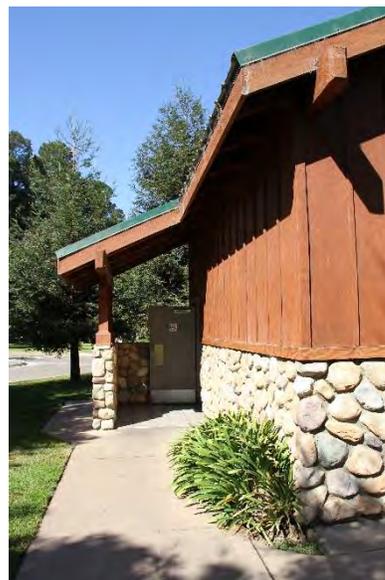
All but one of the restrooms featured a newer design with tile floor and tile part way up the way. Fencing was generally in good condition and standardized with the use of lodge pole rail fencing. Some minor repair was needed to the fencing adjacent to Group Areas 37. As stated earlier, the ballfield fencing is in need of replacement.

- Park buildings should be regularly inspected for vandalism, safety issues and proper operation of equipment.
- Restrooms should be upgraded to waterless urinals and hands free fixtures.

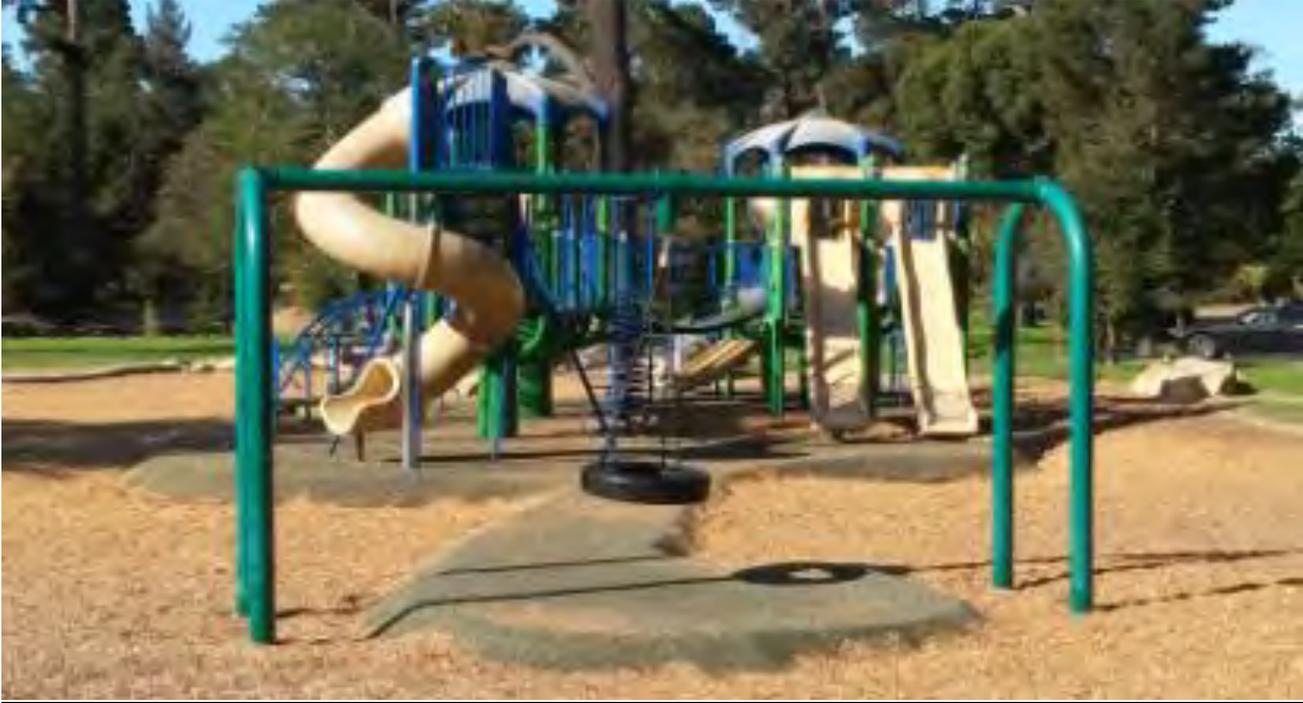
Waller Park Playground Area A does not comply with the California Playground Safety Regulations (CPSR) for the following reasons:

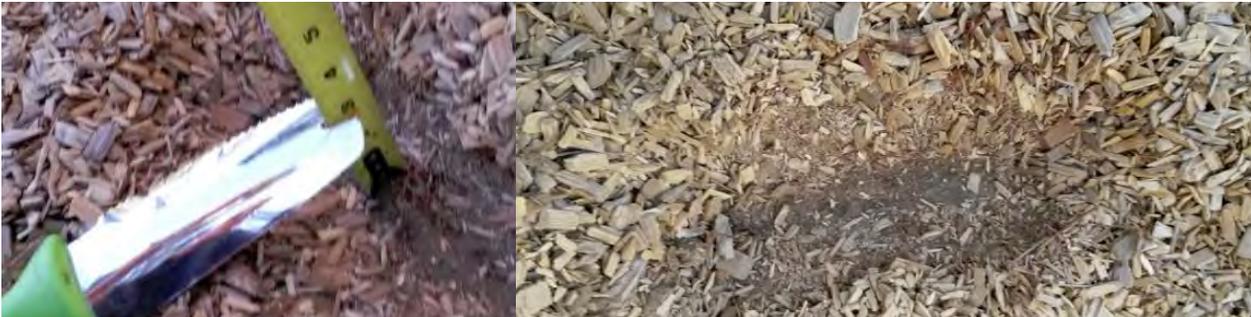
Wood Fiber Surfacing

HAZARD: The playground only has 2-3" of wood fiber in some areas. California Playground Safety Regulations state that a minimum 9 Inches of wood fiber is required. Priority 1 Hazard -Indicates a life-threatening or debilitating injury. Appropriate action is to remove or fix immediately.

Solution: Fill the playground area with wood fiber to 10"-12" to compensate for the rate of compaction which is 1"-2" every year.

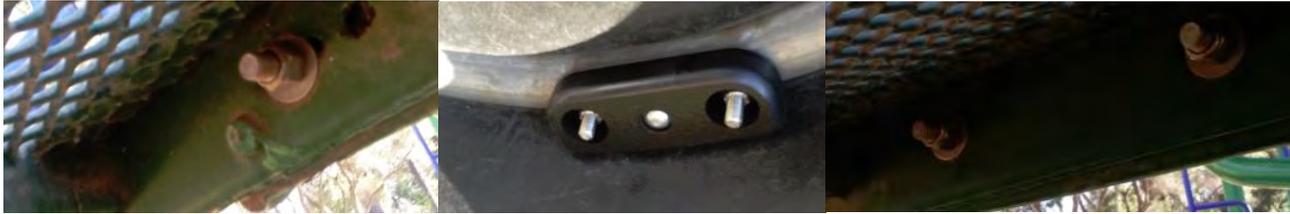
Protrusions

Hazard: There are bolts under the main decks and the tire swing that protrude too far beyond the nut. California Safety Regulations state that the end of a bolt shall not protrude more than 2 threads beyond the nut. - Level of risk: Priority 1 Hazard - Indicates a life-threatening or debilitating injury. Appropriate action is to remove or fix immediately.

Solution:
Grind down the bolts and sand to remove sharp edges

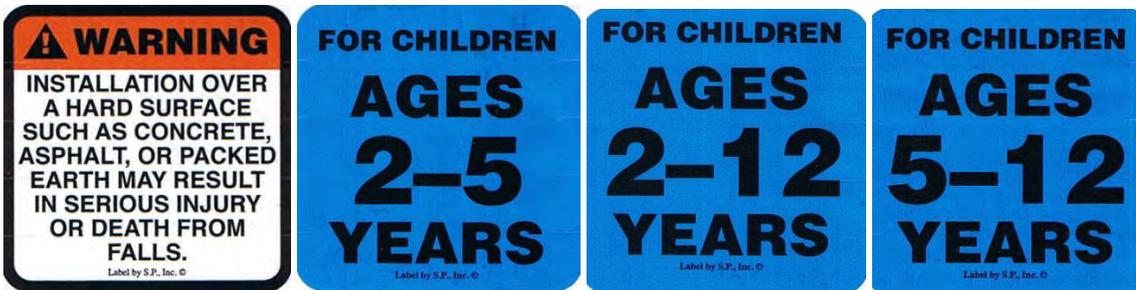
Safety-Signs and Labels

HAZARD: There are no signs or labels which state the age group that this is intended for as required by CPSR. Labels are also required that state “WARNING: Installation over a hard surface such as concrete, asphalt, or packed earth could result in serious injury or death from falls.” Priority 3 Hazard - Indicates cuts, scrapes or other minor injuries. Appropriate action is to place on regular maintenance schedule.

Solution:
Purchase Labels from original manufacturer and place on structure.

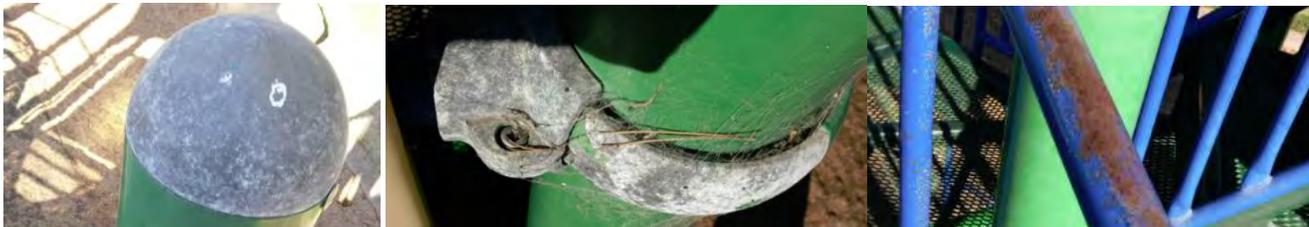
Rust and/or Corrosion

HAZARD: There is paint missing and rust on metals. CPSR state that “Metals subject to structural degradation such as rust or corrosion shall be painted, galvanized, or otherwise treated. Paint and other finishes should be maintained to prevent rusting of exposed metals and to minimize children playing with peeling paint and paint flakes.” Priority 3 Hazard - Indicates cuts, scrapes or other minor injuries. Appropriate action is to place on regular maintenance schedule.

Solution: Sand, prime and paint all rusted areas as well as components without paint.

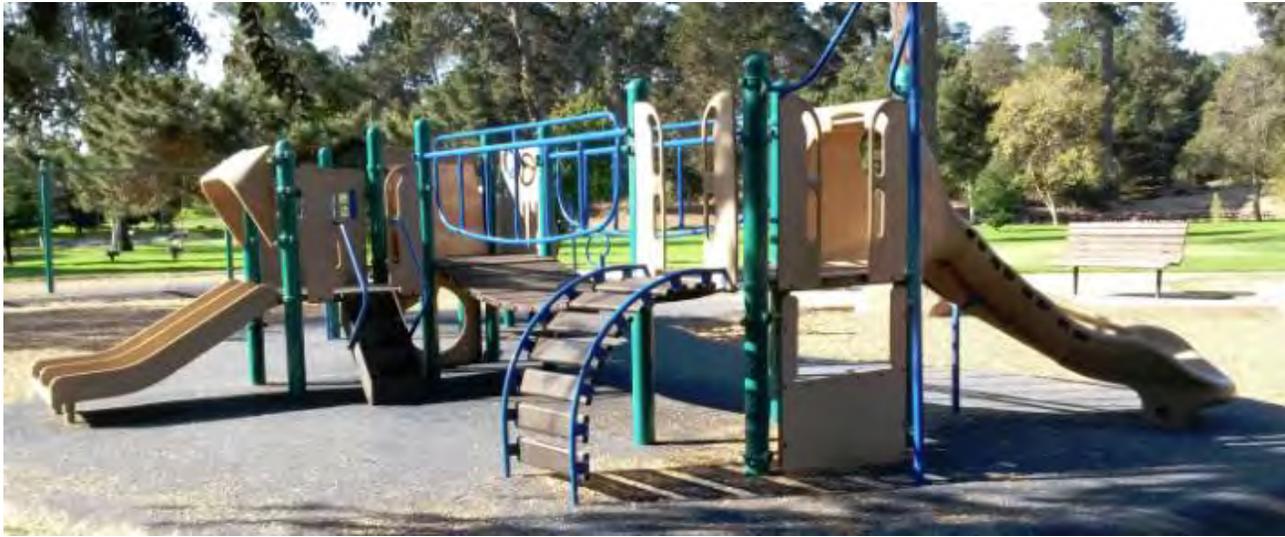
Waller Park Playground Area B does not comply with the California Playground Safety Regulations (CPSR) for the following reasons:

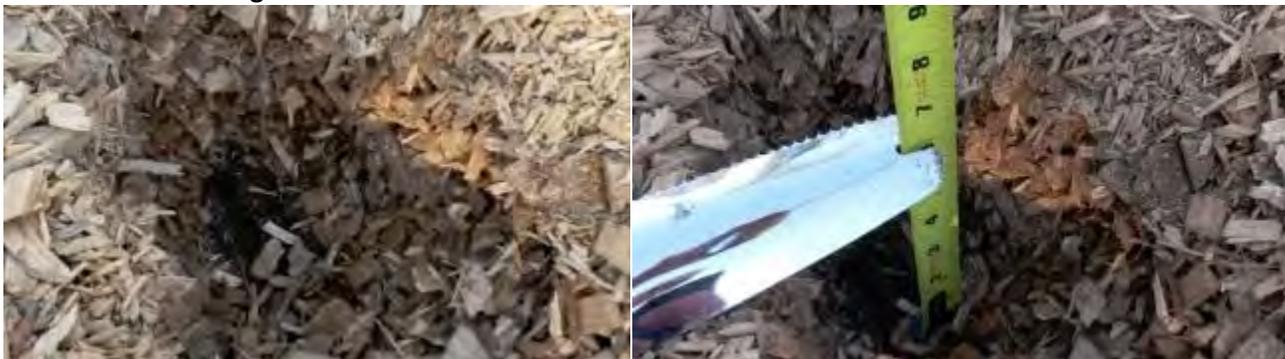
HAZARD: The playground only has 6"-7" of wood fiber in some areas. California Playground Safety Regulations state that a minimum 9 Inches of wood fiber is required. Priority 1 Hazard -Indicates a life-threatening or debilitating injury. Appropriate action is to remove or fix immediately.

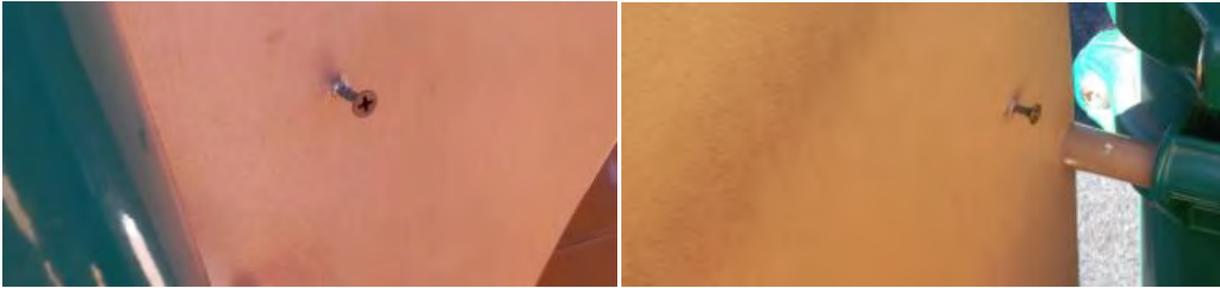
Protrusions

Hazard: There screws protruding out of the panels around the tunnel. This a violation of California Playground Safety Regulations. - Level of risk: Priority 1 Hazard - Indicates a life-threatening or debilitating injury. Appropriate action is to remove or fix immediately.

Solution:
Remove the screws immediately

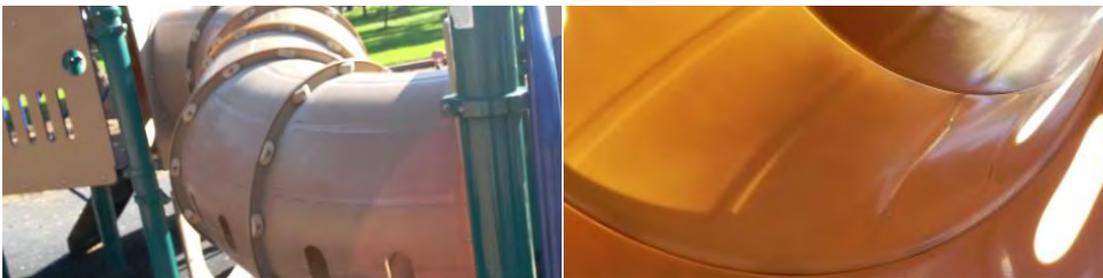
Cracked Plastic Crawl Tunnel

Hazard: A section of the crawl tunnel is cracked. This a violation of California Playground Safety Regulations. - Level of risk: Priority 1 Hazard - Indicates a life-threatening or debilitating injury. Appropriate action is to remove or fix immediately.

Solution:
Repair or replace immediately.

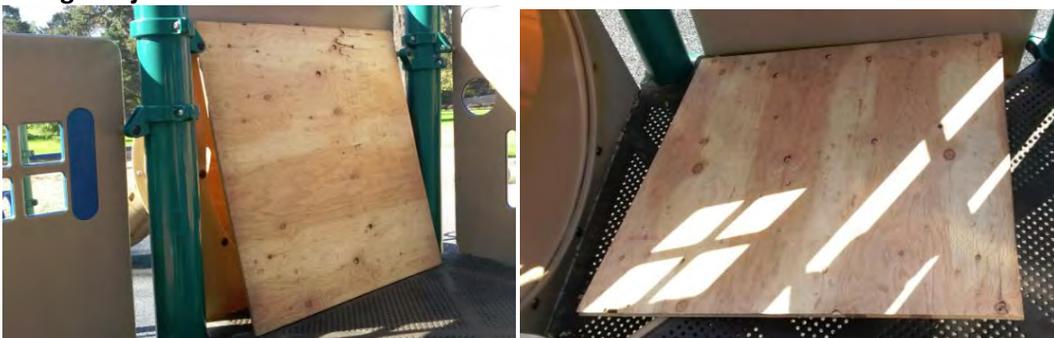
Foreign Objects

HAZARD: There are foreign objects in the play area as shown below. Any mobile or temporary object within the play area is subject to become non-compliant if it lies and is moved within the 6' fall zone around the playground. - Level of risk: Priority 1 Hazard - Indicates a life-threatening or debilitating injury. Appropriate action is to remove or fix immediately.

Solution: Remove all foreign objects from the play area and at least 6' away from the play structure.

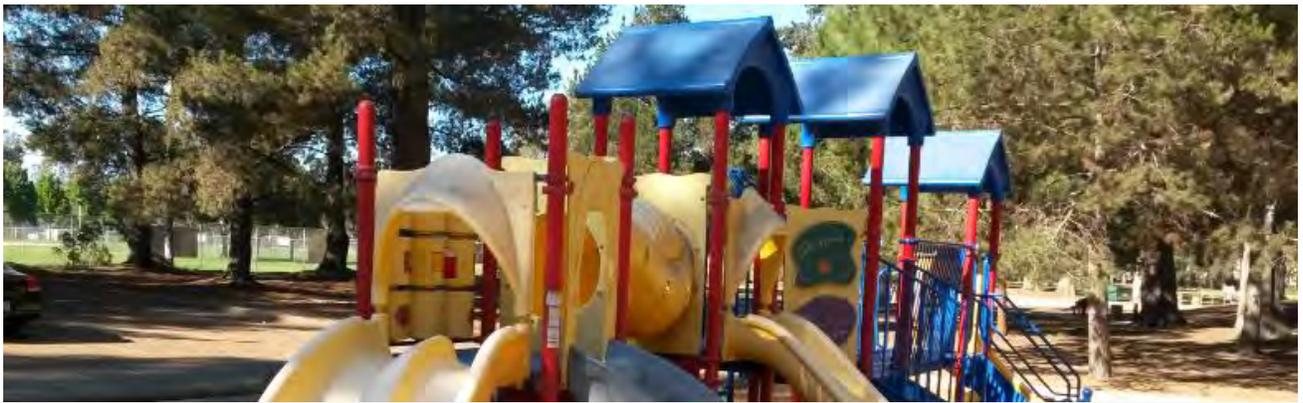
Waller Park Playground Area C does not comply with the California Playground Safety Regulations (CPSR) for the following reasons:

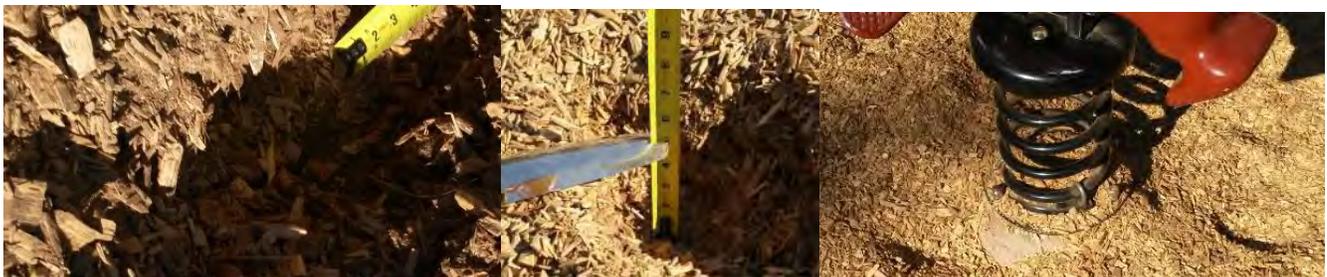
Wood Fiber Surfacing

HAZARD: The playground only has 4”-5” of wood fiber in some areas. California Playground Safety Regulations state that a minimum 9 Inches of wood fiber is required. Priority 1 Hazard -Indicates a life-threatening or debilitating injury. Appropriate action is to remove or fix immediately.

Solution: Fill the playground area with wood fiber to 10"-12" to compensate for the rate of compaction which is 1"-2" every year.

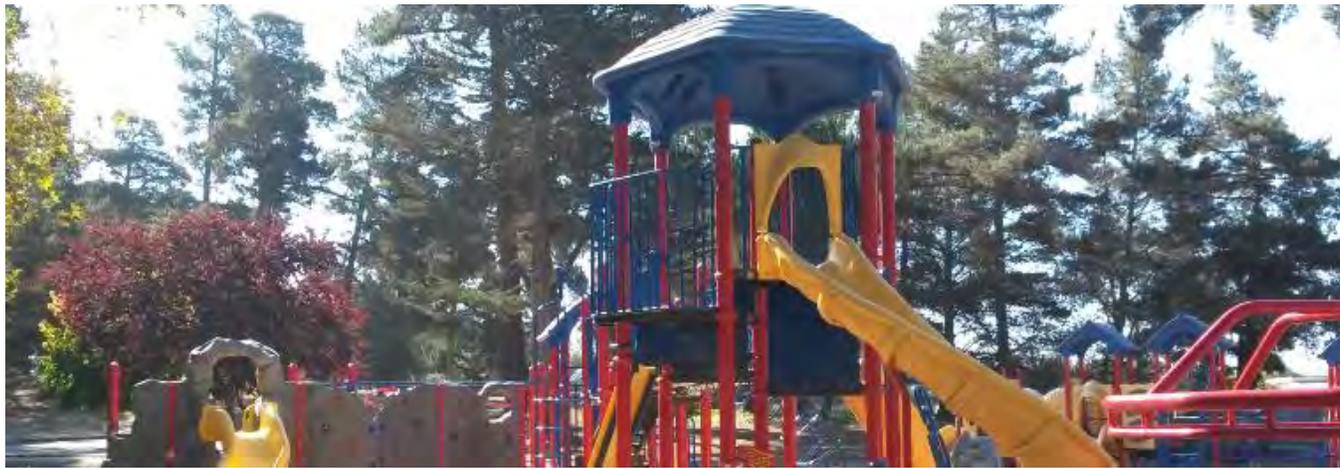
Waller Park Playground Area D is in full compliance with the California Playground Safety Regulations (CPSR).

The County of Santa Barbara must develop an inspection and maintenance program for the play area and maintain detailed records of inspections and repair records to assure continued compliance. The play area should be inspected frequently for missing or damaged equipment, broken glass and foreign objects in the play area. Loose fill fall materials should be inspected to insure that they have not been displaced or compacted in high traffic areas such as under swings and at slide exits. The material should be leveled whenever necessary; almost 80% of injuries in play areas are caused by falls to the surface so maintenance of fall surface is a priority. Loose fill materials will need to be replenished occasionally based on usage and wear.

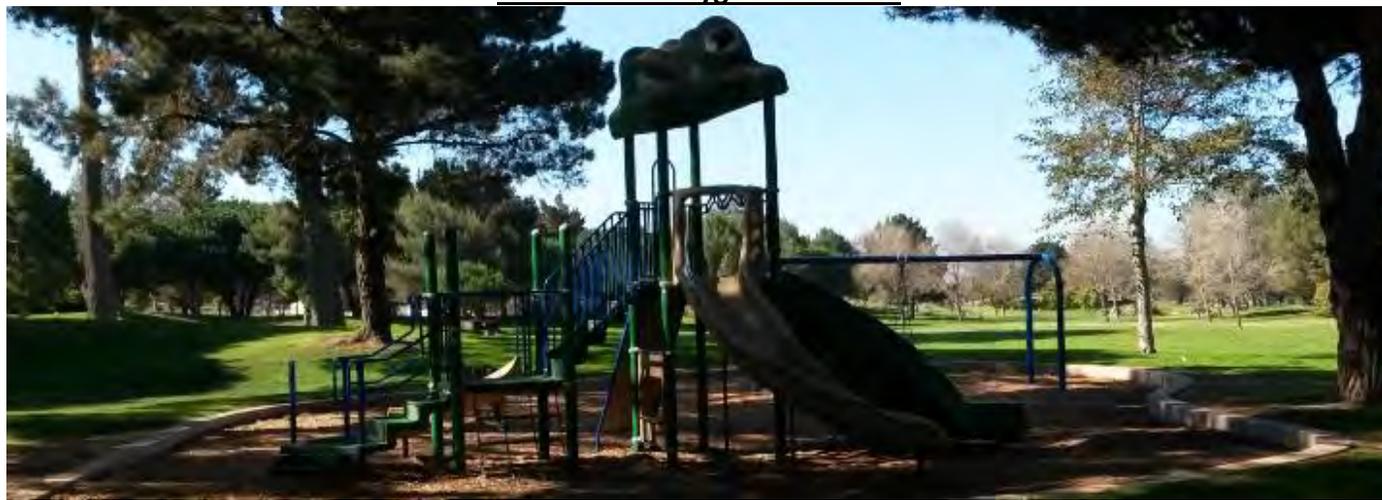
Waller Park Playground Area E does not comply with the California Playground Safety Regulations (CPSR) for the following reasons:

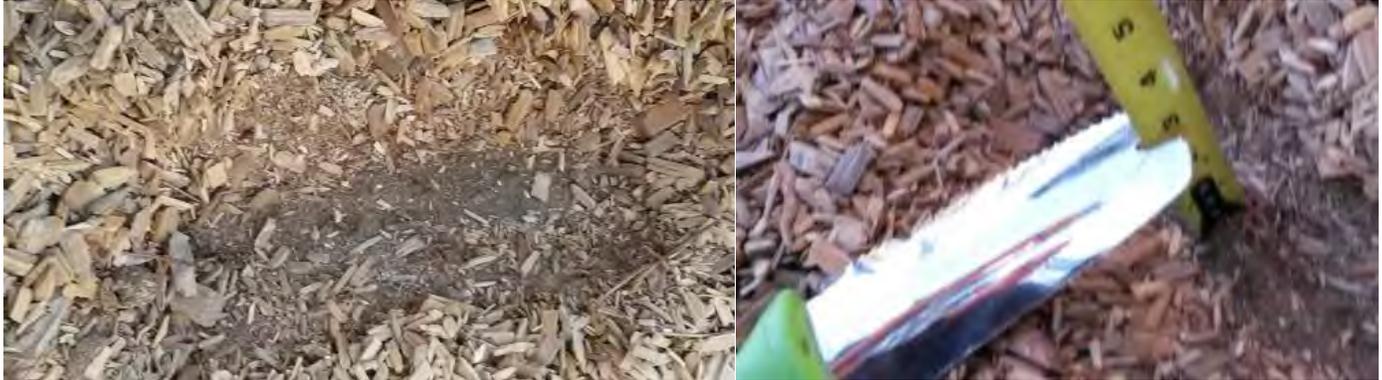
HAZARD: The playground only has 2"-3" of wood fiber in some areas. California Playground Safety Regulations state that a minimum 9 Inches of wood fiber is required. Priority 1 Hazard -Indicates a life-threatening or debilitating injury. Appropriate action is to remove or fix immediately.

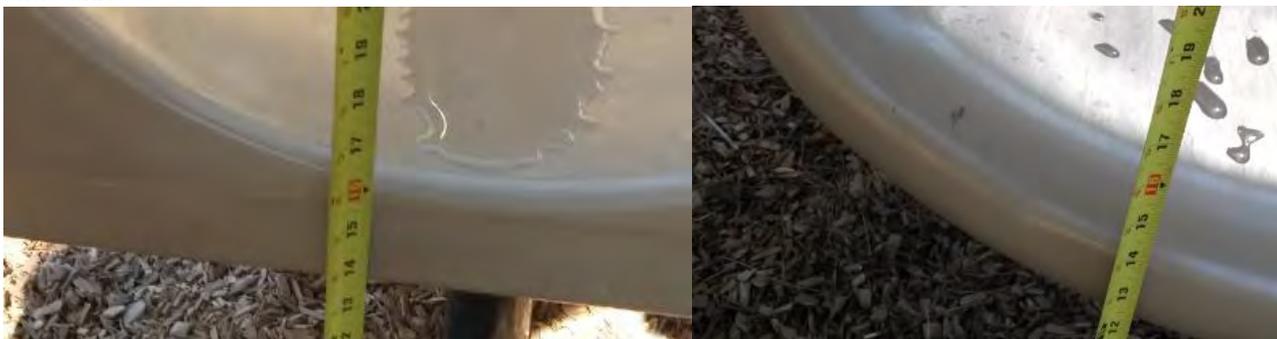
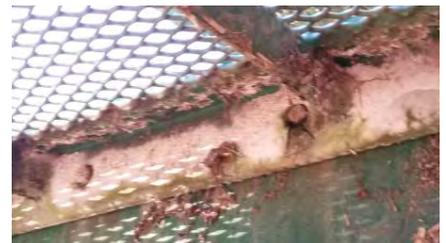
Slide exits

Hazard: Slide exit is 17 inches above the safety surfacing. CPSC requires that the slide exit be no more than 15 inches from the safety surfacing. Priority 2 Hazard - Indicates the possibility of broken bones, stitches, etc. Appropriate action is to schedule to fix or replace as soon as possible.

Solution: Add additional wood fiber to close the gap of at least 2”

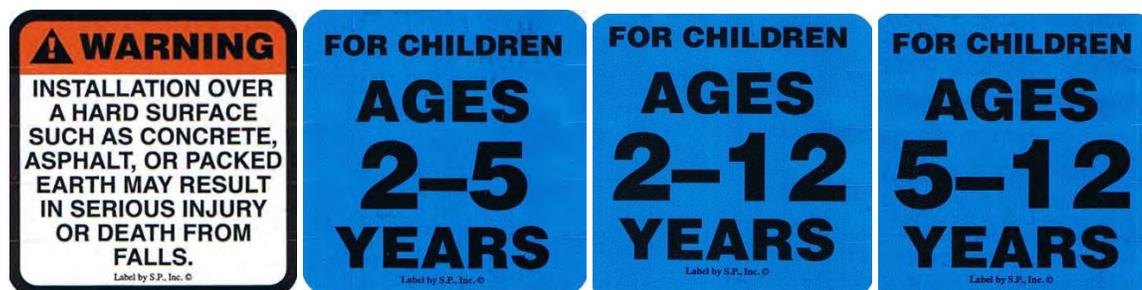
Safety-Signs and Labels

HAZARD: There are no signs or labels which state the age group that this is intended for as required by CPSR. Labels are also required that state “WARNING: Installation over a hard surface such as concrete, asphalt, or packed earth could result in serious injury or death from falls.” Priority 3 Hazard - Indicates cuts, scrapes or other minor injuries. Appropriate action is to place on regular maintenance schedule.

Solution:
Purchase Labels from original manufacturer and place on structure.
