Appendix 3 – RJM Design Report

Community Parks

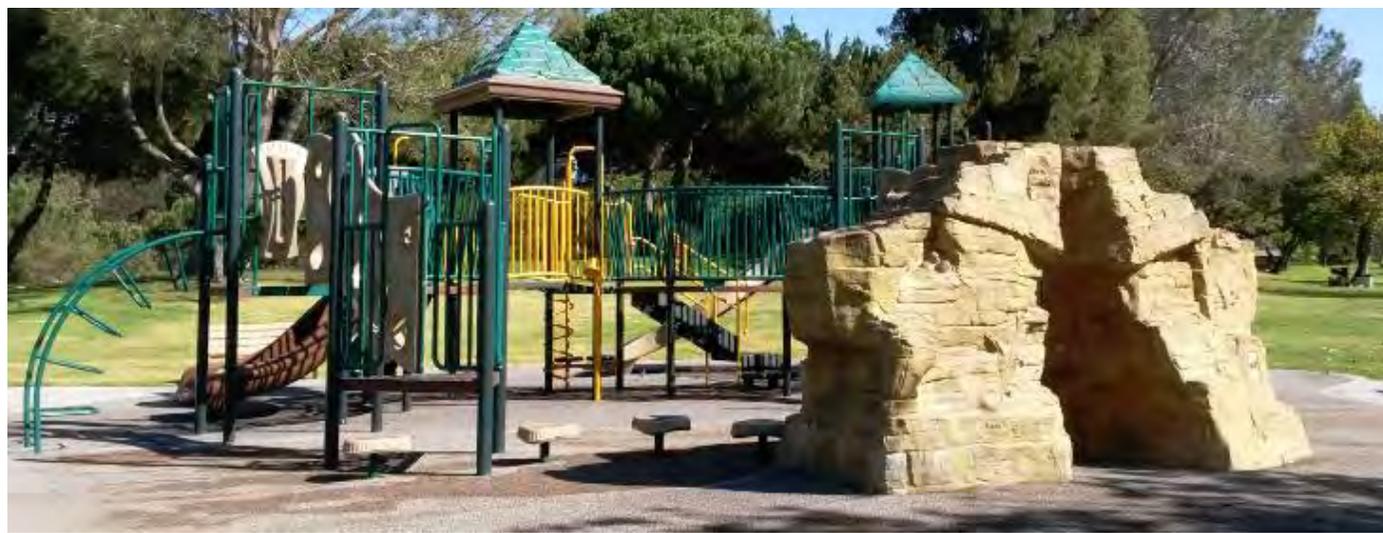
Waller Park Playground Area F is in full compliance with the California Playground Safety Regulations (CPSR).

The County of Santa Barbara must develop an inspection and maintenance program for the play area and maintain detailed records of inspections and repair records to assure continued compliance. The play area should be inspected frequently for missing or damaged equipment, broken glass and foreign objects in the play area. Almost 80% of injuries in play areas are caused by falls to the surface so maintenance of fall surface is a priority. Loose fill materials will need to be replenished occasionally based on usage and wear.

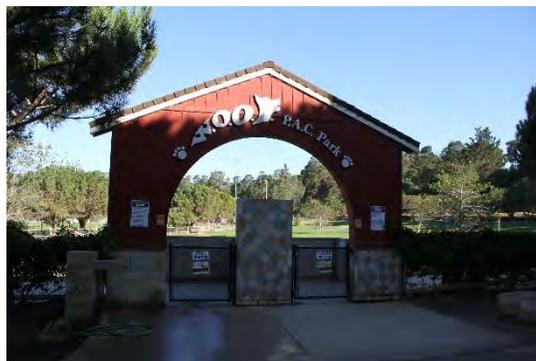
The Dog Park was well utilized and in excellent condition excluding several large holes in the turf from gophers and where dogs apparently were digging for gophers.
