DOS PUEBLOS CREEK RESTORATION, MAINTENANCE AND MONITORING PLAN

JUNE 2015

PREPARED FOR:
California Rangeland Trust
1225 H Street
Sacramento, California 958149

PREPARED BY:
DUDEK
621 Chapala Street
Santa Barbara, CA 93101

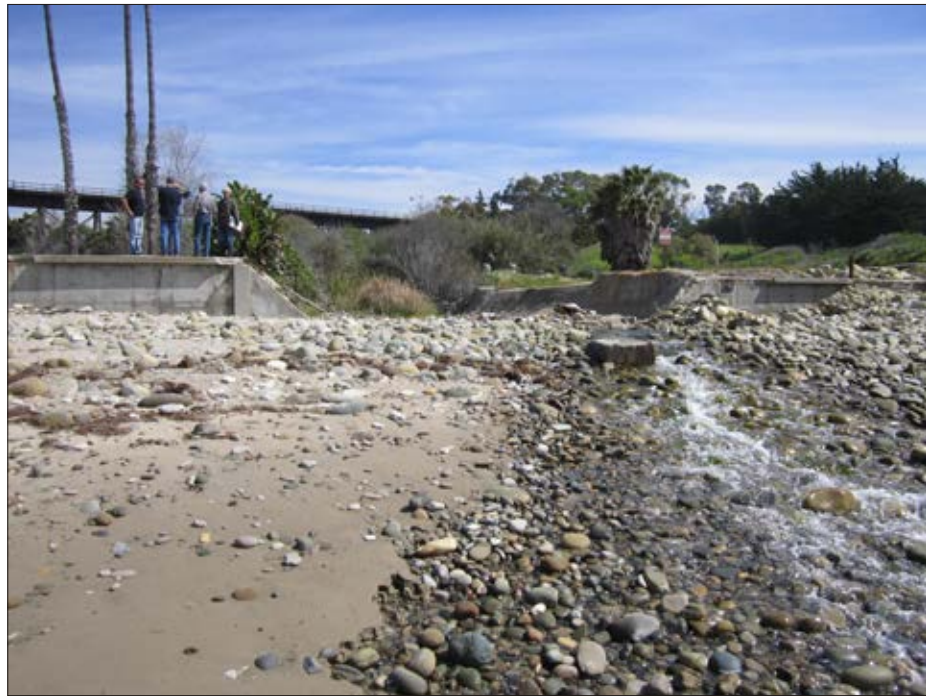
Photo 1: Beach outfall looking northeast

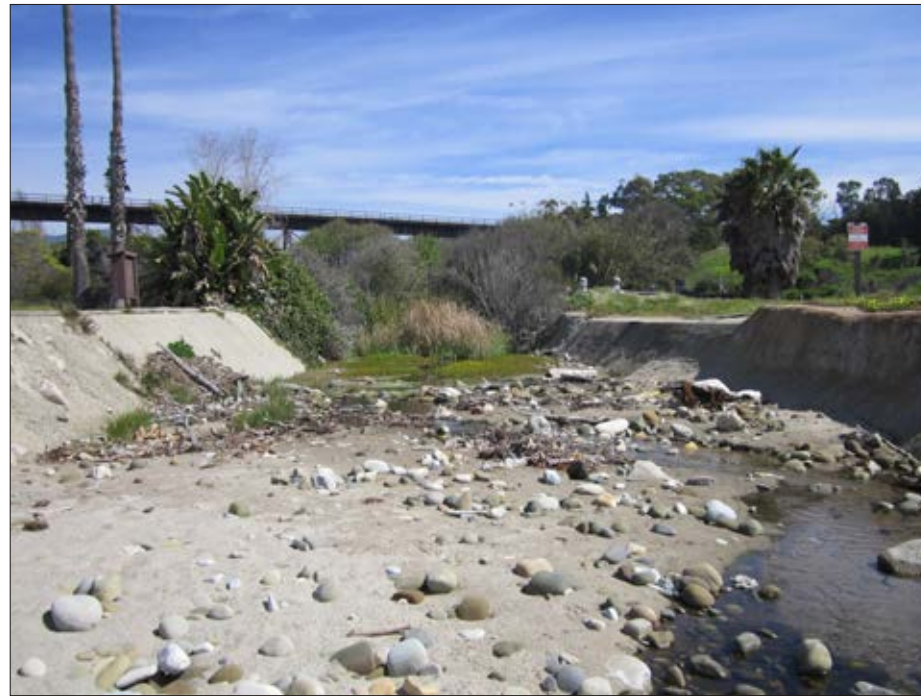
Photo 2: Concrete channel looking northeast

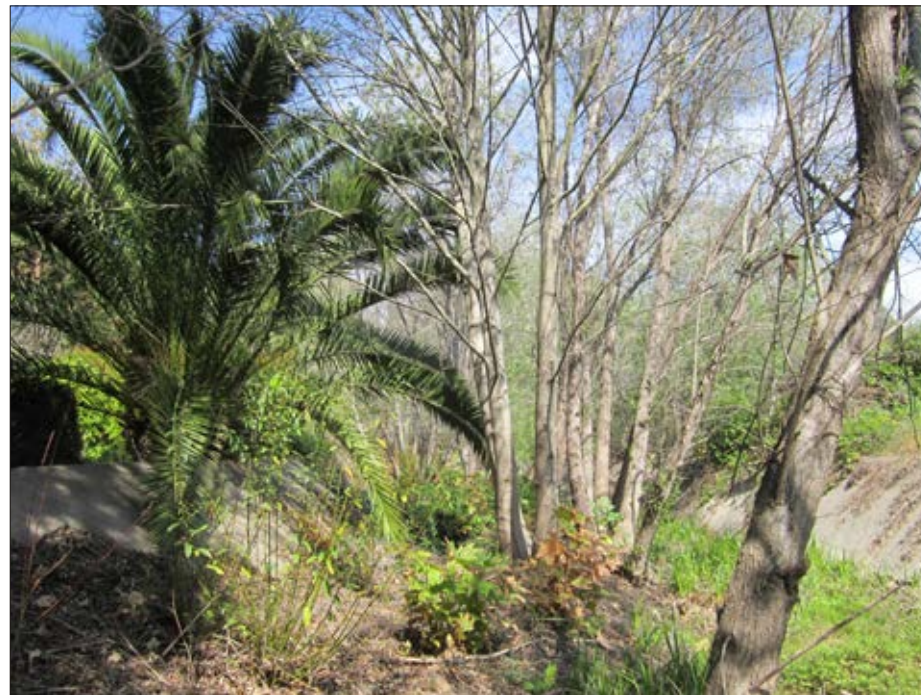
Photo 5: Giant reed to be removed on creek bank looking east tressle

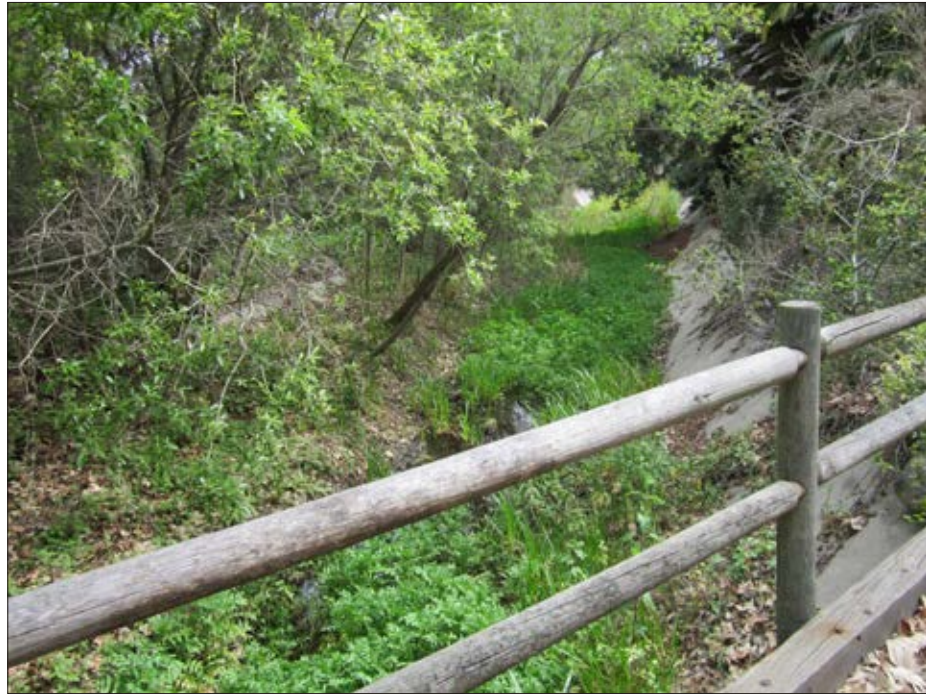
Photo 1: Downstream of beach access road bridge

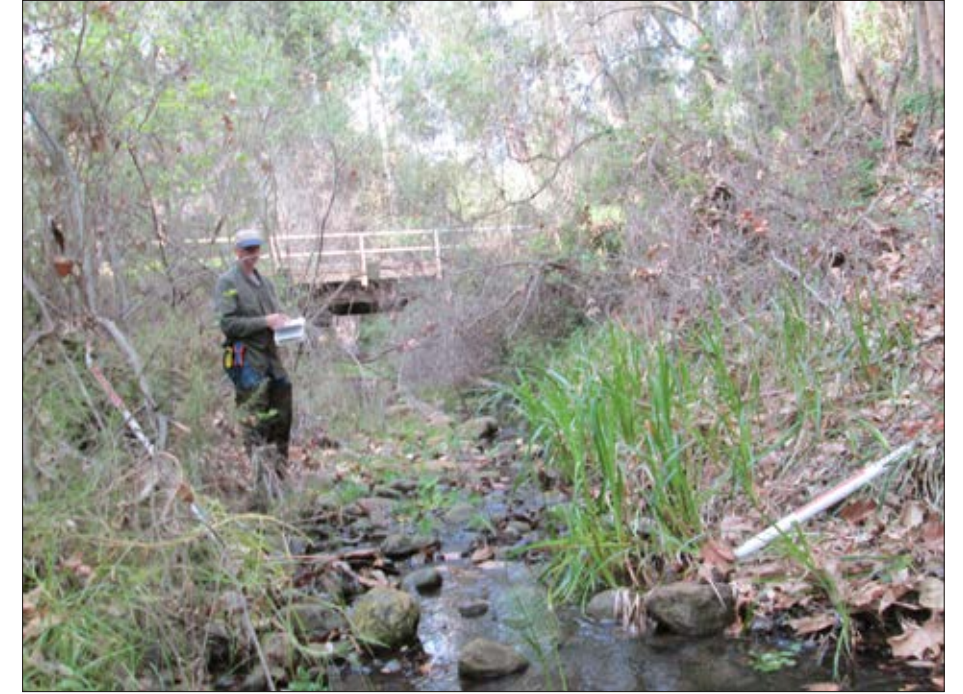
Photo 3: Taking measurement downstream of La Casa Grande Bridge

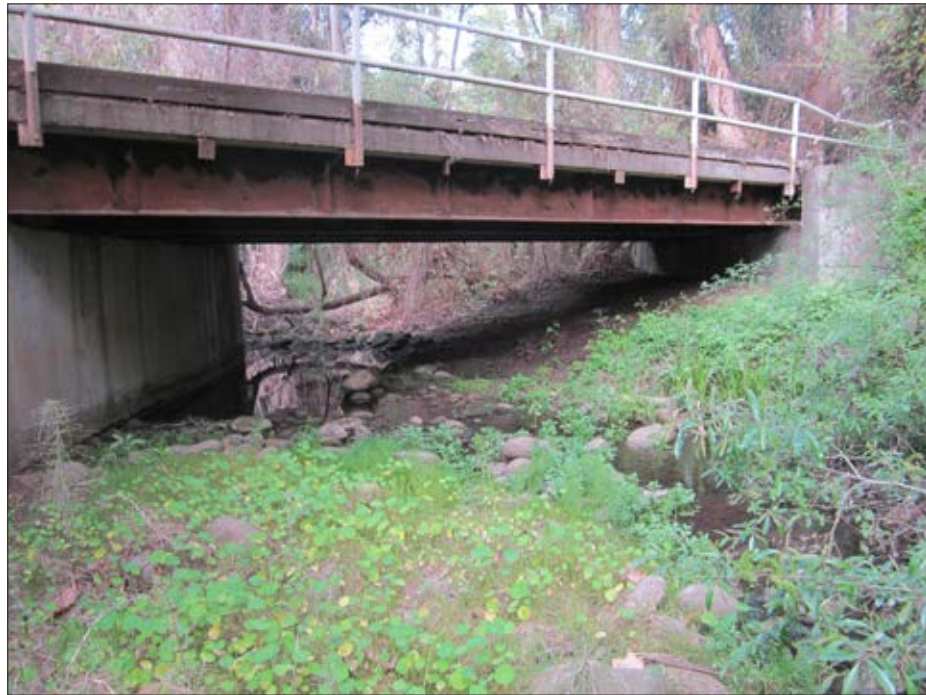
Photo 4: Underneath La Casa Grande Bridge

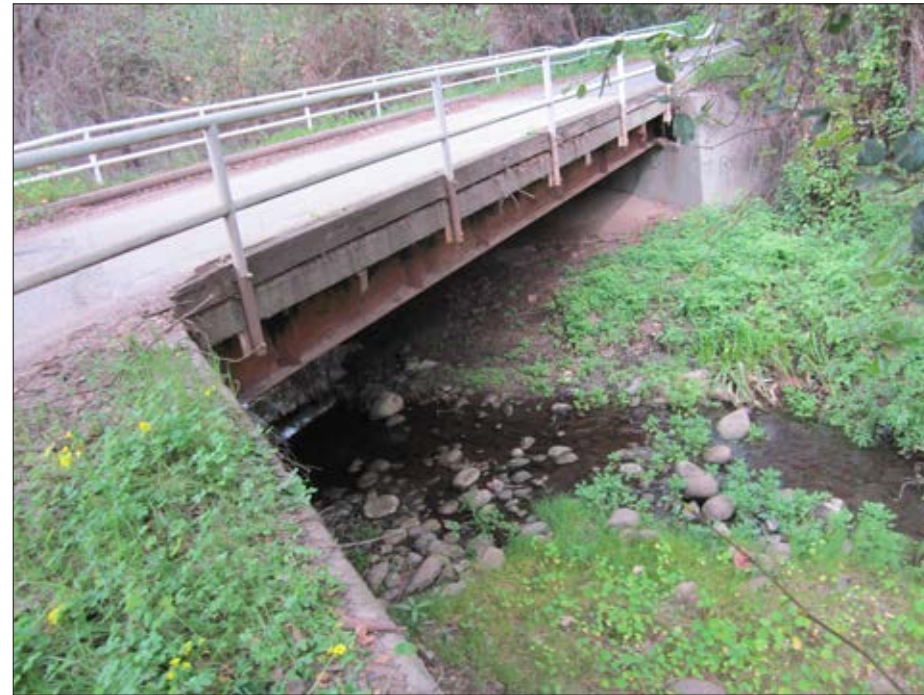
Photo 5: Looking into creek at upstream side of La Casa Grande Bridge

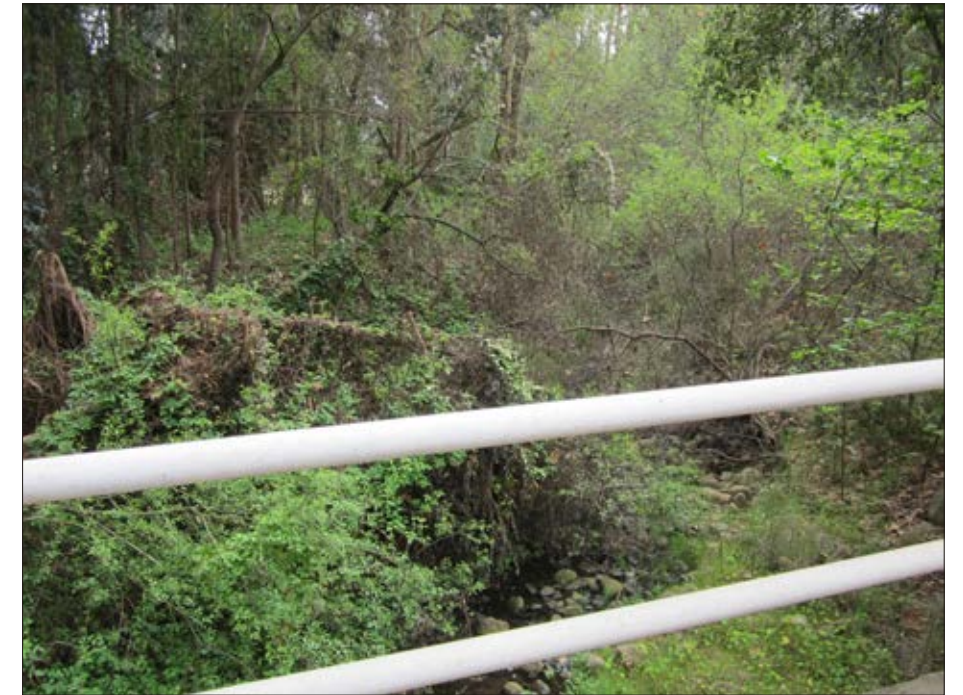
Photo 6: Looking upstream from La Casa Grande Bridge

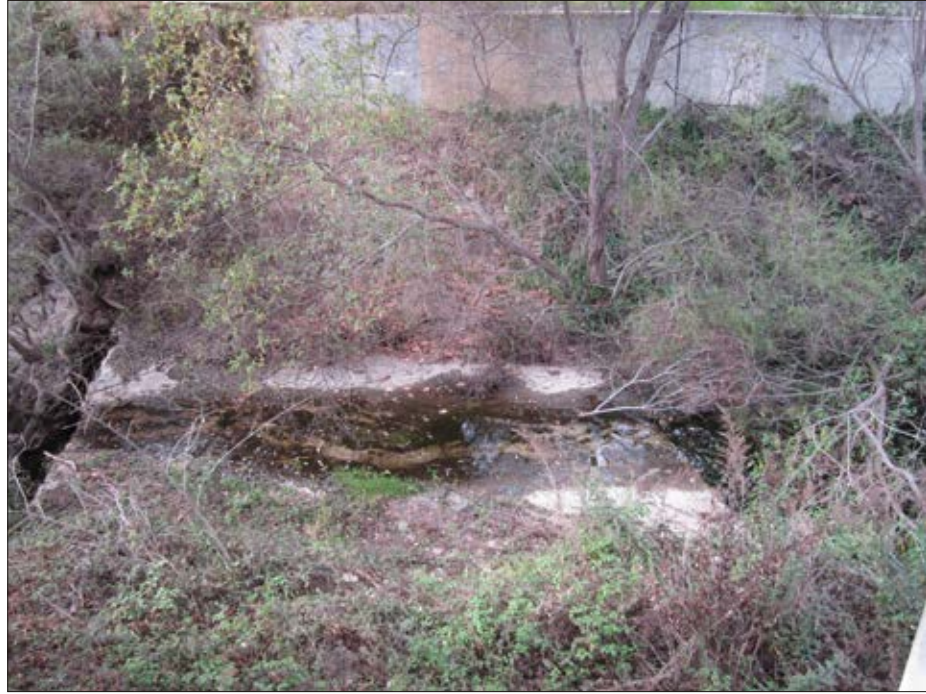
Photo 1: Hwy 101 bridge concrete paving and drop structure

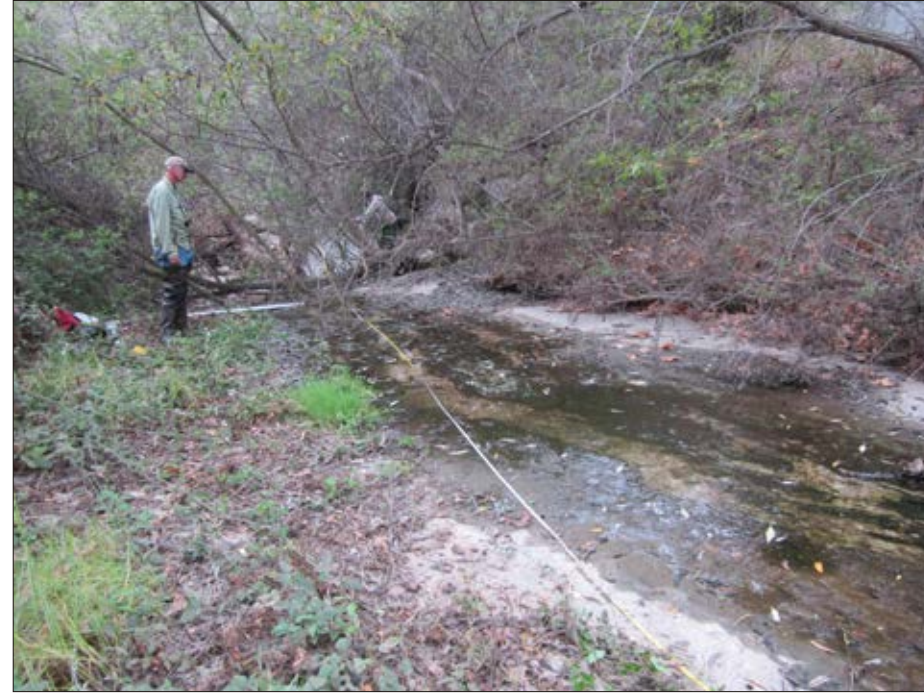
Photo 2: Old concrete paving under bridge looking south towards drop structure

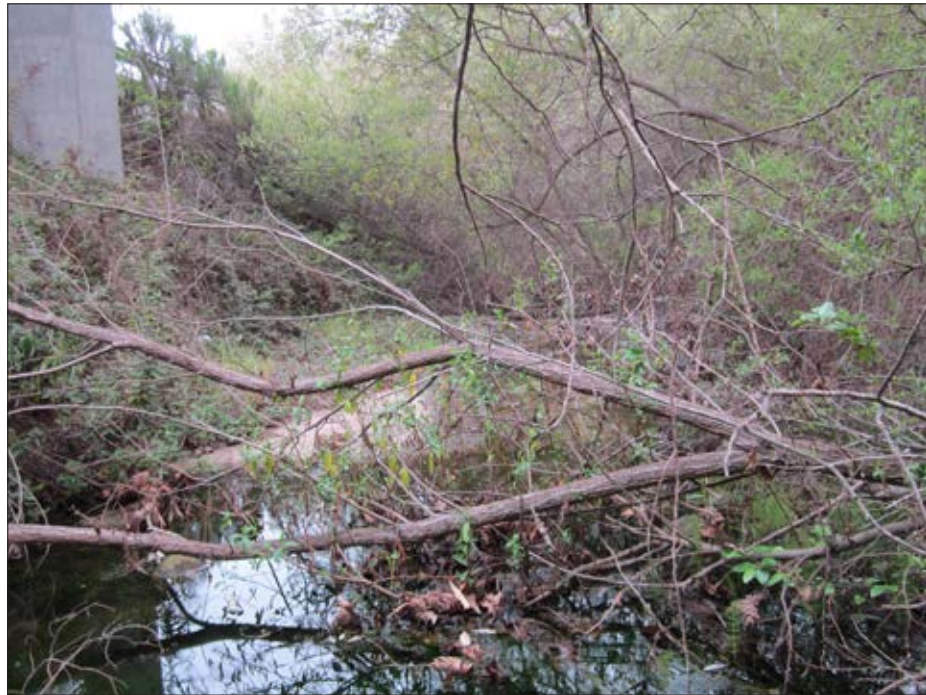
Photo 4: View looking south along creek to old concrete paving under bridge

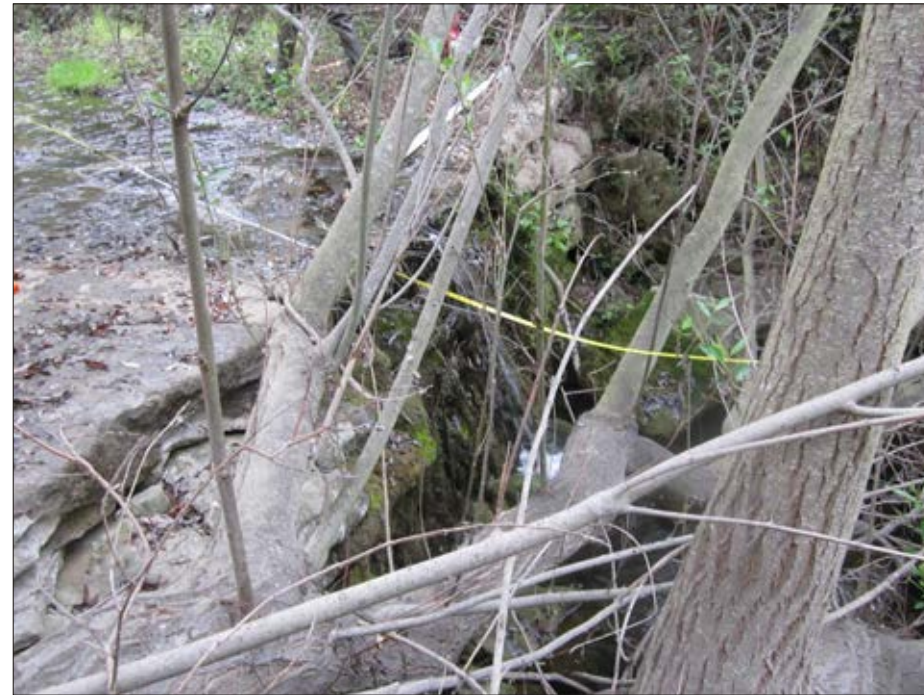
Photo 5: View looking east at spillway of drop structure

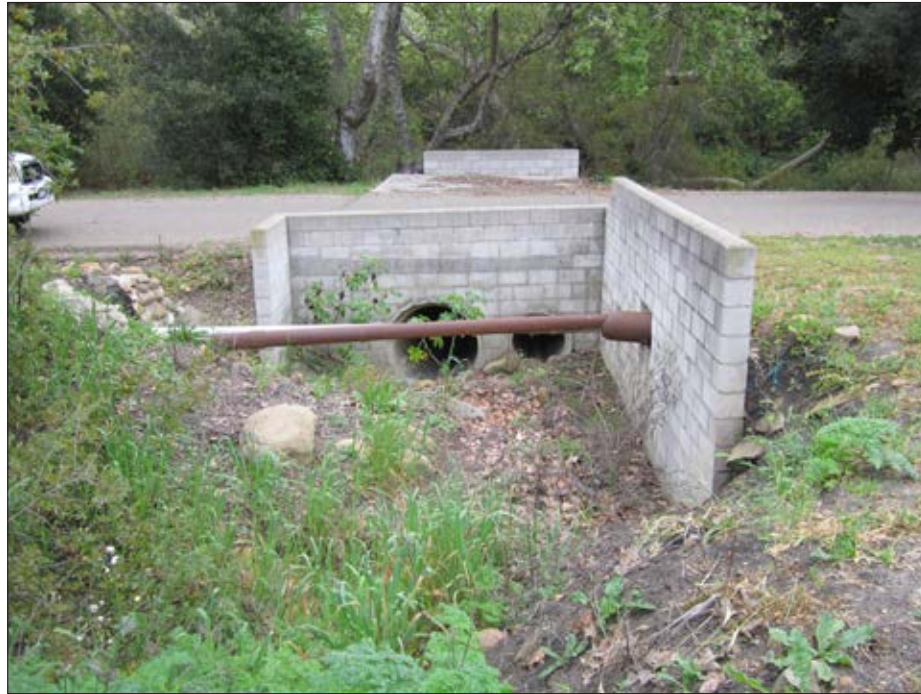
Photo 1: View of agriculture drain structure/culvert on west side of access road (potential bioretention basin location)

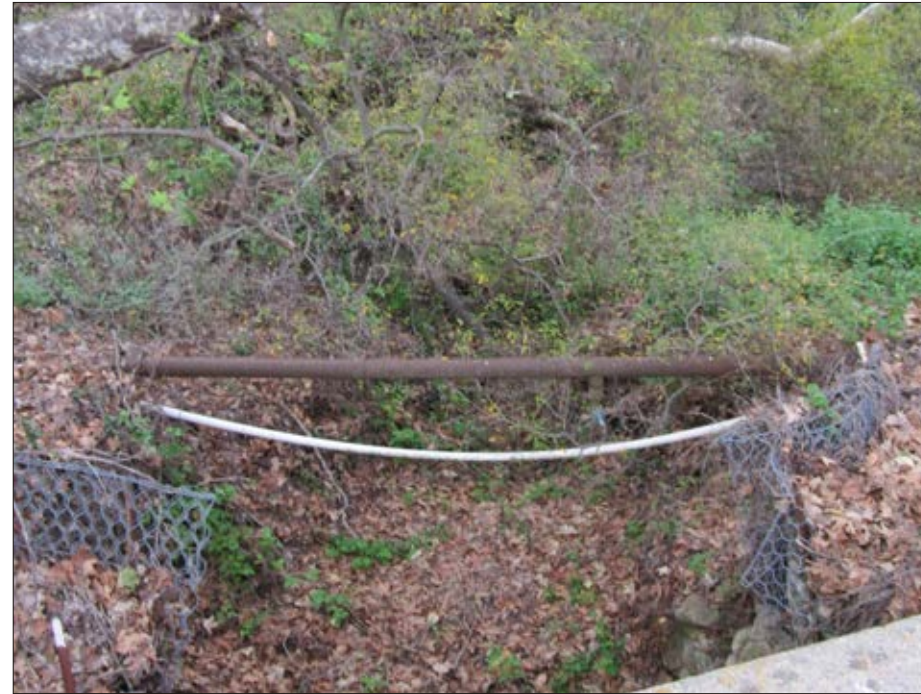
Photo 2: View of secondary drainage downstream of agriculture drain structure/culvert

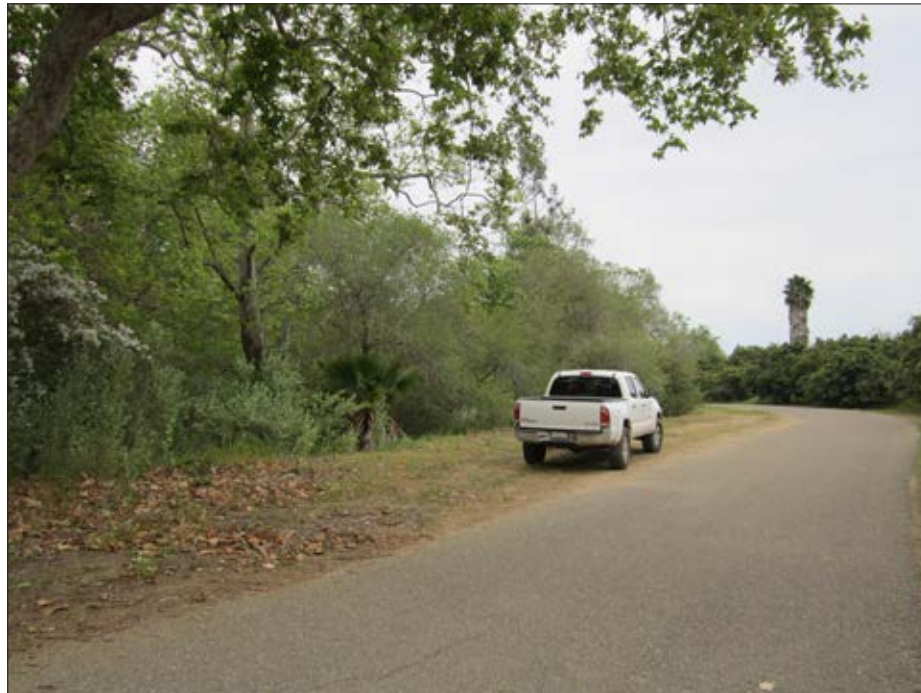
Photo 4: Palm on creek bank to be removed on east side of access road south of agriculture drain

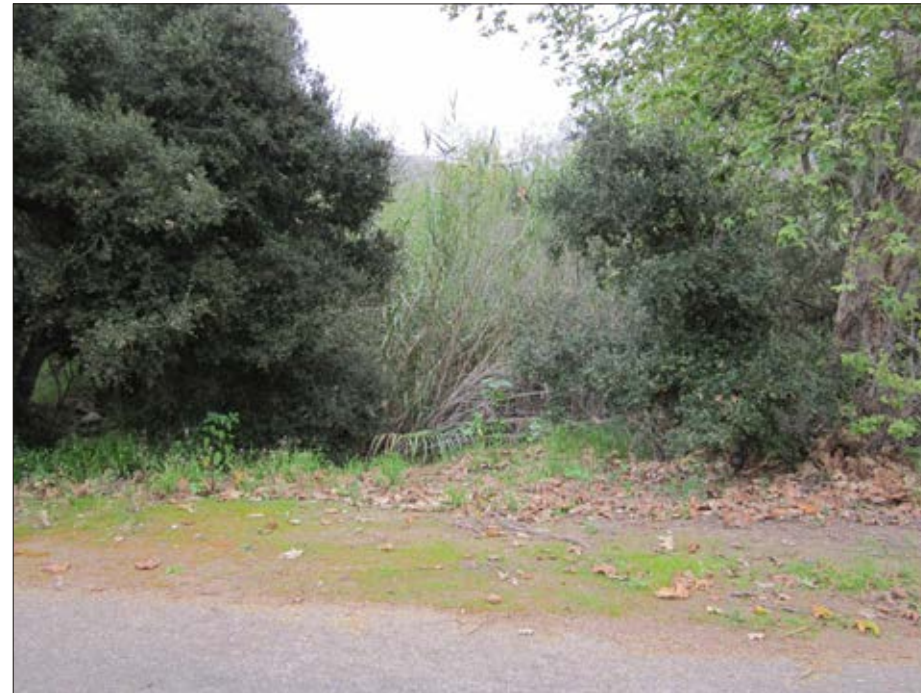
Photo 5: Giant reed on creek bank to be removed on east side of access road south of agriculture drain
