Assessment of the post-fire debris flow and flooding events of January 20, 2017 in the Sherpa Fire burned area:

Jonathan Yonni Schwartz – Minerals & Geology Program Manager, Los Padres NF

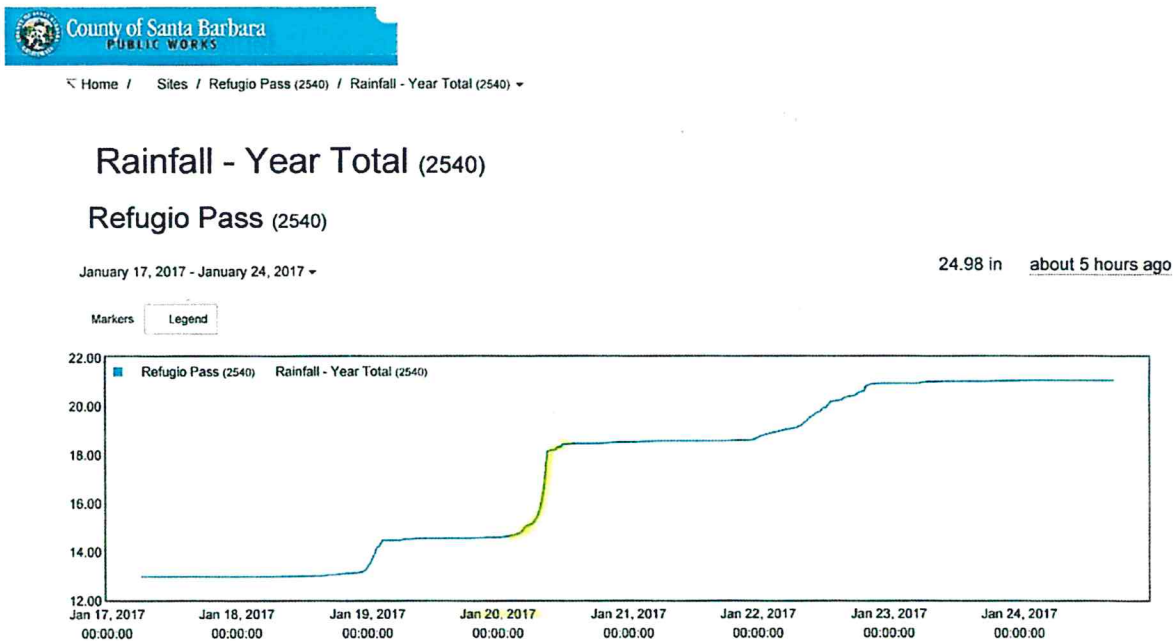
On the morning of January 20, 2017 a second consecutive rainstorm in a 3-day period started coming down at about 2:00 a.m. and continued till 11:45 a.m. PST. Over this time period of about 10 hours 4 inches of

rain came down at the Refugio Pass rain gage station (which best represents the upper El Capitan watershed) with the maximum 1-hour rainfall (2.05 inches) occurring between 8:10 and 9:10 a.m. PST (Figure 4 & 5). This rainstorm had a peak 15-minute rainfall intensity storm of 0.75 inches occurring between 8:53 and 9:08 a.m. PST, which is equivalent to a precipitation frequency of 25 to 50 year-storm (NOAA, 2016, Hydrometeorological Designs Study Center Precipitation Frequency Data Server (PFDS). National Oceanic and Atmospheric Administration. <http://hdsc.nws.noaa.gov/hdsc/pfds/index.html>. Accessed February 2017). From the start of the 2016-17 rain season, this upper watershed area received 21.04” of rain (Figure 6), which means that by Jan. 20, 2017, when this event took place, the soil and channel-bed moisture was likely elevated, which potentially contributes to an increase in surface runoff and mobility of materials (Kean et. Al., 2013).

Figure 4: Precipitation data – Jan. 20, 2017 – Refugio Pass Rain-gage Station

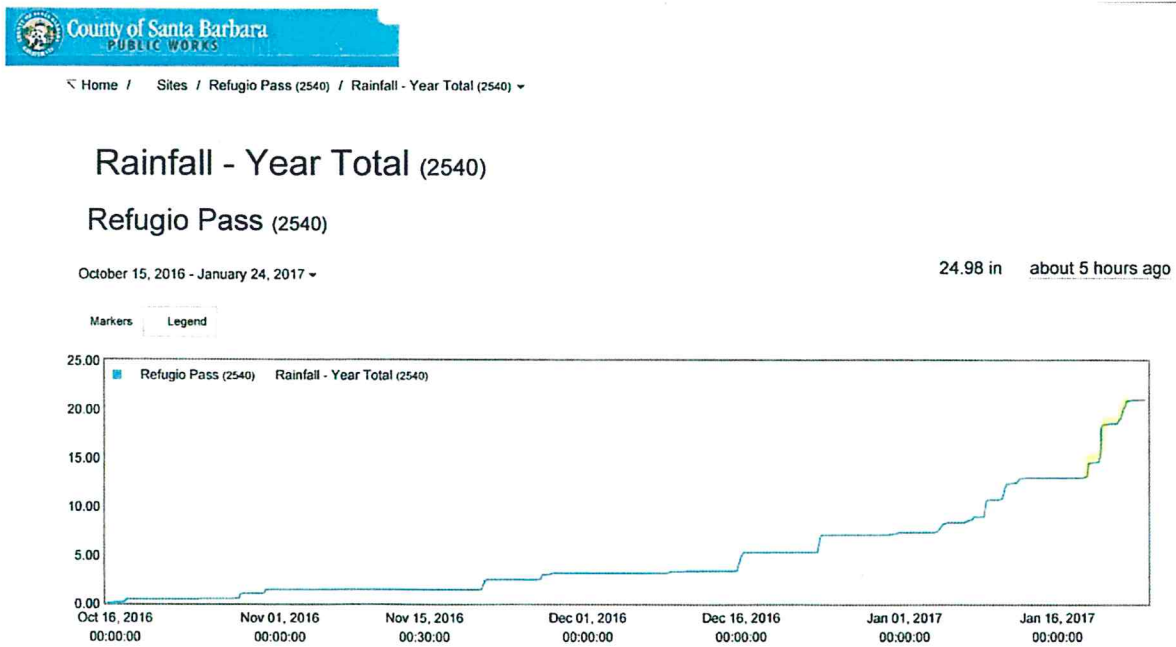
Figure 6: 2016-2017 rain season total precipitation data – Refugio Pass Station

- From the start of the 2016-17 rain season and up in till January 20, 2017, the area of these upper watersheds received 21.04” of rain, which means that by the time this flooding event took place, soil were saturated, the channel-beds moisture was likely elevated, which contributed to an increase in surface runoff and mobility of materials.
