ACIN RANCH HISTORIC MINING INVESTIGATION

1. Executive Summary

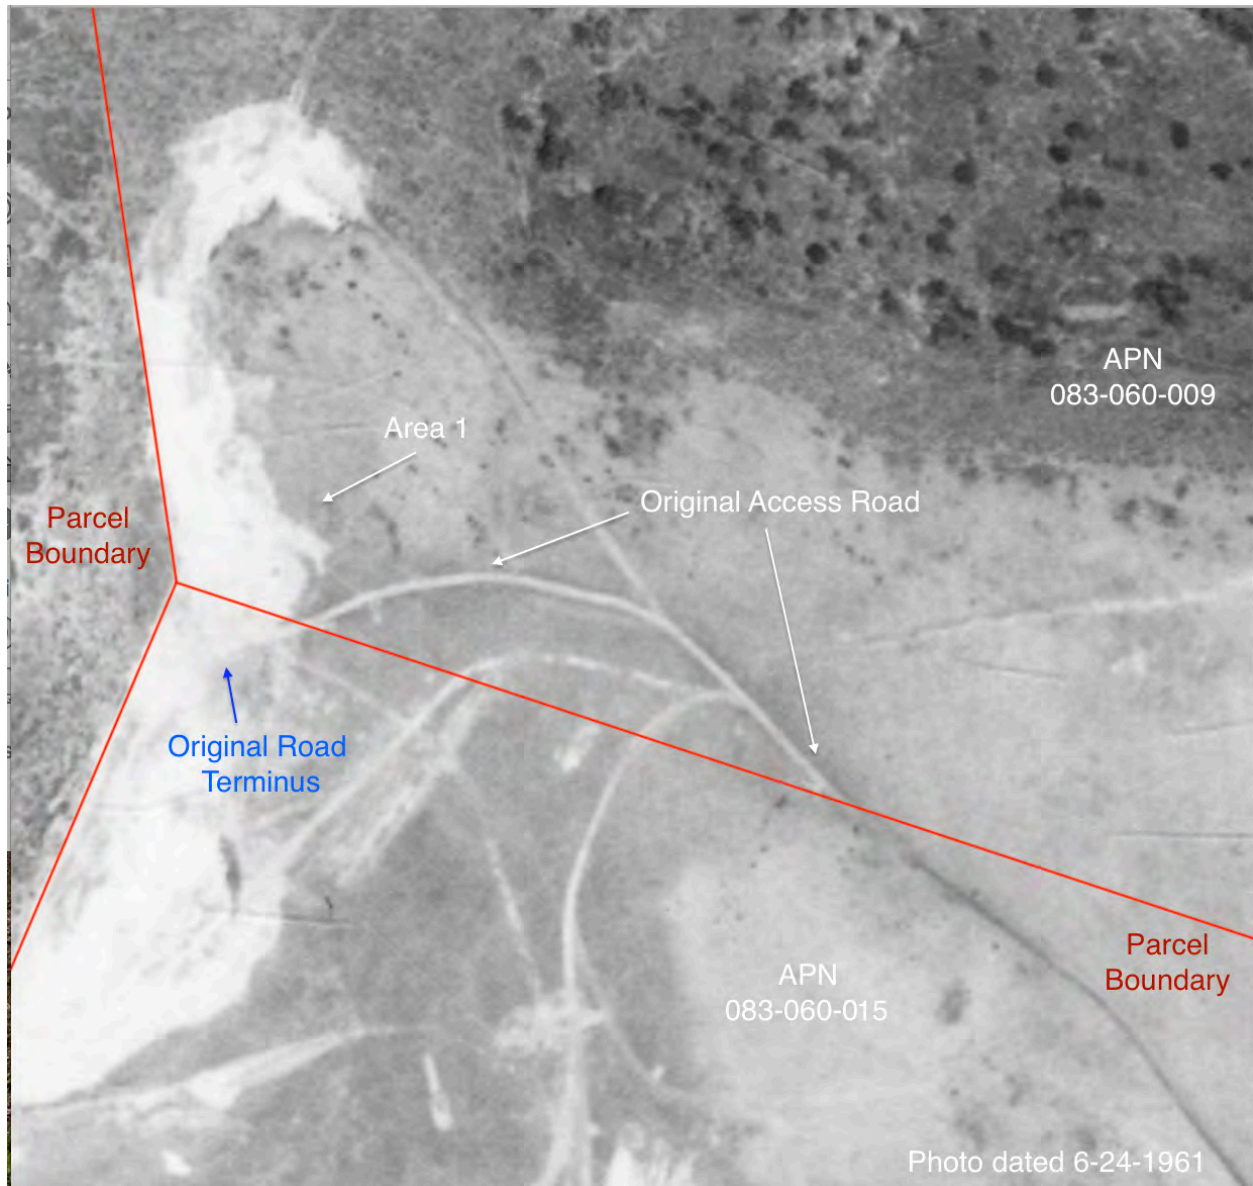
Fig. 20. June 24, 1961 aerial photograph closeup of Area 1.

This photograph is included to illustrate the expansion of mining activities in this location after the effective date of County Ordinance 971 on September 29, 1958.

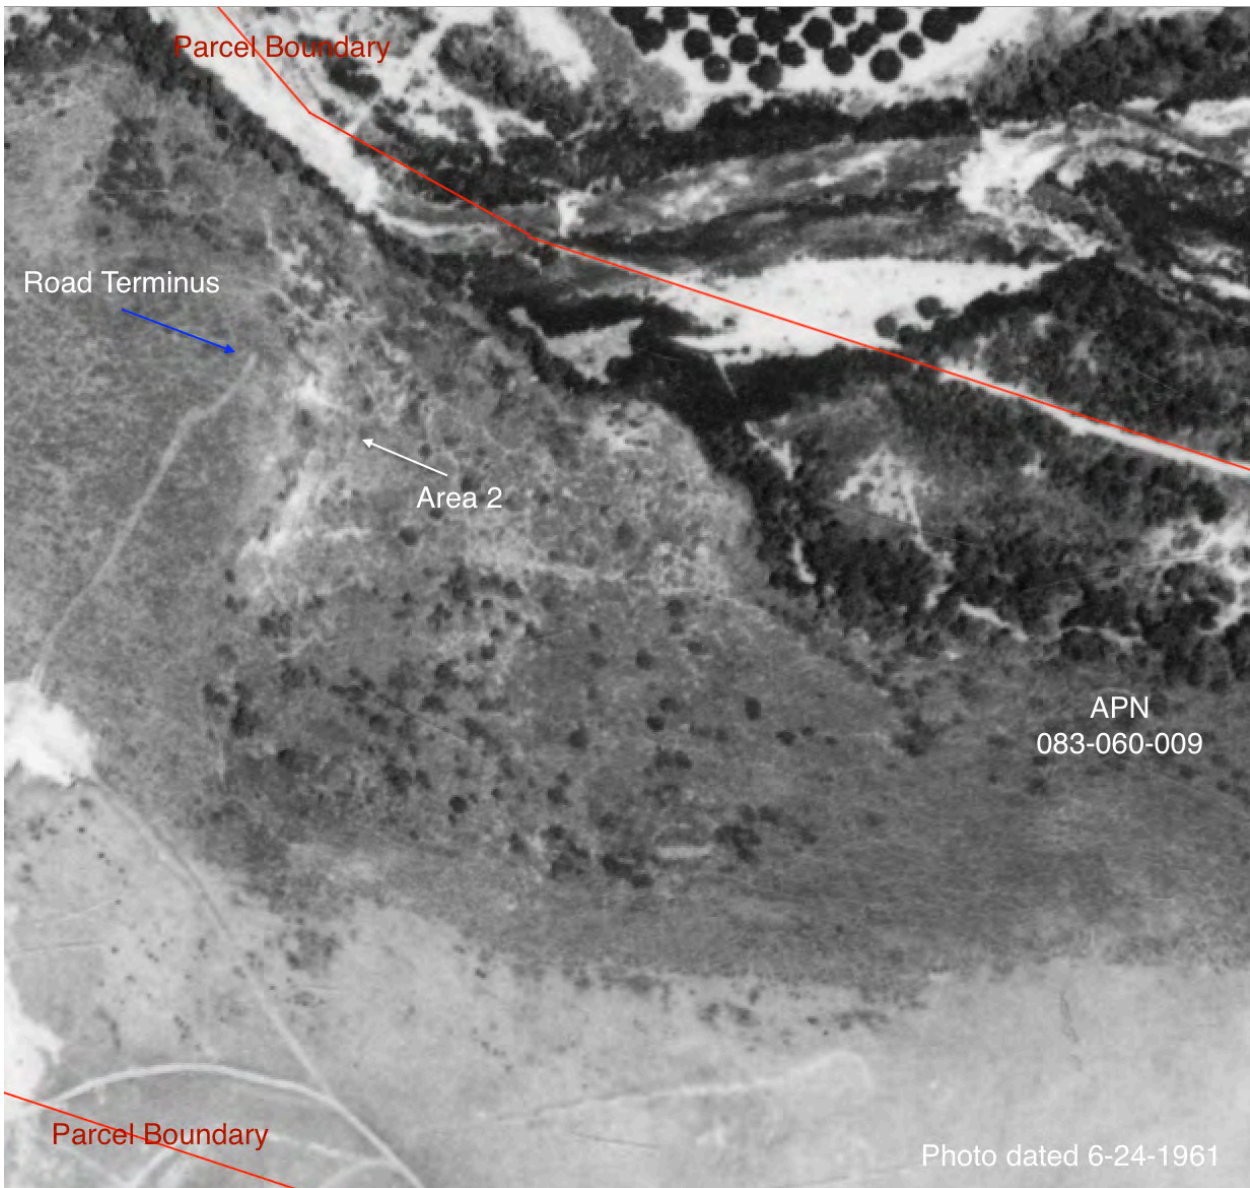
Fig. 28. June 24, 1961 aerial photograph closeup of Area 2.

This photo is dated after the enactment of County Ordinance 971 of September 29, 1958.

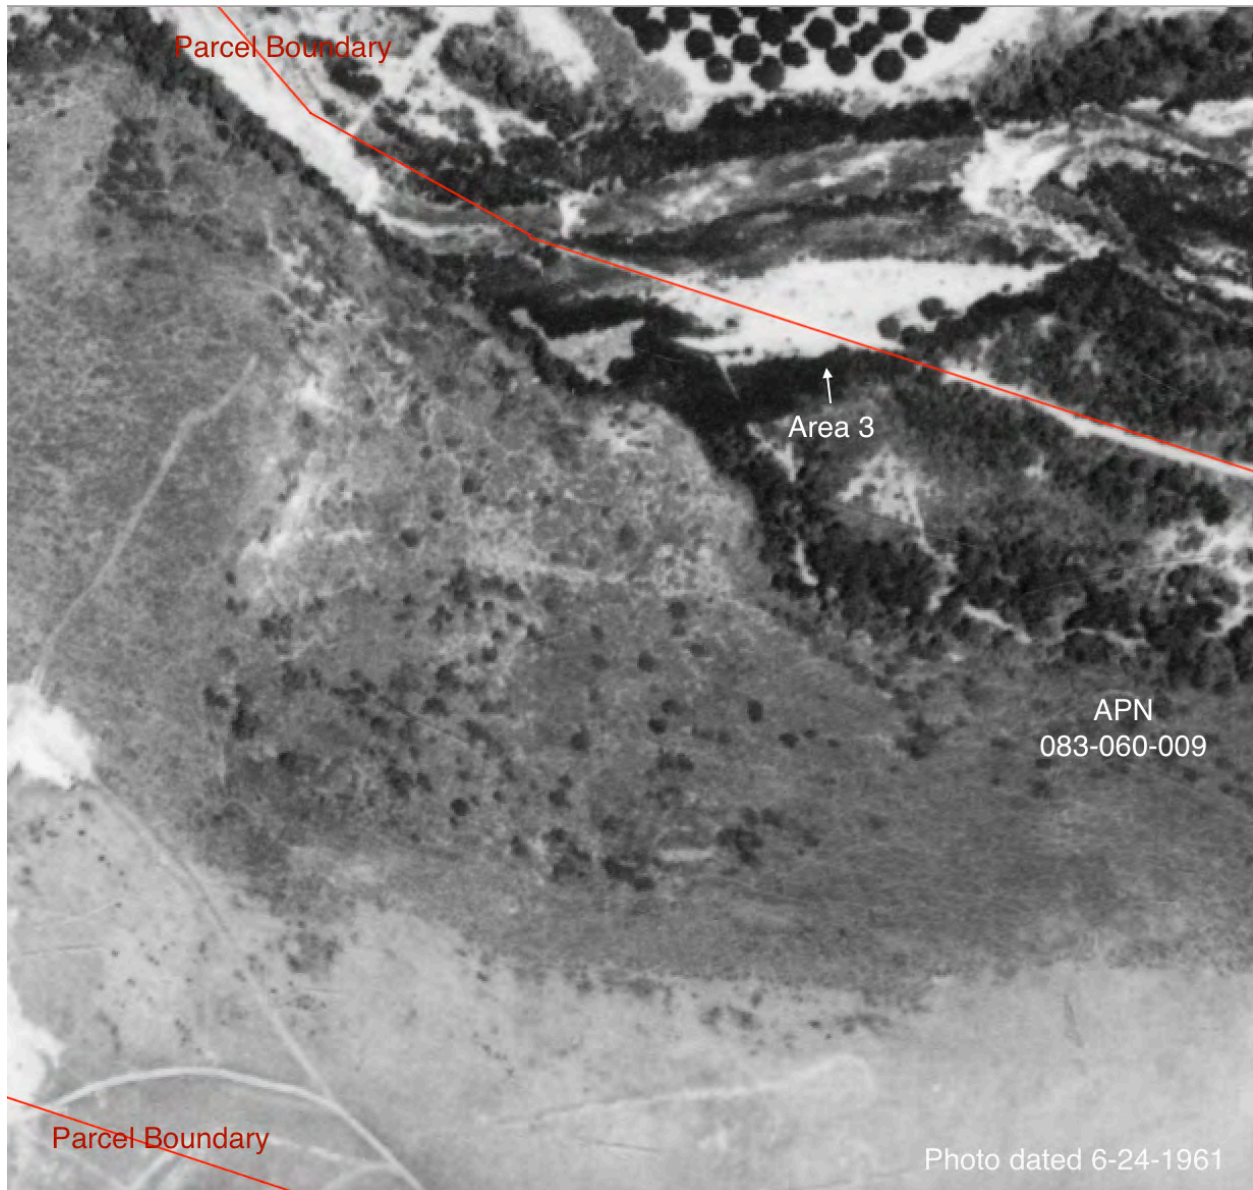
Fig. 36. June 24, 1961 aerial photograph closeup of Area 3.

This photo is dated after the enactment of County Ordinance 971 of September 29, 1958.

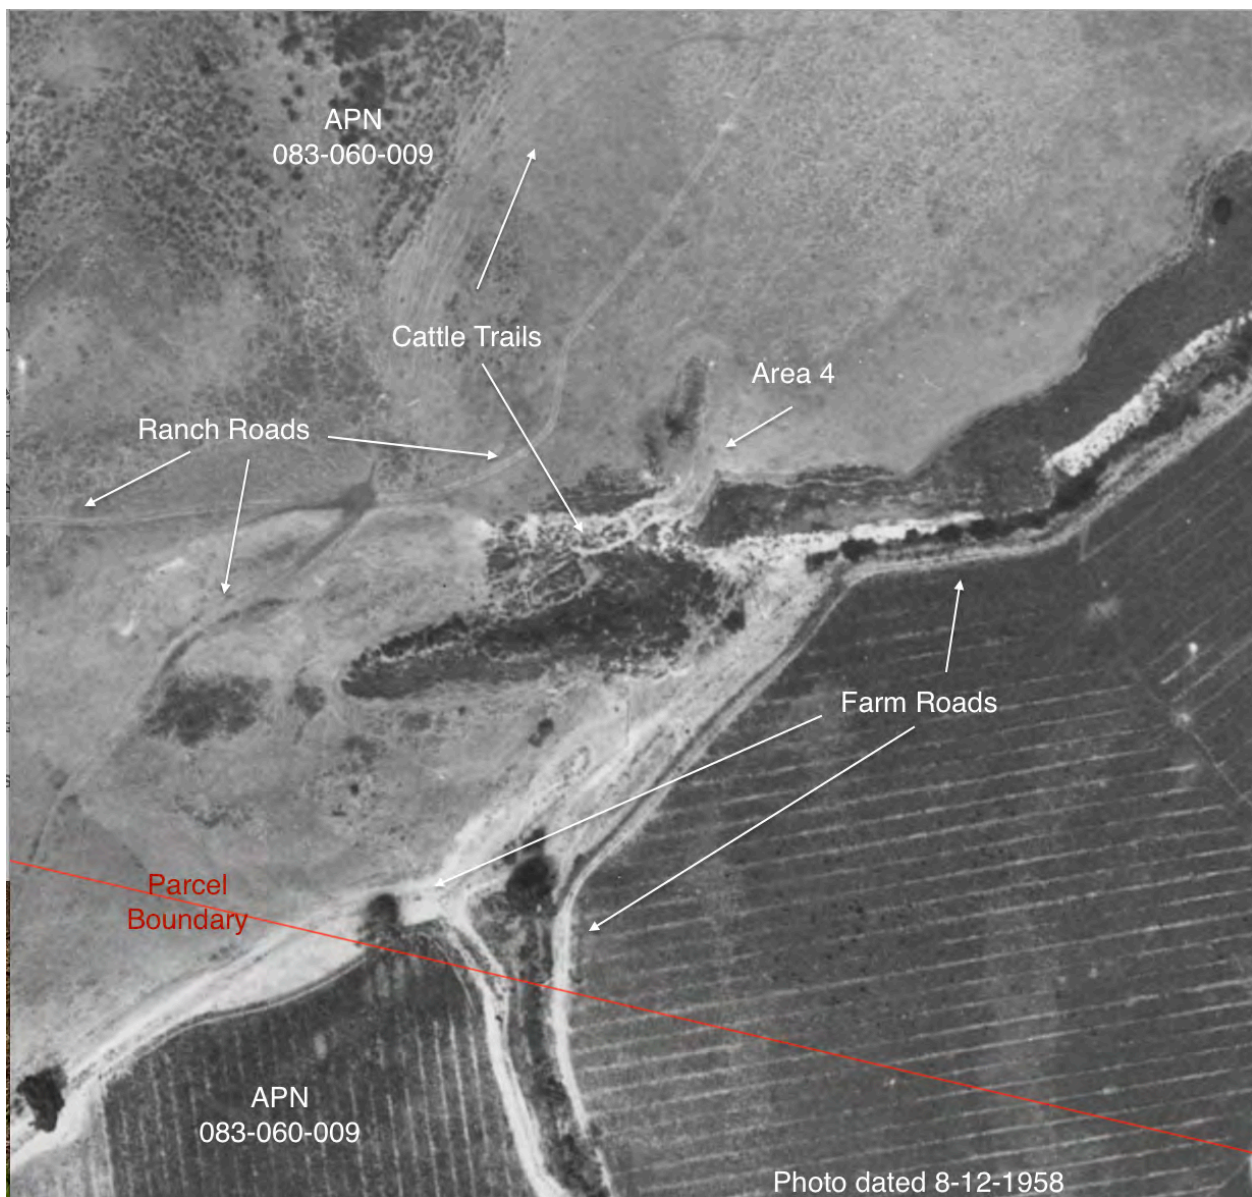
Fig. 43. August 12, 1958 aerial photograph closeup of Area 4.

A large area of soil slumping or a landslide can be seen at the base of the hill, near the farm road, and would account for the large amount of bare soil visible.

No surface mining or soil disturbance associated with surface mining is visible in this location.

This photo was taken six weeks before the implementation of County Ordinance 971 on September 29, 1958.

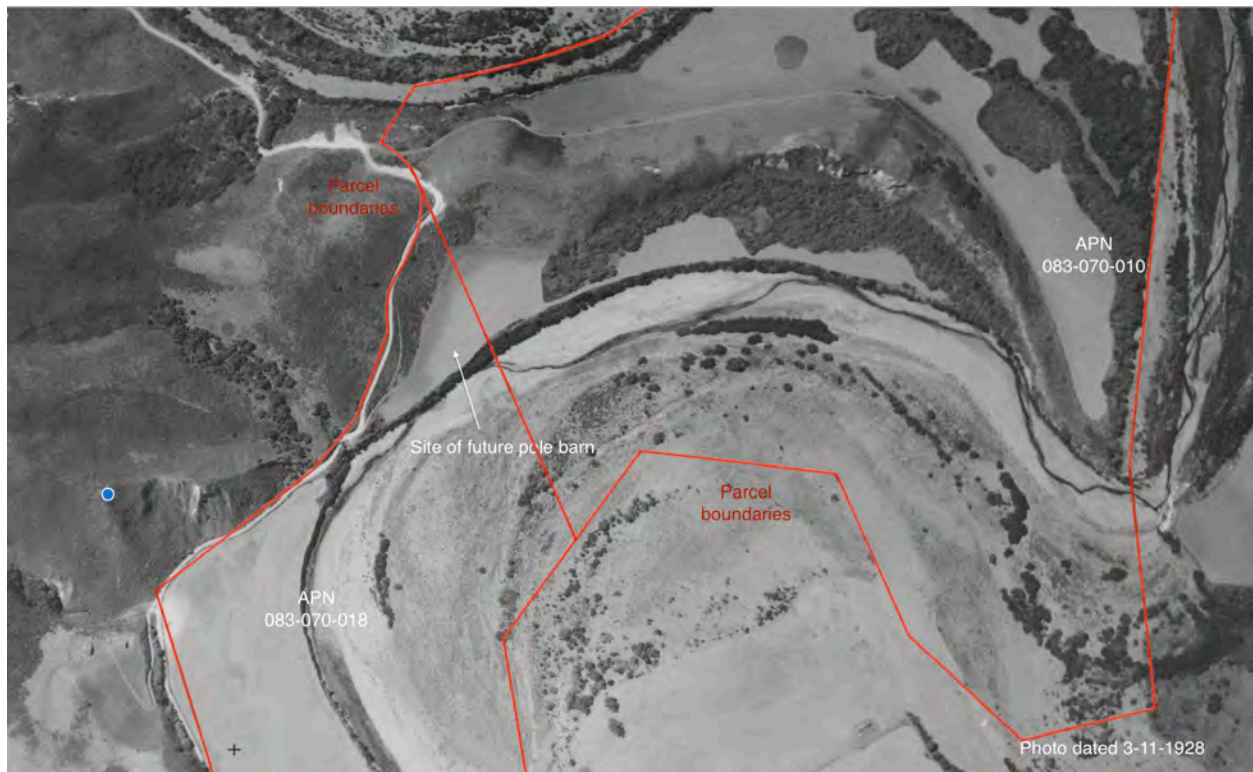
Fig. 45. March 11, 1928 aerial photograph of Site 1B.

The additional parcels that comprise the Acin Ranch, APN 083-070-010 and APN 083-070-018, are also said to be covered by California Mine ID #91-42-0011. As such, they would be bound by the County Ordinance 971, effective Sept 29, 1958.

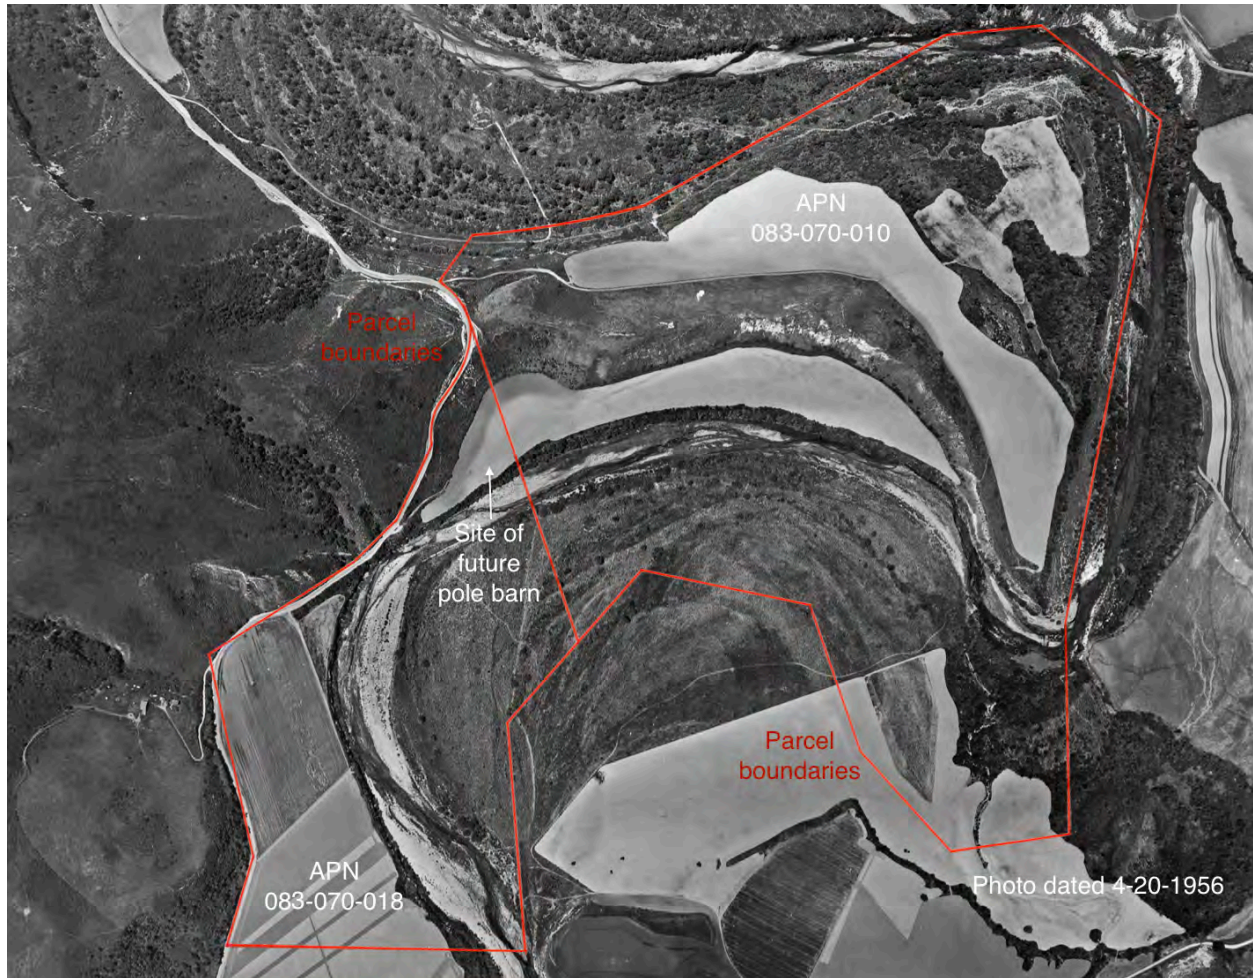
Fig. 48. April 20, 1956 aerial photograph of Site 1B.

No significant change is visible in the use of the farm roads. A small dirt road is visible along the western boundary line, accessing the northwestern farm fields.
