**Failure Investigation Report**

**Plains Pipeline, LP, Line 901  
Crude Oil Release, May 19, 2015  
Santa Barbara County, California**

**May 2016**

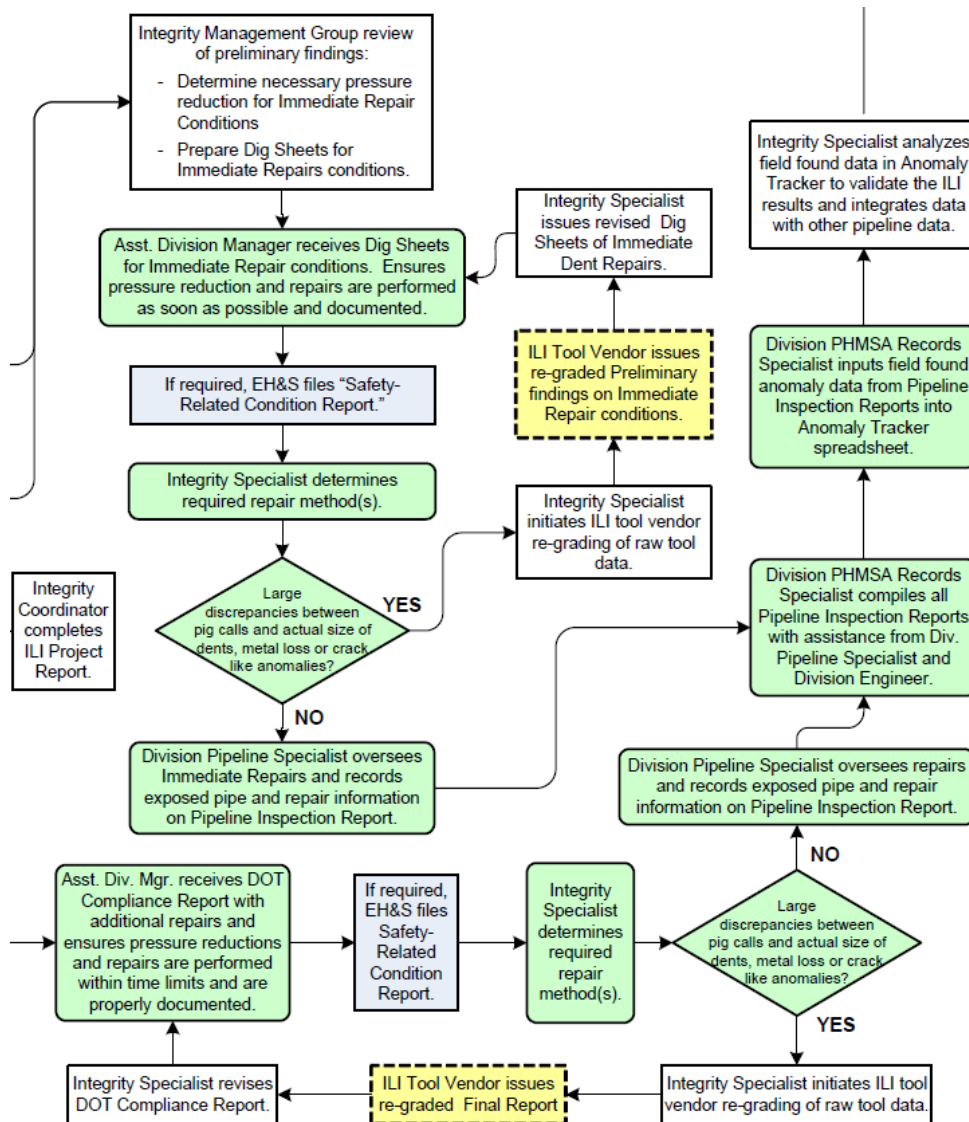
The two diamond shapes in the flowchart state the same decision point:

“Large discrepancy between pig calls and actual size of dents, metal loss or crack like anomalies?”

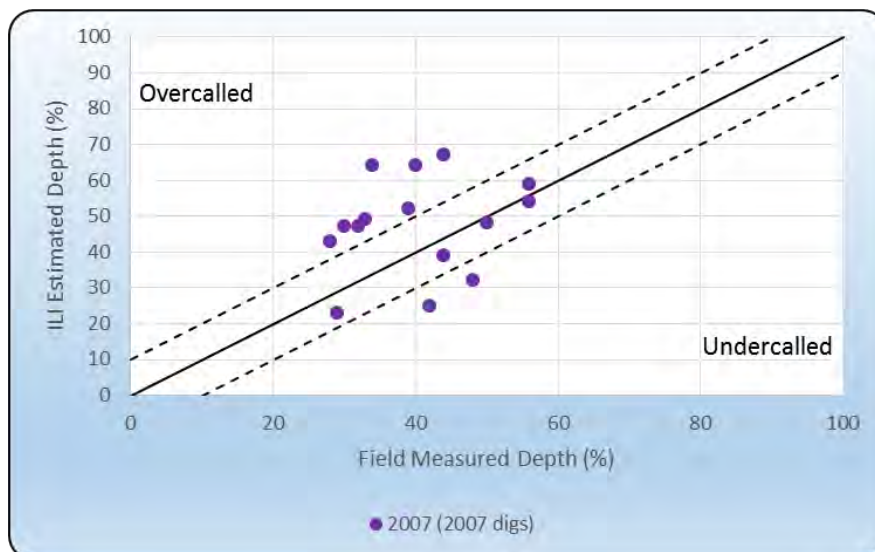
**Figure 11. Unity plot for the 2007 MFL inspection.**

The unity plot for the 2007 inspection is provided in Figure 11. The 2007 Rosen inspection is within  $\pm 10\%$ , 33% of the time with respect to the 2007 excavations.

Likewise, employing API 1163, the tool performance was not within stated specifications. If overcalled anomalies were considered (i.e.  $>10\%$  over actual) then in all years the unities would be  $\pm 10\%$ ,  $>70\%$  of the time.

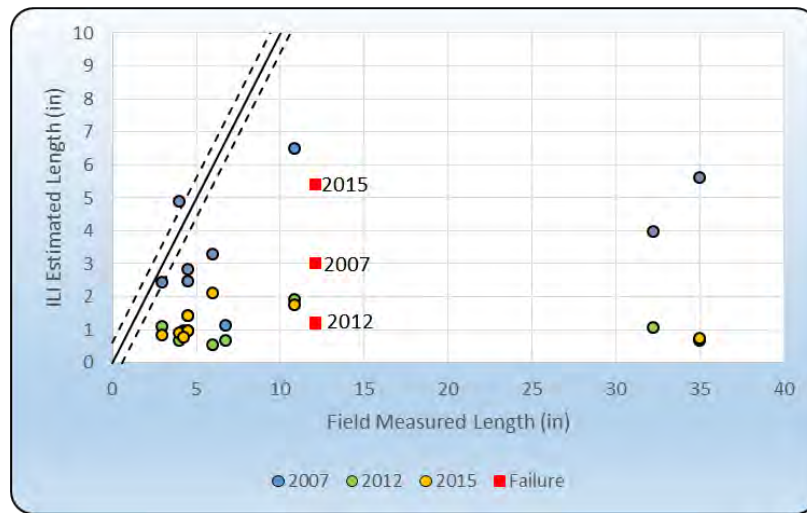
Figure 13. ILI estimated length compared to field measured.

Now consider the length and width sizing with respect to that measured in excavations. Figures 13 and 14 compare the tool estimates of length and width to measurements taken during a few field excavations and repair. There are only a few as these were all of the length and width measurements from the field that were provided. In both figures the solid line represents the ideal where the estimated tool sizing is equal to the field measurement and the dashed lines represent  $\pm 0.59"$ , the tool sizing error for length and width specified by the vendor. Figure 13 shows the data to have a couple length estimates within specification but the remainder of length and width estimates were all under estimated. The excavations shown were done after the 2012 inspection and only the locations that were called by all three tool runs are included. The red markers representing the failure lengths and widths will most assuredly not be the same field measurement in 2007 or 2012, this only represents the dimensions as called by the ILI in that year.

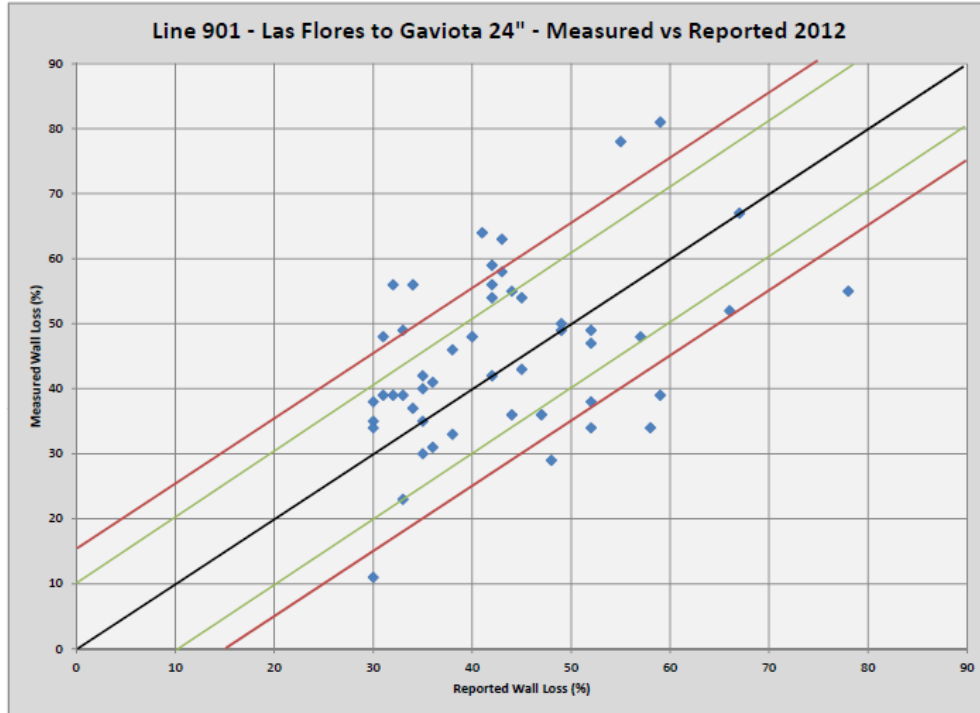
The black line is the one to one line where any “as-called equal as-found” anomalies would be plotted. The green lines are +/- 10% lines and the red lines are +/- 15% lines. ~57% of the plotted anomalies are within the +/- 10% lines. Reported tool accuracy is +/- 10% 80% of the time. There is no documentation regarding any further analysis or discussion which may have ensued after the creation of this Unity Plot for wall loss (depth).

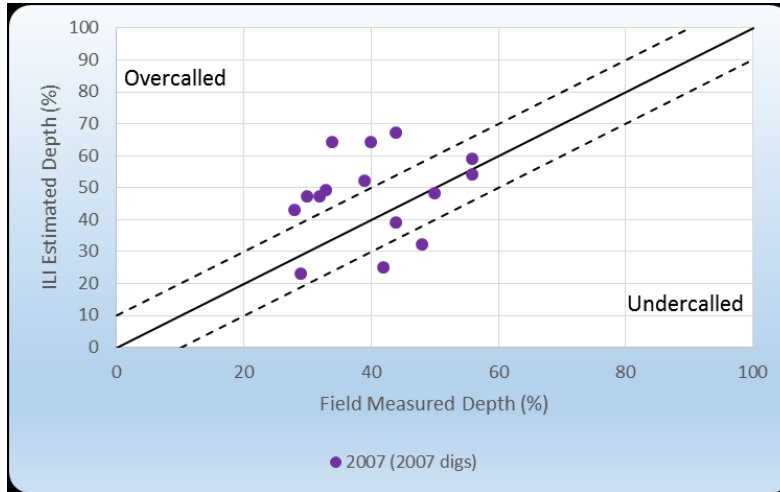
“The unity plot for the 2007 inspection is within  $\pm 10\%$ , 33% of the time with respect to the 2007 excavations.”

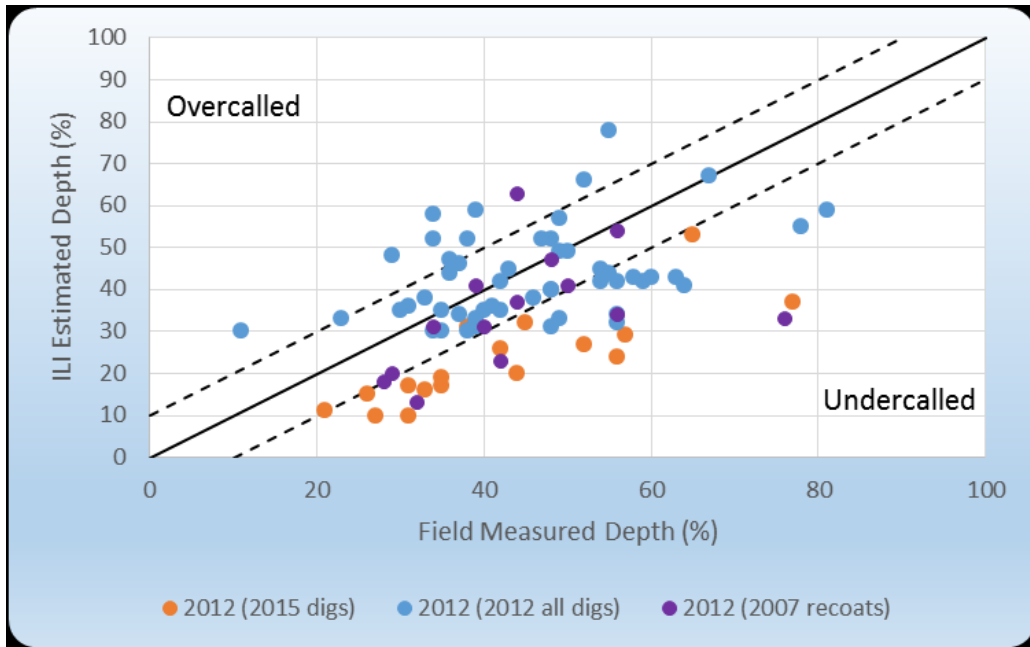
“The unity plot for the 2012 inspection is within  $\pm 10\%$ , 58% of the time with respect to the 2012 excavations (blue) and 2007 excavation recoats (violet). When comparing to the 2015 field excavated results based on the 2012 ILI data, growth may have occurred, causing the comparisons between field and ILI to be under-called (orange). The 2015 digs were not considered in the above stated accuracy.”

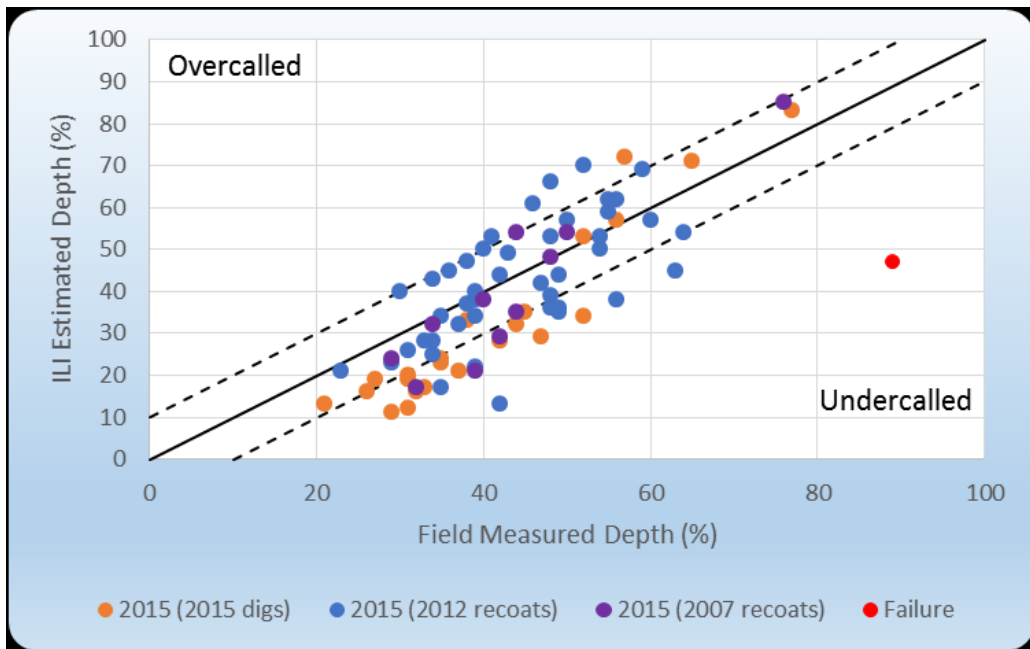
“The 2015 ILI estimated depths are compared to field measured depths either from the 4 excavations following the failure or the areas recoated after the 2007 and 2012 inspections. The unity plot shows that the 2015 Rosen inspection is within  $\pm 10\%$ , 57% of the time. It may be seen that the failure location has an uncharacteristically high deviation from the ILI estimate.”

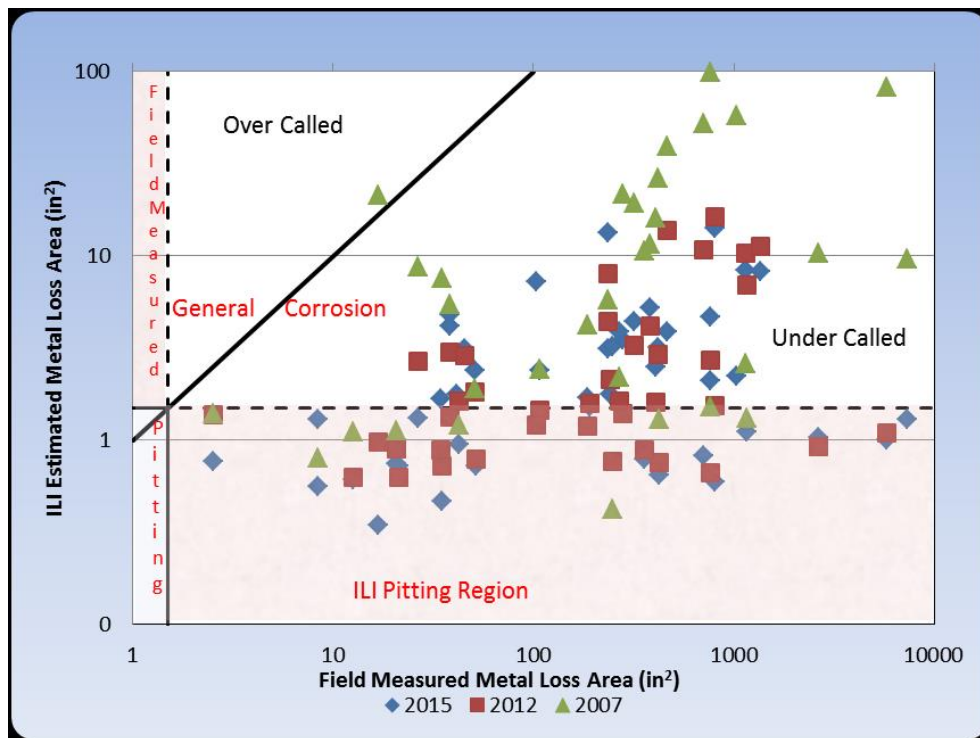
**Figure 16. Metal loss area; ILI vs field measurement.**

**From the ILI-SME report:** "The issue of underestimating the length and width of a corrosion anomaly will lead to gross underestimations of the corrosion area. Figure 16 delineates all of the line 901 anomalies with width and length reported from ILI estimates versus excavations made, on a logarithmic scale. As an example, it is showing that 38% of the anomalies had an area stated by the ILI of  $\leq 1.5 \text{ in}^2$  when in fact the corrosion areas were between  $2.5 \text{ in}^2$  and  $7300 \text{ in}^2$ . This being said, there may be a difference in the field measurement technique to consider. It is important that the techniques used in the field be comparable to that required by the ILI analysis to enable a proper assessment of the ILI performance."

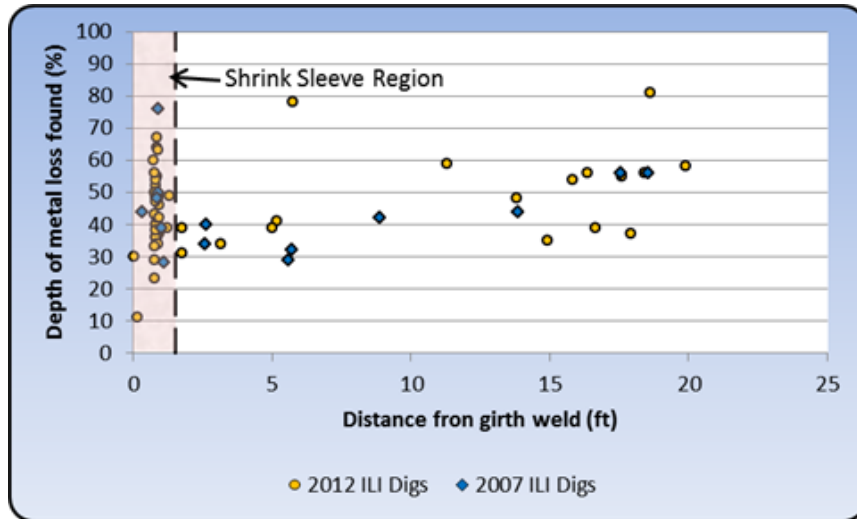
“Within the 2007 excavation locations approximately 50% were within 1.5’ of a GW (blue diamonds). Within the 2012 excavation locations approximately 76% were within 1.5’ of a GW (yellow circles). (The shrink sleeve utilized was 34” total, therefore the length from each side of the GW is app 1.5’). The depth of metal loss found within these excavations relative to distance from the girth weld is shown below.”

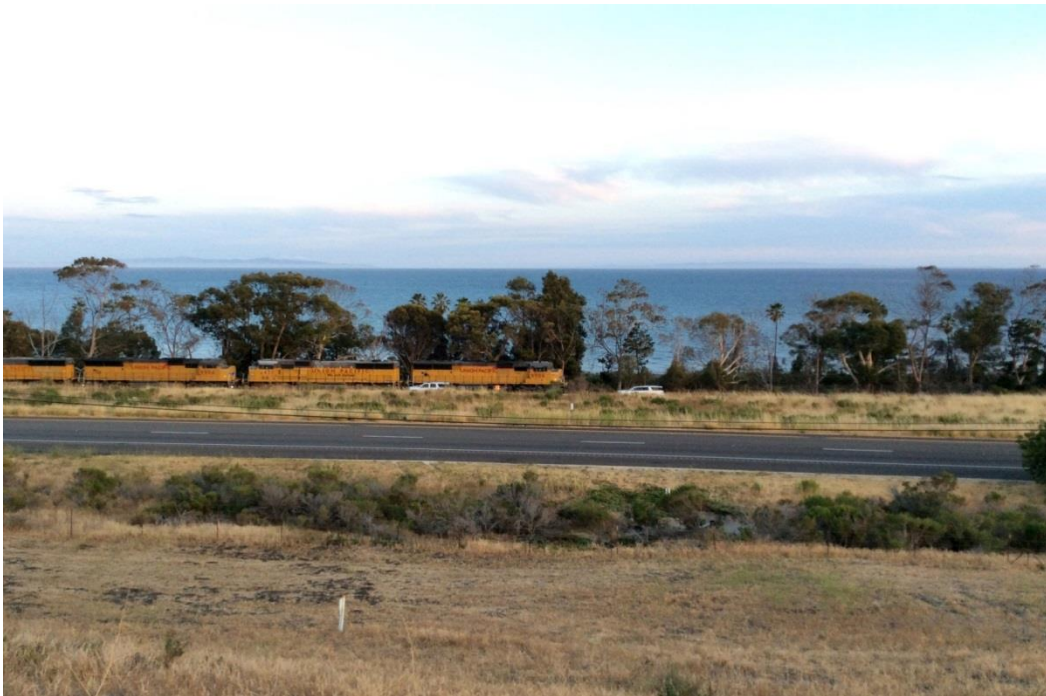
Culvert Under Highway and RR Tracks to Ocean

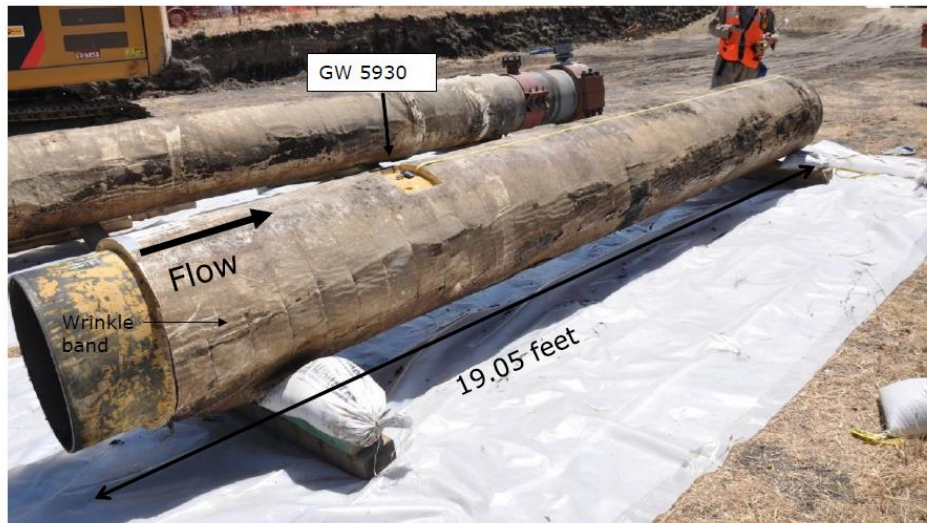
Figure 2. Photograph showing Pipe Section 1 following removal from the ditch.

This picture was copied from the Final Metallurgical Report. One can see the bare pipe where the insulation and other coatings were removed to allow the pipe to be cut.

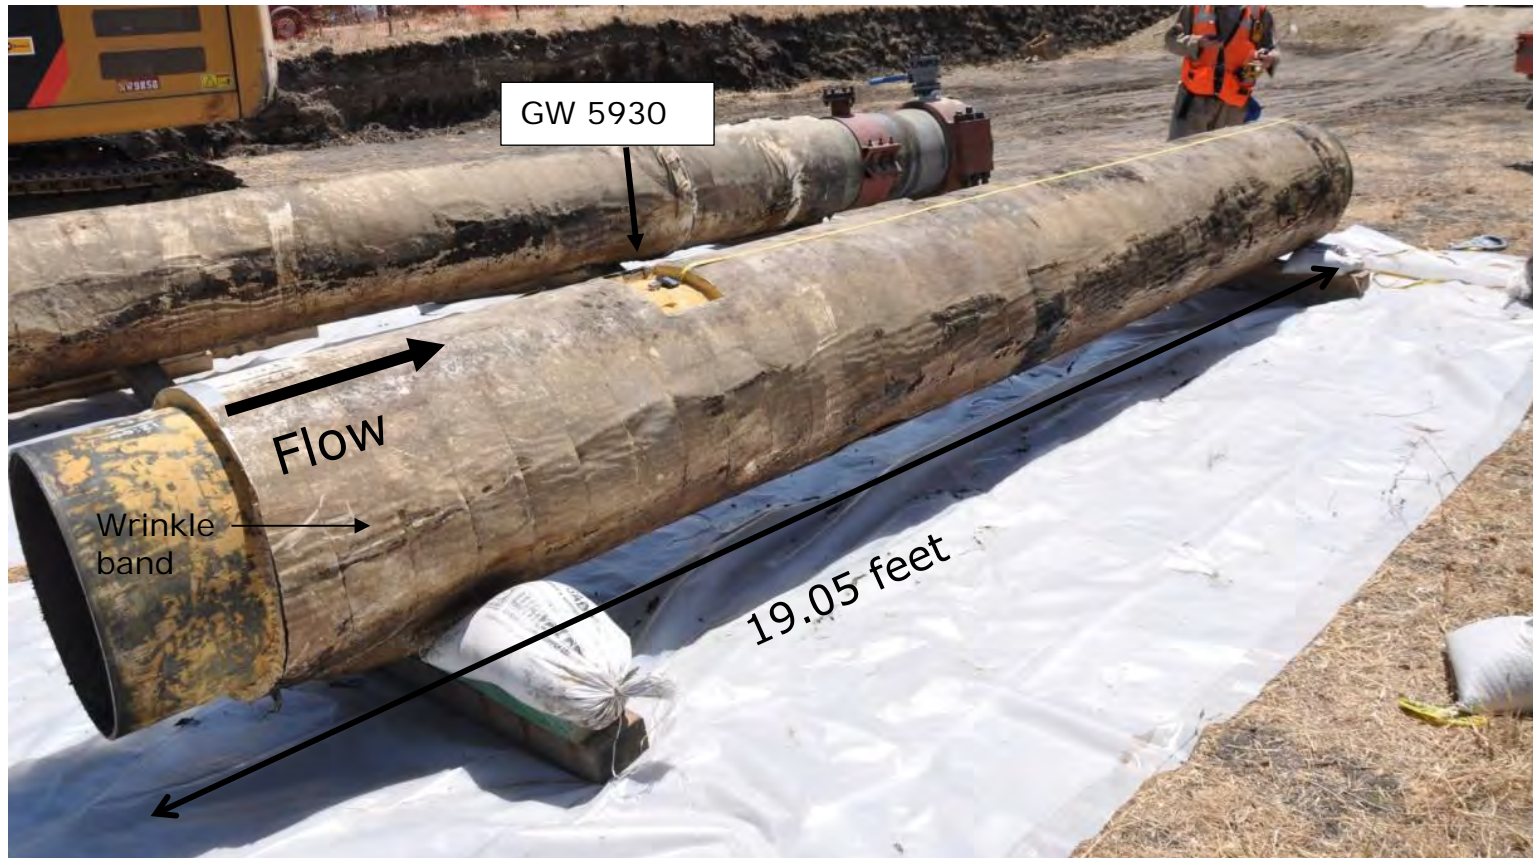
Figure 2. Photograph showing Pipe Section 1 following removal from the ditch.

An external polyethylene tape (external surface of the rigid polyurethane insulation) was present on PS 1 and PS 2, Figure 2 and Figure 10 respectively. The tape is installed in a white condition; however, exposure to the soil and released product discolored the tape to varying shades of brown. Areas of decohesion from the insulation substrate were observed in varying degrees along the length of the two pipe sections. The most pronounced areas were located near the failure location, as shown in the photographs presented at the bottom of Figure 10. Cracks were also observed in the PE tape, primarily at the 12- and 6-o'clock orientations; some of the cracks are identified in Figure 10. Wrinkles in the tape were observed along the entire length of both pipe sections on the bottom half of the pipe (2:00 to 10:00 orientation).

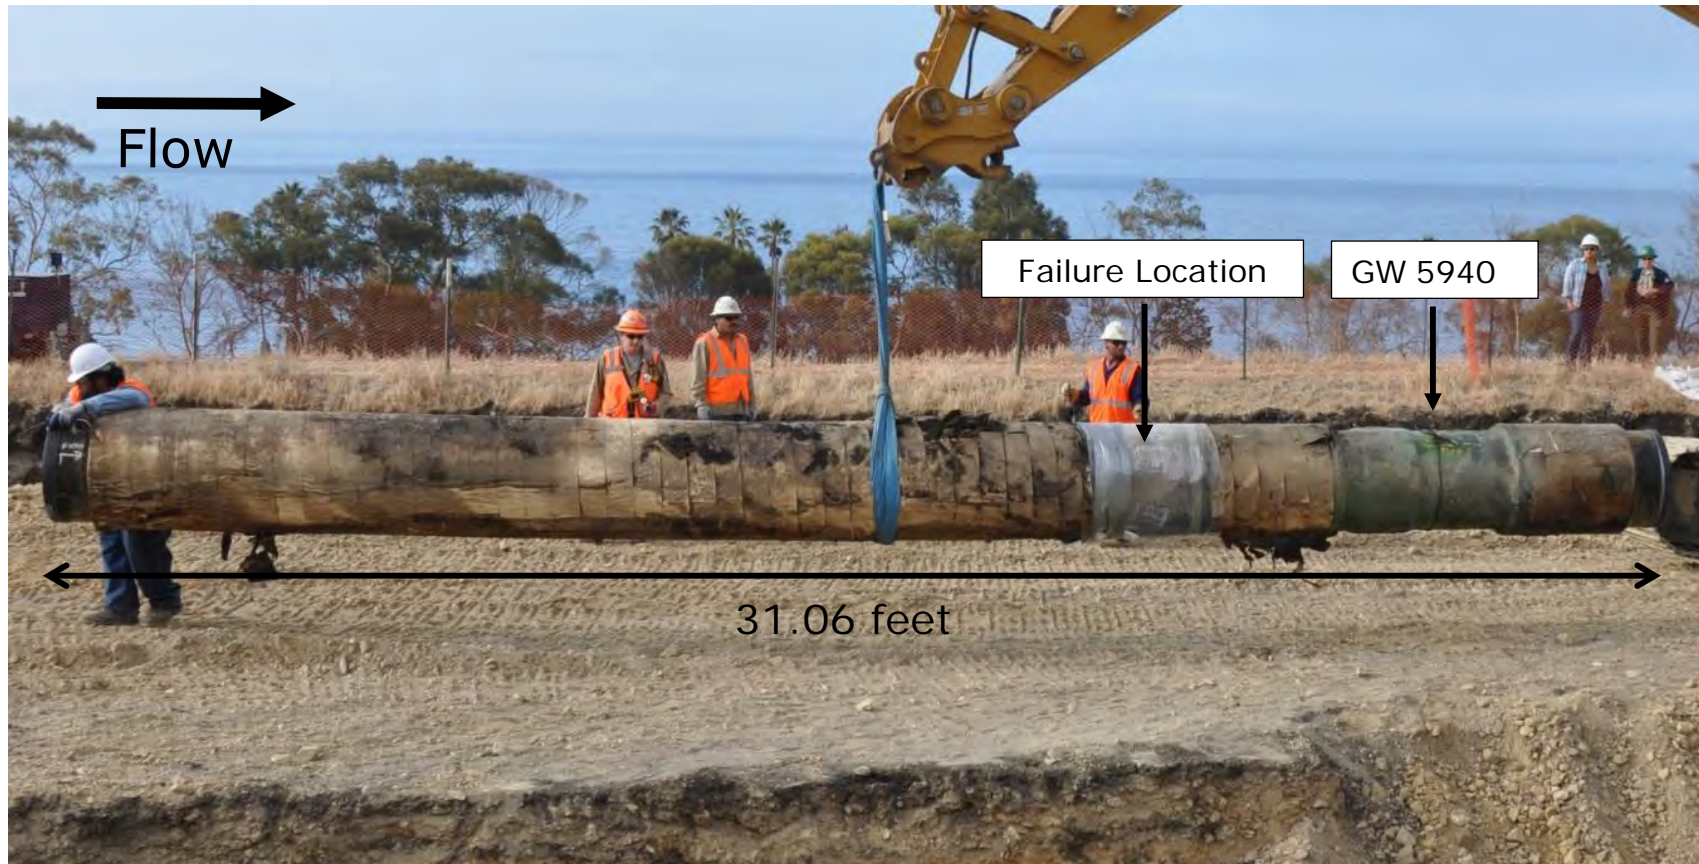
Figure 3. Photograph showing Pipe Section 2 being removed from the ditch.

PS 1 was 19.05 feet in length and contained 5.05 feet of the U/S joint, the U/S girth weld (GW) and 14 feet of the failure joint U/S of the failure. Pipe Section 2 was 31.06 feet in length and contained 26.06 feet of the failure joint, including the failure location, the D/S GW, a 2013 composite repair sleeve, and 5 feet of the D/S joint. PS 2 was 31.06 feet in length and contained the failure location, the D/S GW, a composite repair sleeve, and 5 feet of the D/S joint. Reference markings were identified on each pipe section noting the top-dead-center (TDC) and the location of each girth weld. A stamp was identified on the internal surface of the failure joint towards the D/S end, adjacent to GW 5940. Figure 9 is a photograph showing the stamp; "NIPPON", "24", and other indiscernible characters were observed.

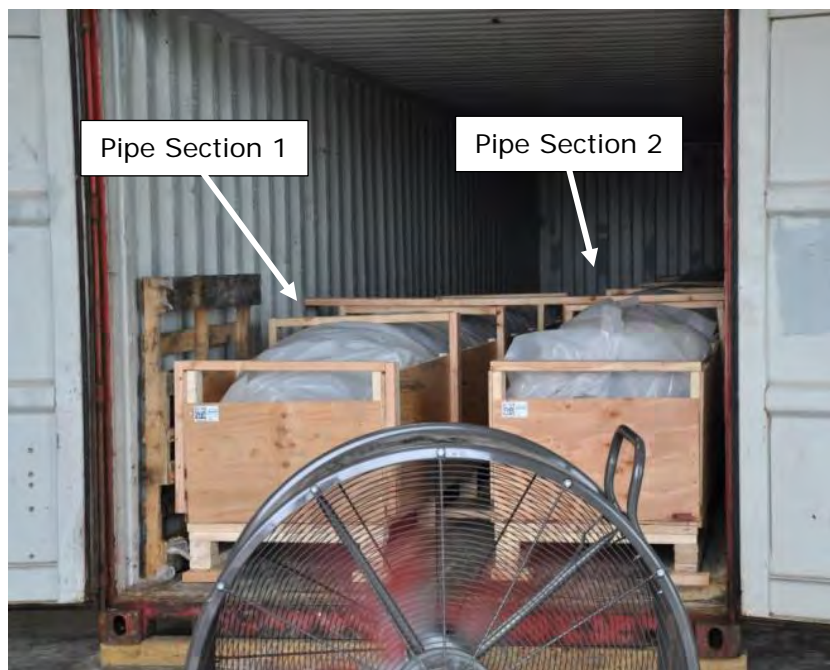
Figure 6 contains photographs showing the two pipe sections in the as-received condition. The pipe sections were wrapped in opaque plastic wrap and boxed. Evidence tape was

Figure 6. Photographs showing the pipe sections in the as-received condition, within the cargo container.

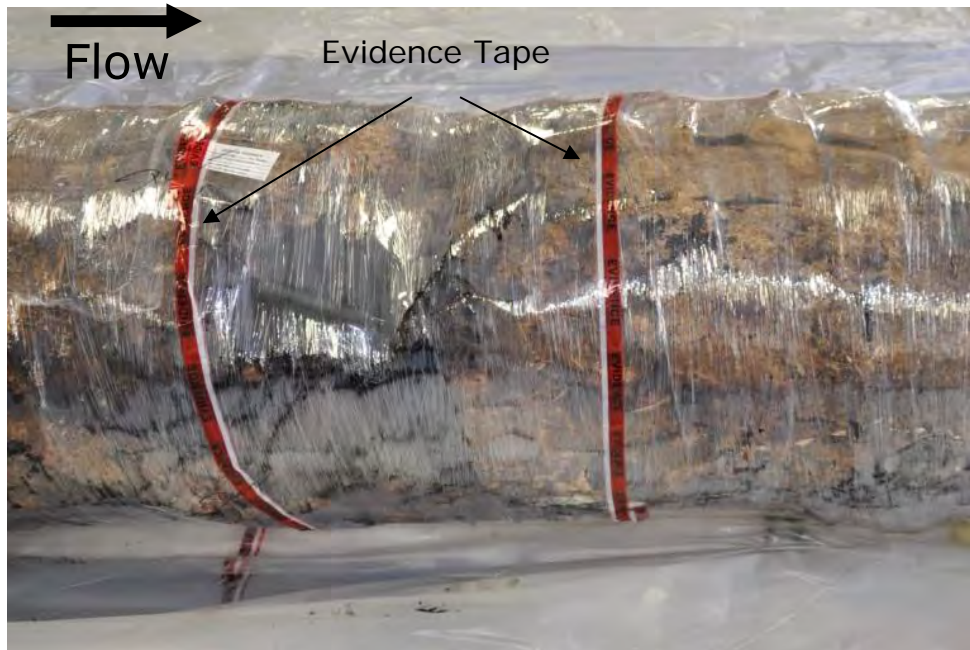
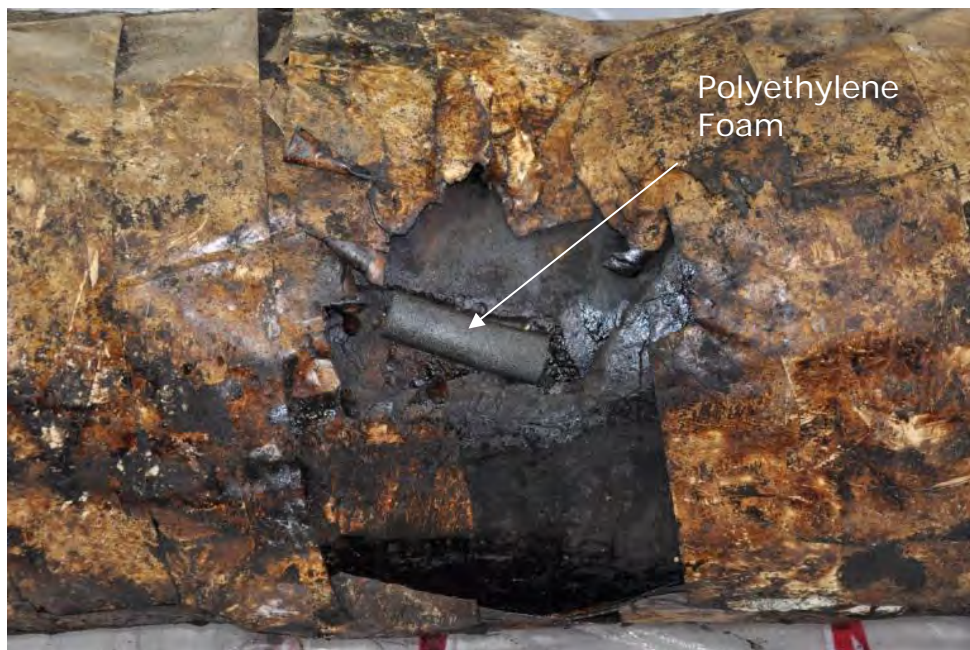
applied in the field on top of the plastic wrap approximately 1 foot U/S and D/S of the failure on PS 2. Figure 7 contains photographs showing the failure location before and after removal of the evidence tape and protective plastic wrap at DNV GL's facility. The fracture surfaces were protected with foam insulation that was placed around the clockwise (CW) fracture surface; shown in Figure 7b. Figure 8 contains photographs showing the failure location while on site (Figure 8a - May 28, 2015) and at DNV GL's facility (Figure 8b - June 15, 2015). Some red corrosion products were observed near the failure location, as shown in Figure 8b. The failure opening was 6.6 inches in length and located at the 4:15 orientation, consisting of an irregular fracture path that opened in the clockwise (CW) direction looking D/S. The U/S and D/S ends of the fracture path were located at 33.35 and 33.9 feet, respectively, from the U/S GW. The maximum opening measured 1.14 inches, approximately 33.45 feet from the U/S GW. The failure is associated with a corrosion feature that measured approximately 12.1 inches axially in length by 7.4 inches circumferentially in width. Additional data are presented in Section 3.1.4.

Figure 7. Photographs showing failure location on PS 2 a) before and b) after evidence tape and a clear protective wrapping was removed.

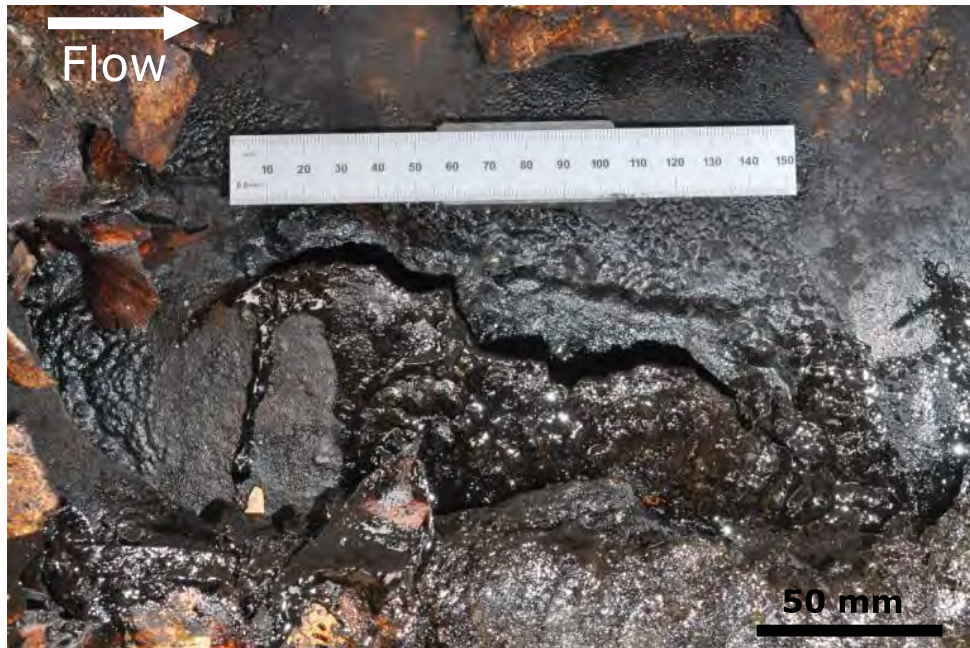
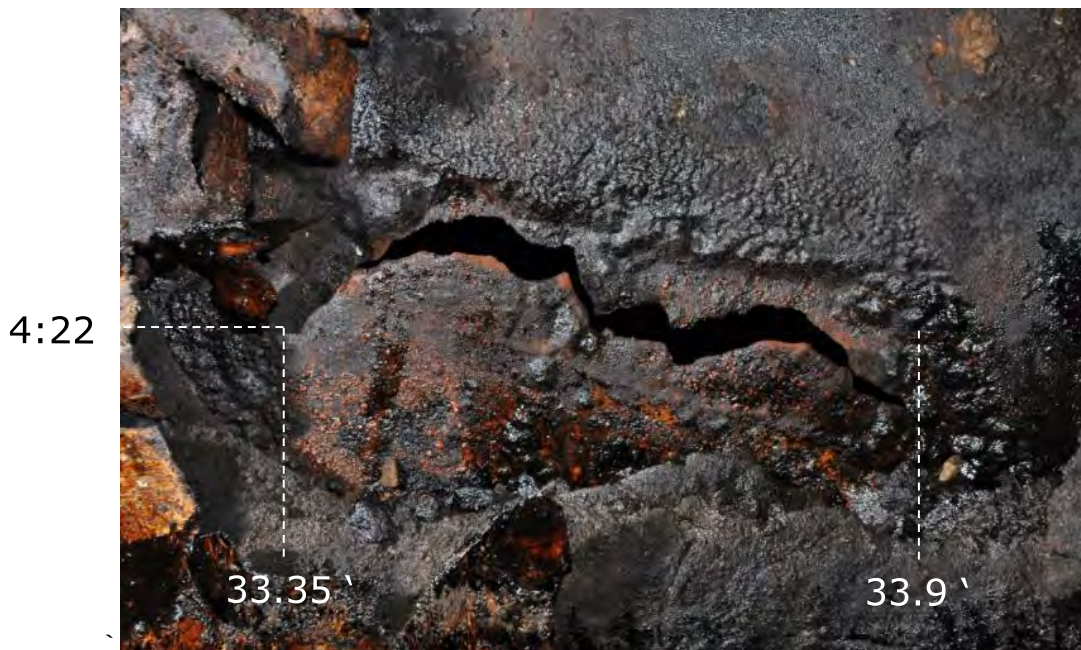
Figure 8. Photographs showing the failure location a) while on site (May 28, 2015) and b) after transit to DNV GL's facility (June 15, 2015).

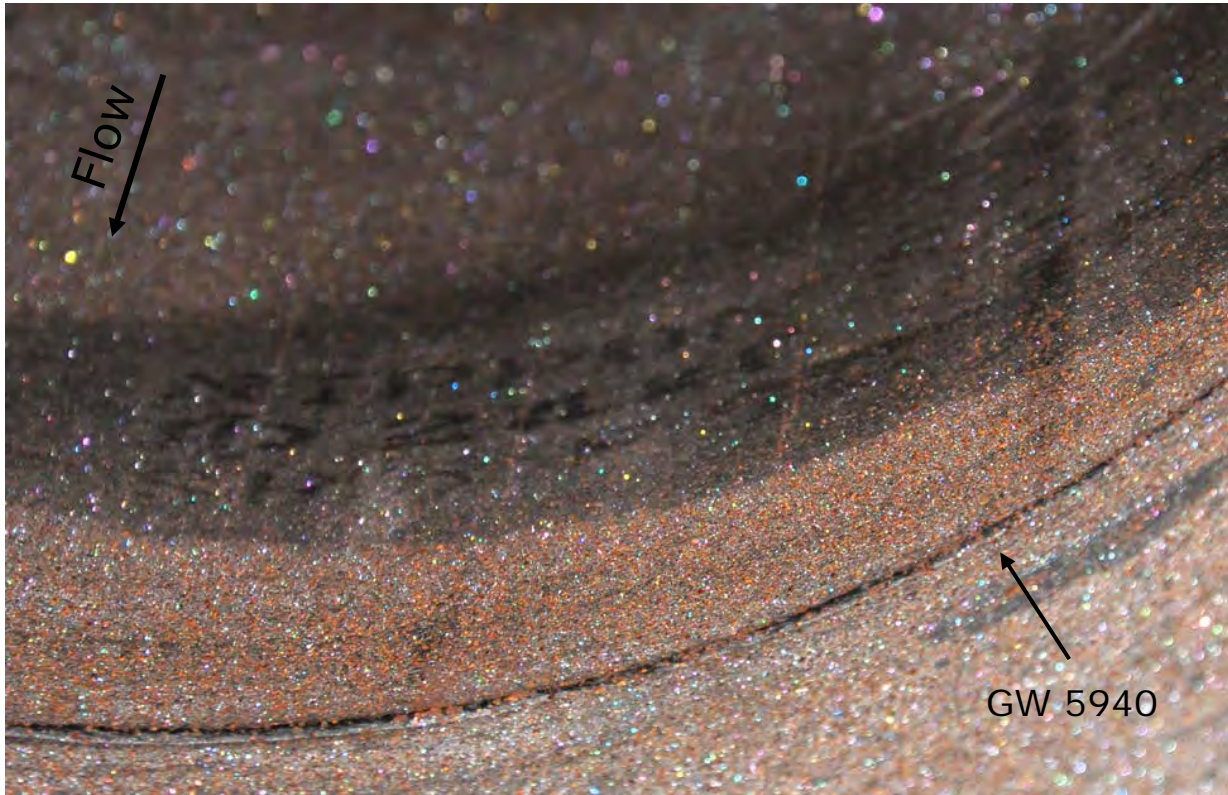
Figure 9. Photograph showing a stamp on the internal surface of the failure joint, near the D/S GW (GW 5940). "NIPPON" and "24" are legible.

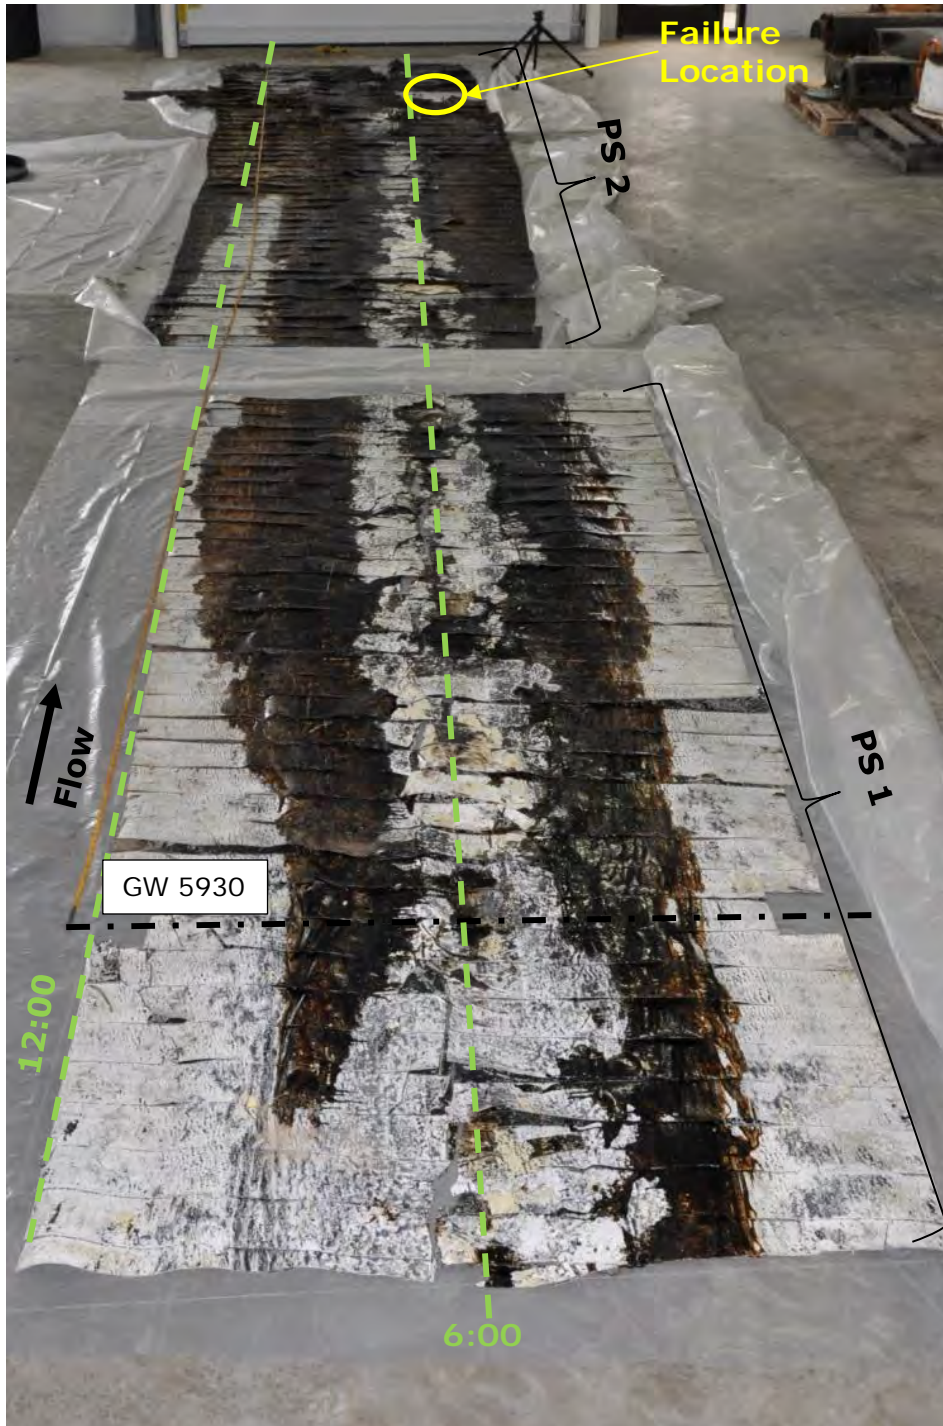
The PE tape was removed from each pipe section, aligned as it was on the pipe, and visually inspected and photographed. Figure 11 is a photograph of the internal surface of the tape looking D/S. The original white coloration of the PE tape is apparent in the figure along with bands of product at the 4:00 and 7:00 orientations, which appear to correlate with the wrinkle bands in the tape along the pipe section. In general, the areas exhibiting wrinkles were disbonded or partially disbonded from the insulation and were much easier to remove from the pipe section. Figure 12 and Figure 13 are photographs showing the internal and external surfaces of the PE tape at the failure location, respectively. Similar to other areas along the pipeline, cracking and wrinkles in the PE tape were observed near the failure location. The cracks in the tape were located at the 6:00 orientation, while the wrinkles were located at the 4:00 and 7:00 orientations.

Figure 11. Photograph showing the internal surface of the external tape from the failure joint.
