August 28, 2023

**BIOLOGICAL REPORT
AS-BUILT WALL REPAIR PROJECT
1690 San Leandro Lane (APN: 007-280-012)
Montecito, California**

BIOLOGICAL ASSESSMENT
AS-BUILT WALL REPAIR PROJECT
1690 San Leandro Lane (APN: 007-280-012)
Montecito, California

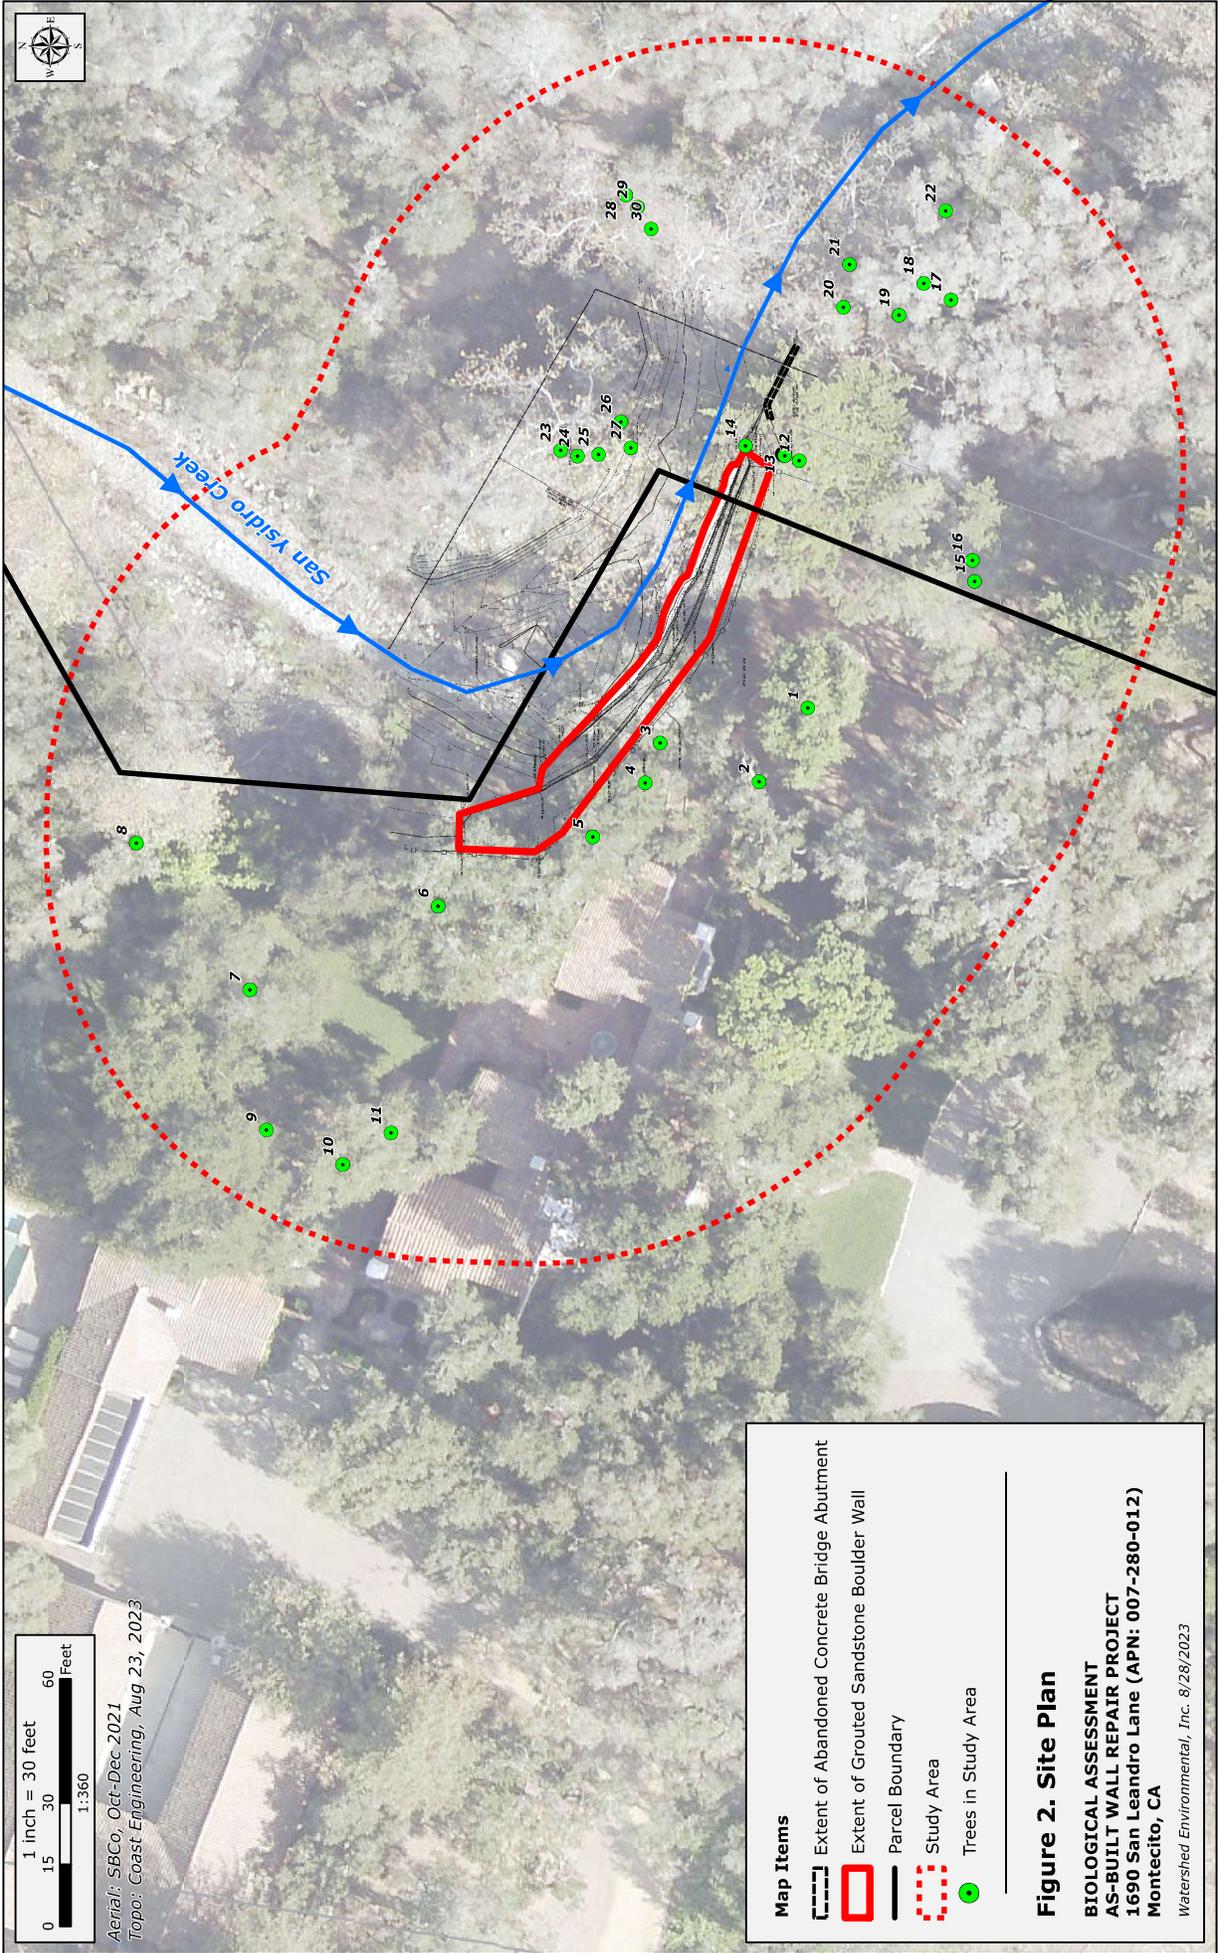
Figure 2. Site Plan

The grouted sandstone boulder wall is approximately 110 ft. long, 2 to 12 ft. tall and 7.5 to 15 ft. wide (Figure 2). It was repaired in February and March of 2018 after the January 9, 2018 Montecito mud/debris flow. Repairs to the damaged wall were performed using an excavator to pick up sandstone boulders and place them where they were needed. Repairs did not change the wall footprint.
