**RESTORATION “AS-BUILT” REPORT AND ADDENDUM  
TO  
CONCEPTUAL HABITAT RESTORATION AND  
REVEGETATION PLAN,  
2825 PADARO LANE, SUMMERLAND,  
SANTA BARBARA COUNTY, CALIFORNIA**

**25 May 2012**

**Hunt & Associates Biological  
Consulting Services  
5290 Overpass Road, Ste. 108  
Santa Barbara, CA 93111**

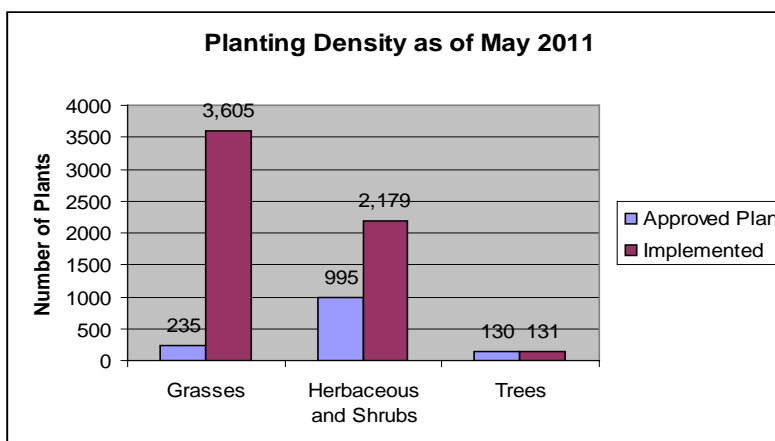
**Figure 2. “As-Built” vs. Approved Plan Planting Density.**

Species richness and planting density under “as-built” restoration is over three to four times greater than that proposed in the Approved Plan (Figs. 2 and 3). Approximately 4,555 additional plants, comprising 61 additional species, were planted in the restoration area.
