DRAFT WHITTIER BURNED AREA REPORT
(Reference FSH 2509.13)

- A. Fire Name: Whittier Fire
- B. Fire Number: CA-LBOR-001770
- C. State: CA
- D. County: Santa Barbara
- E. Region: 5
- F. Forest: Los Padres
- G. Districts: Santa Barbara Management Unit
- H. Fire Incident Job Code: PFK4VE
- I. Date Fire Started: July 8, 2017
- J. Date Fire Contained: pending
- K. Suppression Cost: \$35+ million
- L. Fire Suppression Damages Repaired with Suppression Funds
 - 1. Dozerline repaired / waterbarred: 35 out of 66 miles as of 08/9/2017
 - 2. Hand line repaired: 7 out of 16 miles as of 08/9/2017

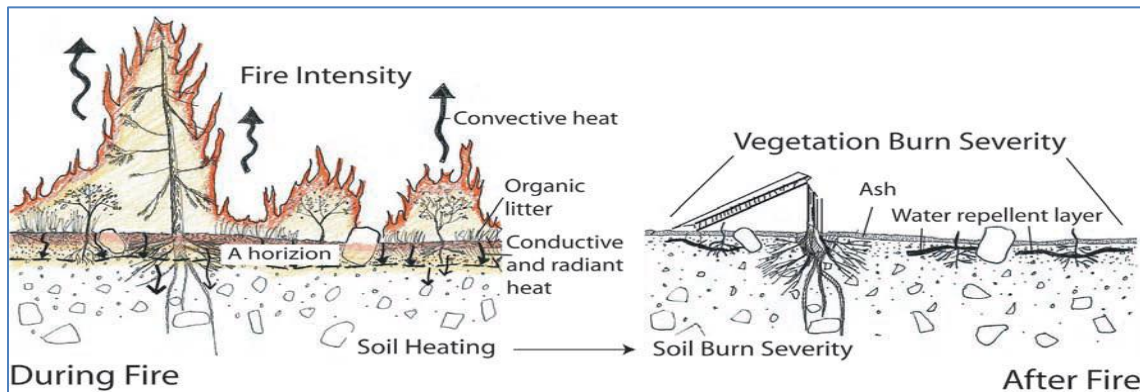
Figure above illustrates the effect of fire intensity on above-ground vegetation and Below ground soil properties (Graphics by Mike Hankinson, National Park Service)
