Subject: **ADDENDUM to Pre-Design Assessment Report
For the New Cuyama Pool Incident Reconstruction Project
290 Wasioja Street, New Cuyama, Ca 93254**
County of SB – P.O. #CN15986
County of SB Project No. 8736 NCPI
W+W Project No. 13032

Joseph Centeno Cuyama Pool & Aquatics Complex Needs Assessment

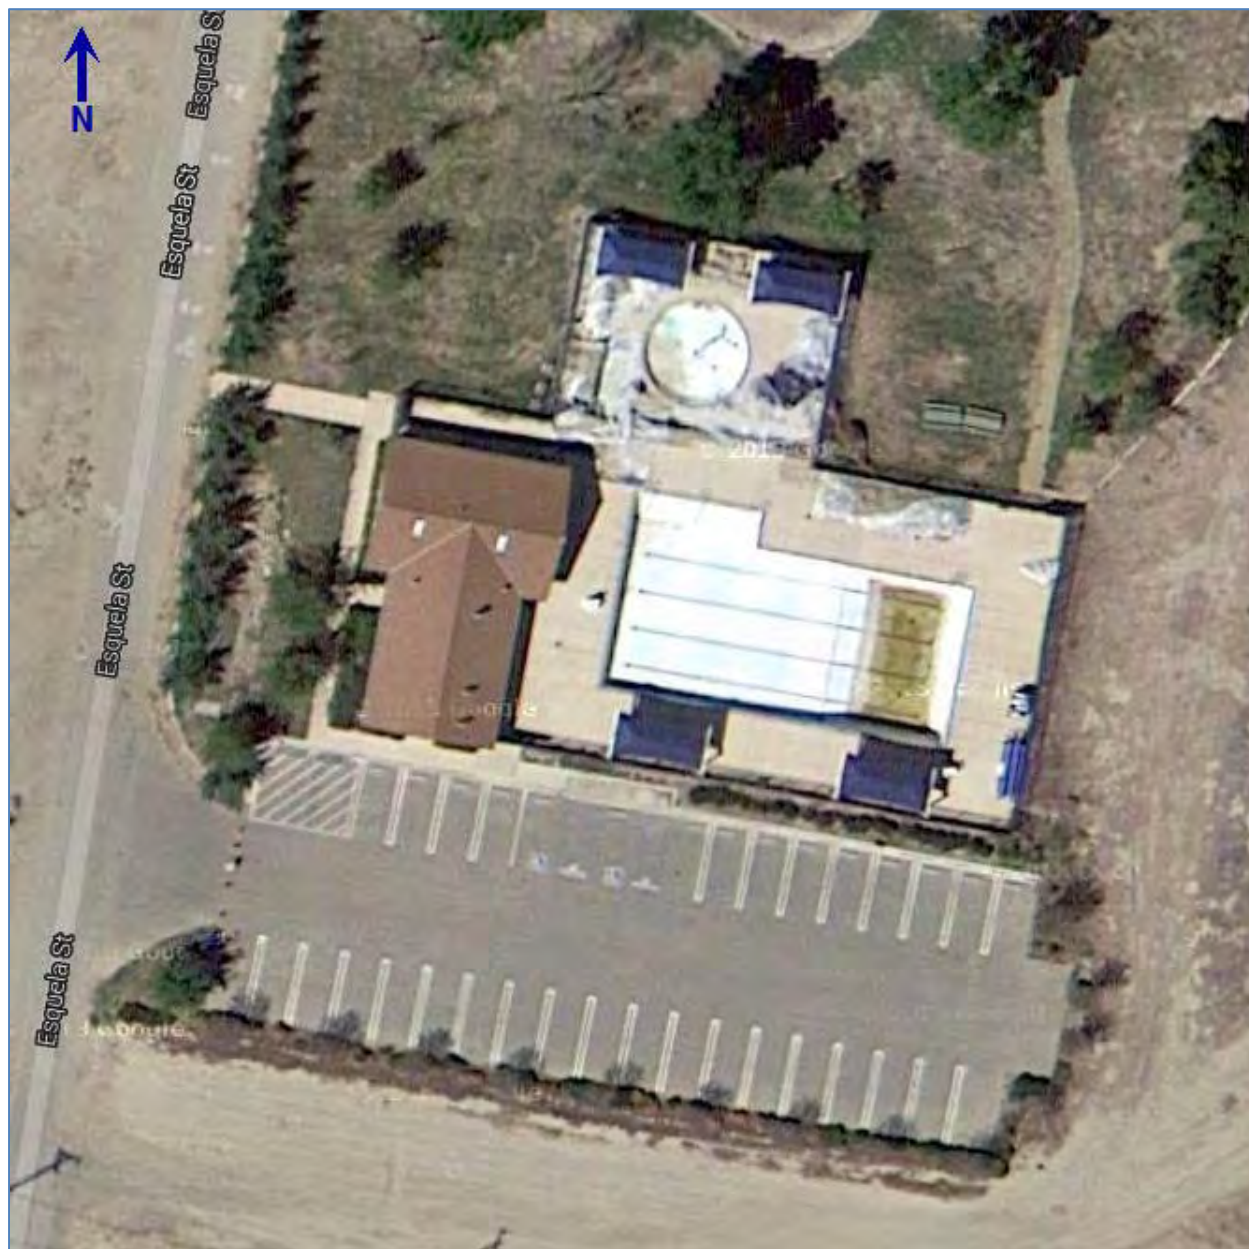
Figure 1: The swimming pool and wading pool at the Joseph Centeno Cuyama Pool & Aquatics Complex, New Cuyama, California.

1. The wading pool and its related systems have suffered major settlement and cracking damage sufficient to warrant replacement of the pool and piping.

2. The N and W portions of the concrete deck areas and related deck drainage systems have suffered major settlement, cracking and demolition sufficient to warrant replacement of the deck, damaged drainage system, piping and sub-grade.

3. The NE corner of the masonry building has been seriously undermined and has settled producing cracking in walls and floor slabs sufficient to warrant its repair by pressure grouting, leveling and stabilization of its sub-grade.

4. The NW corner and quadrant of the large pool has settled approximately 1" and significant differential settlement cracks were observed in the pool bottom, side walls, steps and coping, sufficient to warrant its repair by concrete buttressed underpinning, stabilization of its sub-grade, partial leveling of its bond beam NW quadrant bond beam and repair of cracks, plaster finish, tile and copings

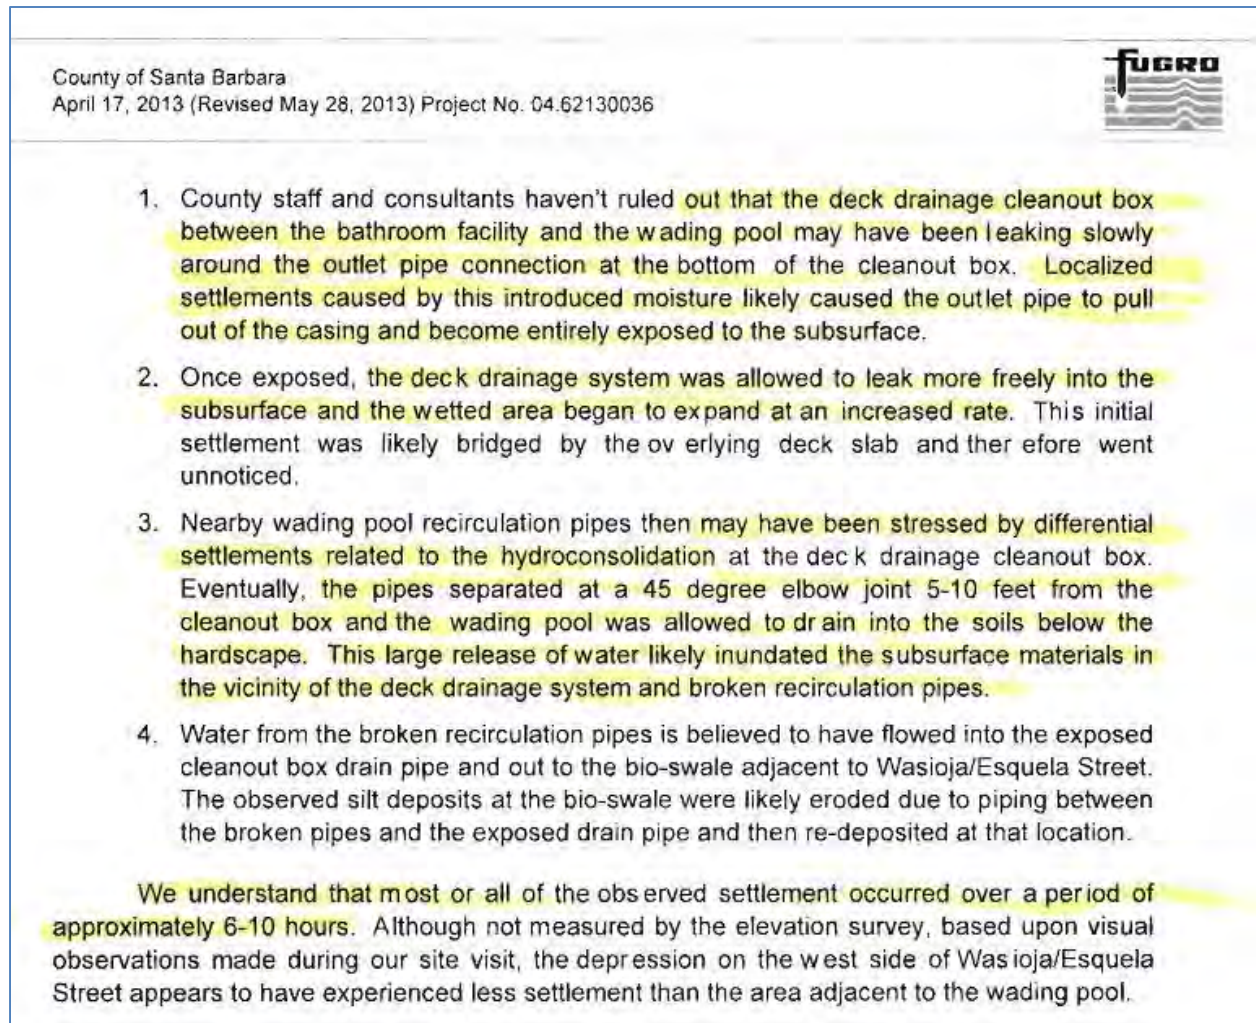
Figure 9). This soils collapse was caused by a large water leak that inundated the subsurface material and caused the hydroconsolidation or differential settlement (See Figures 2, 8-22).

Figure 9: Excerpt from Fugro Consultants April 2013 (Revised May 2013) Report Page 5.

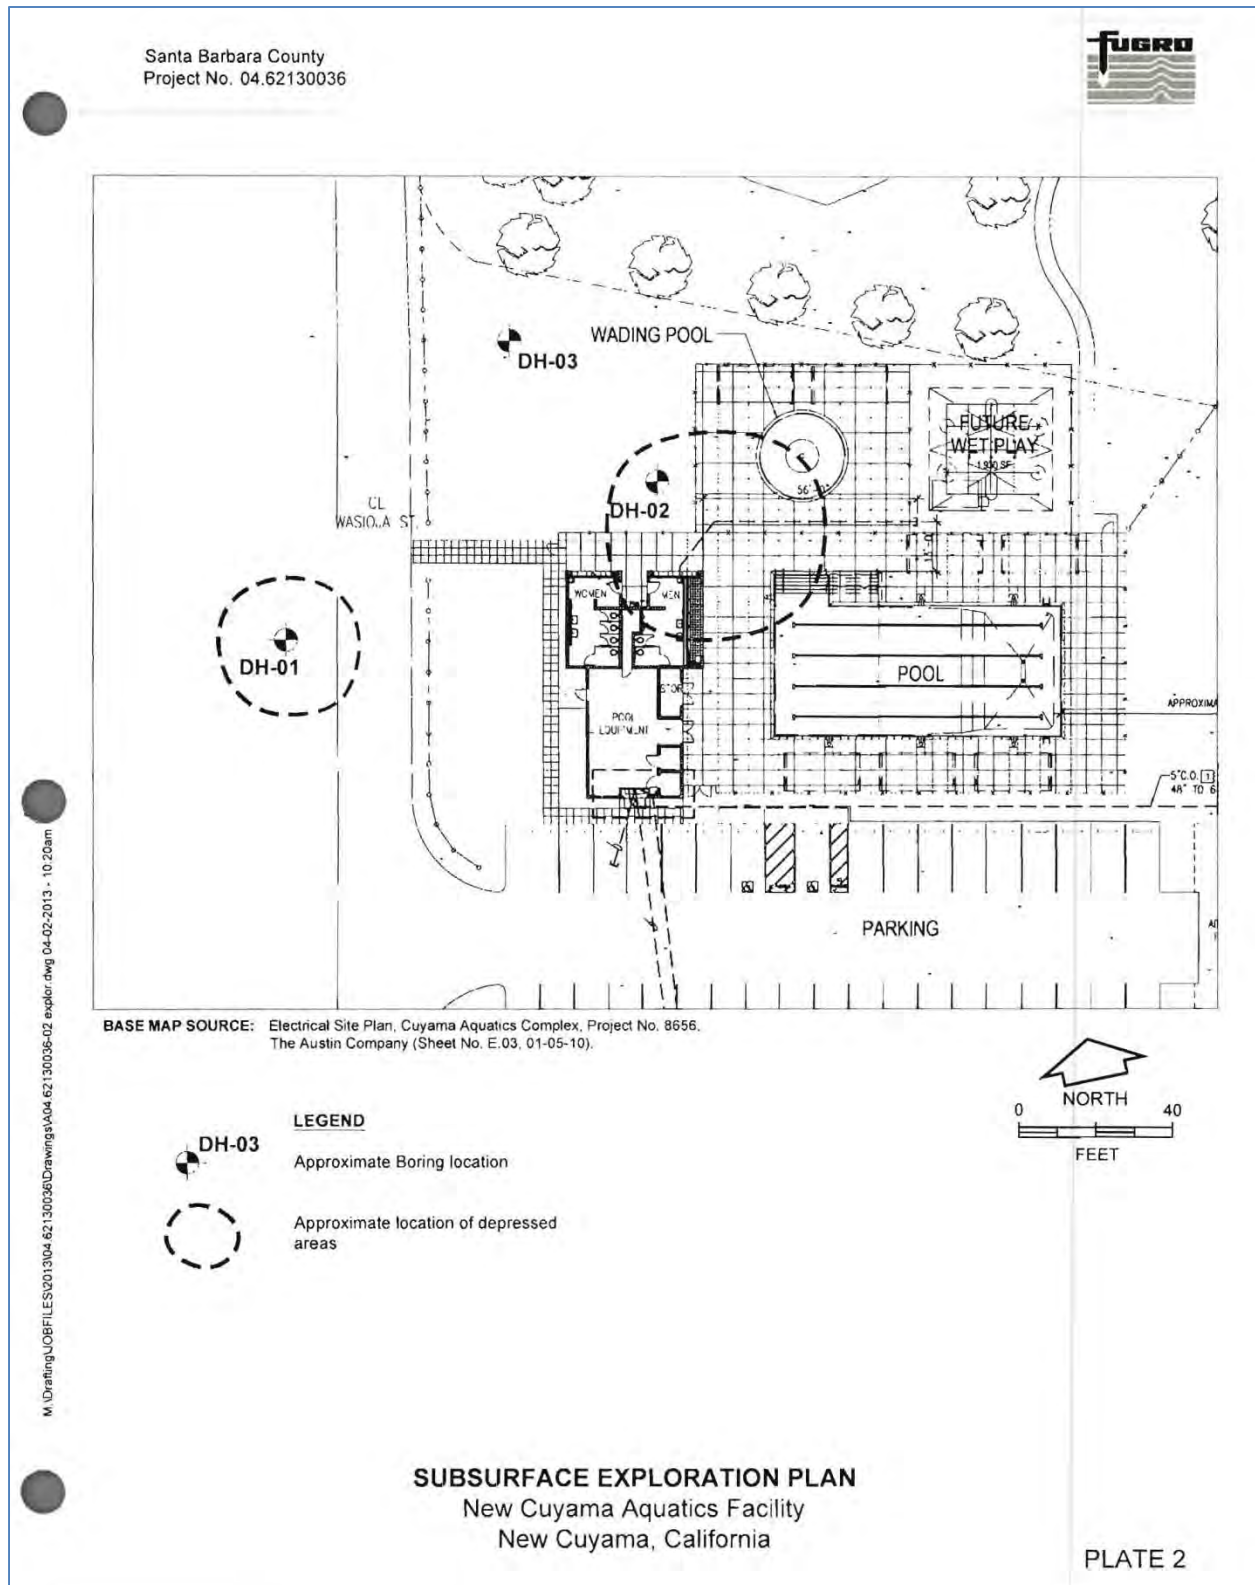
Figure 11: Excerpt from Fugro Consultants April 2013 (Revised May 2013) Report Plate 2.

Figure 40: Excerpt from Fugro Consultants April 2013 (Revised May 2013) Report Page 3. Note in this excerpt that the "grade of the northwest portion of the site was raised approximately 2 to 3 feet." The northwest portion of the site is the area marked in Fugro Consultants' Plate 2 as being depressed (See Figure 11).

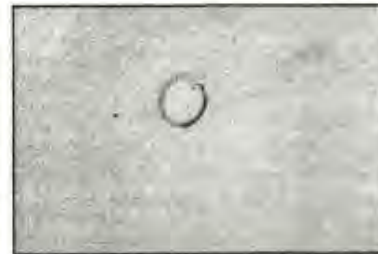
- b. Vertical cracking was observed at the eastern edge of the stairs. The cracking telegraphed across the pool bottom, and is likely caused by tensile stresses at the abrupt change in plan geometry. The tensile stress is likely directly related to the settlement of the northwest portion of the pool.

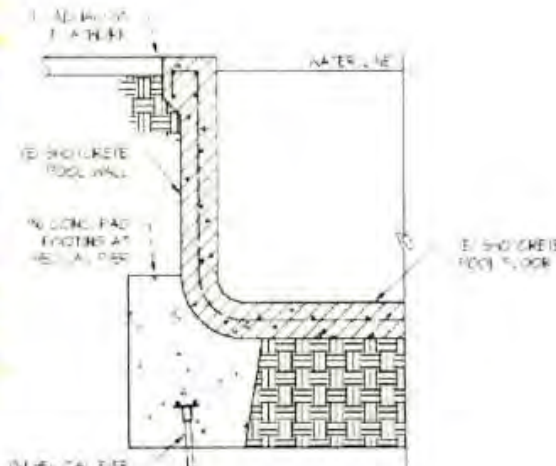
<ol style="list-style-type: none"> d. Per the original soils report by GSI Soils, Inc. the Main Pool should have been constructed with a drainage system under and around the pool connected to a sump pump. It is recommended that a system similar to that recommended in the original report be designed and subsequently installed during the exposure of the West end of the main pool. e. Replacement or repair of the pool's plaster finish will be required to repair cracks and potential for future leaks. <p>5. Wading Pool</p> <ol style="list-style-type: none"> a. Supplemental support and repair for the existing wading pool is not feasible. It is recommended that the wading pool be removed and replaced in its entirety per the original plans. b. Geotechnical recommendations will be required to replace or augment the existing subgrade which had been previously prepared with on-site native soils. These on-site native soils have subsequently been determined to have hydroconsolidation potential.

<ol style="list-style-type: none"> c. The stabilization of the main pool shall be achieved by underpinning with helical piers with cap brackets and thrust blocks of reinforced concrete. This solution will require excavation of the soil directly adjacent to the pool walls in the shallow west end. This operation will be most successful should it be done in stages much like a 'checkerboard' grading operation.

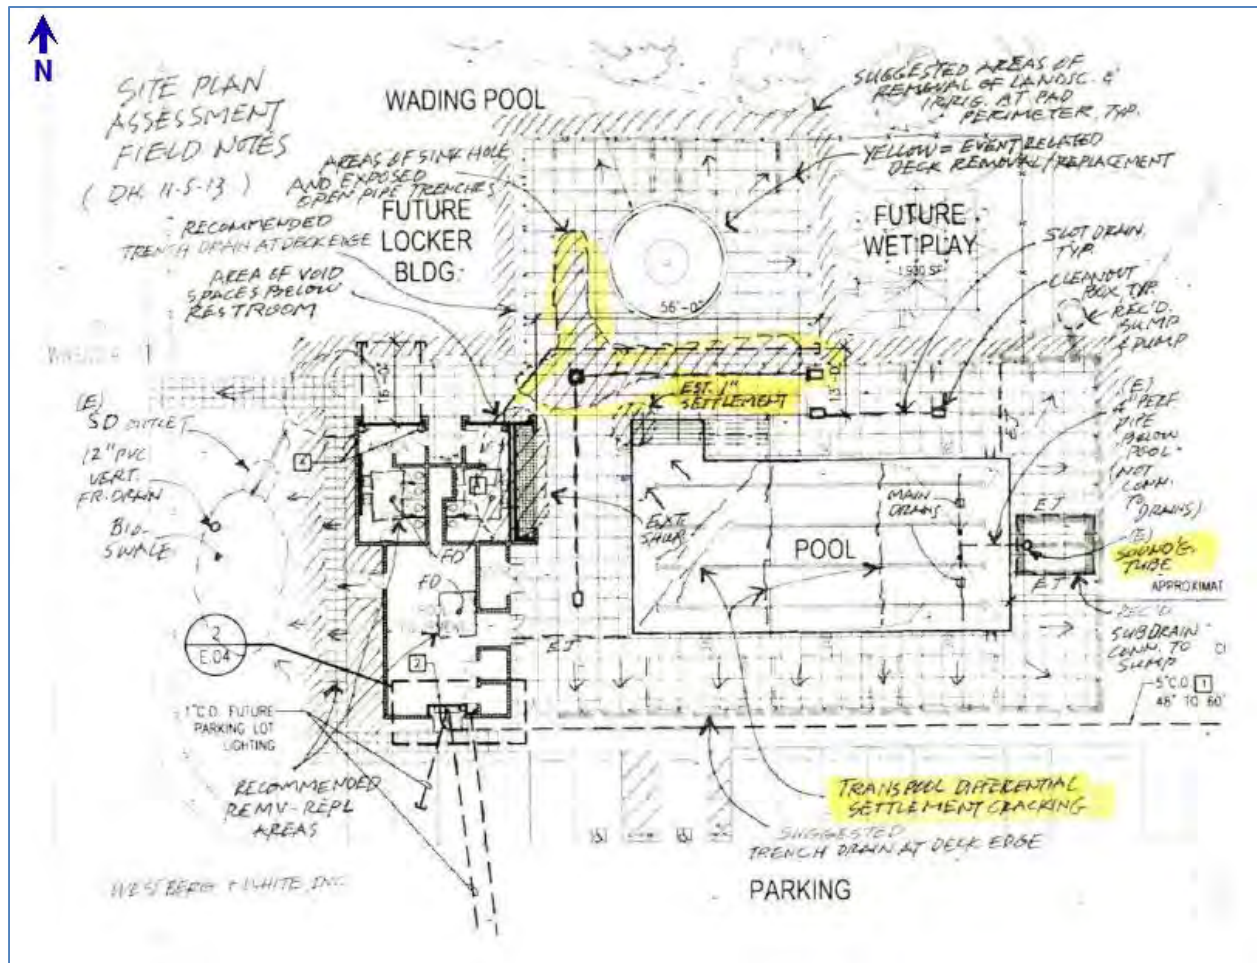
Figure 29: Excerpt from Westberg + White, Inc. Report Page 13. Note cracking in swimming pool floor.

22. The two main drain sumps were full of murky water. Greg Cannon reached in to the south main drain sump and was able to determine by touch that there was a hydrostatic relief valve in the bottom of it ([See Figure 29](#)).
23. The swimming pool cracked in three major areas ([See Figures 29-32](#)). One crack is from the corner of the stepped entry across the shallow end of the pool at approximately a 45-degree angle ([See Figure 29](#)). In many areas in the crack, we were able to get a 0.025-inch-thick feeler gauge (nearly 1/32") into the crack with no problem ([See Figures 33, 34](#)). Another large crack from the same corner goes directly across the pool to the south side wall ([See Figure 29](#)). A third large crack runs across the break in slope from the north side pool wall to the south side pool wall ([See Figure 29](#)).

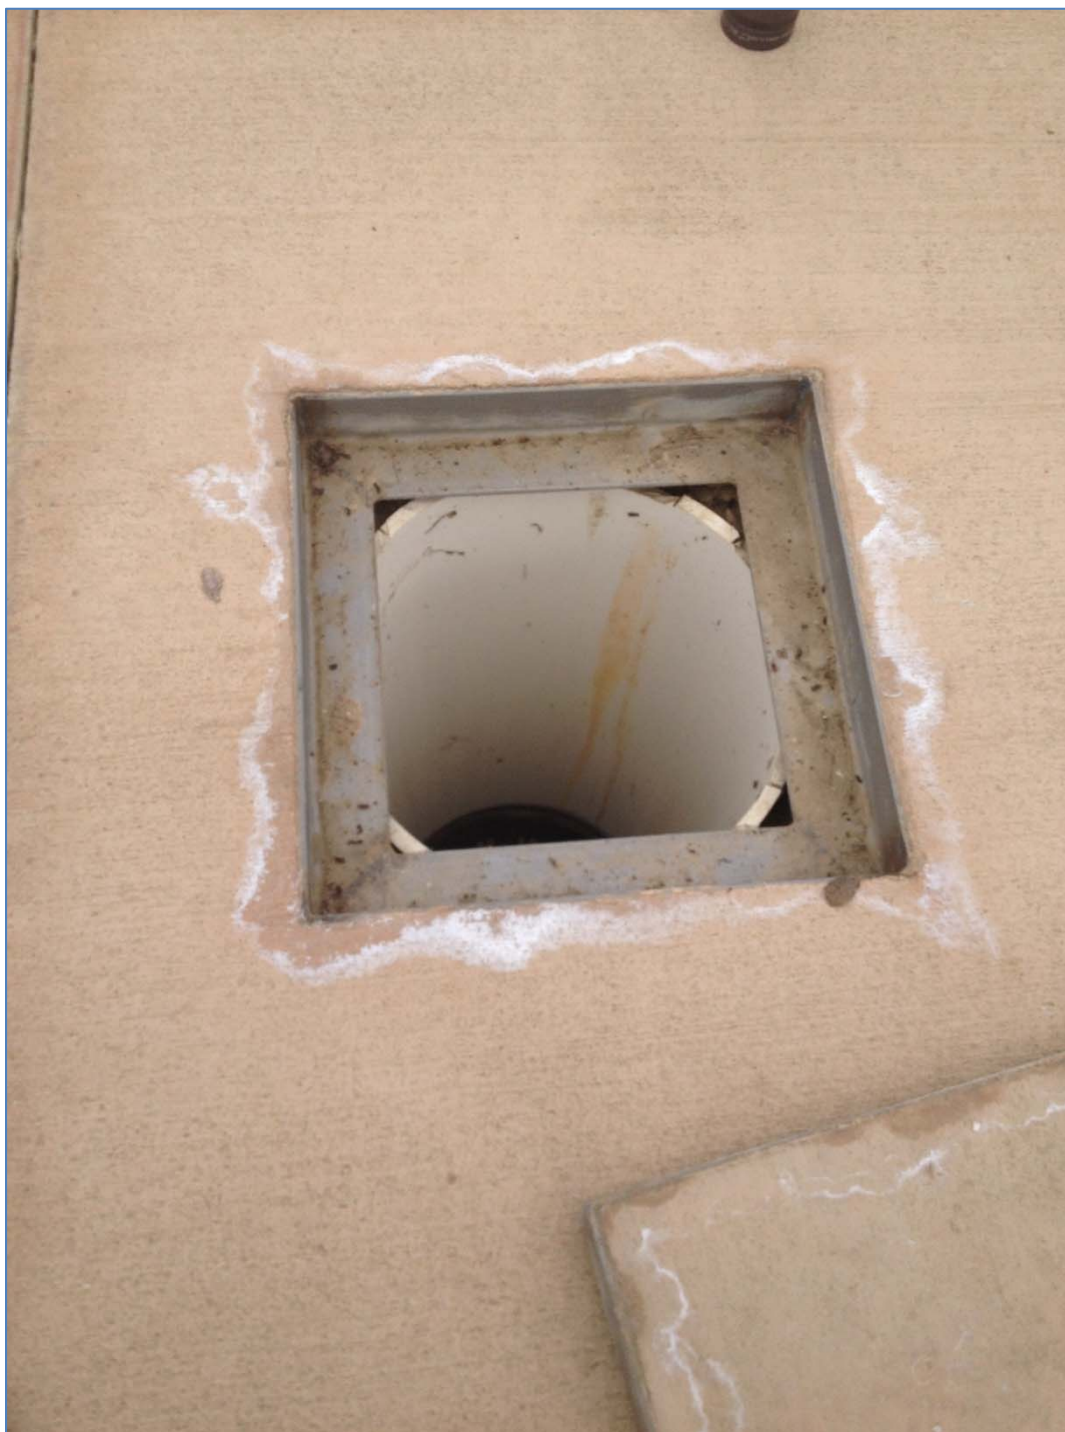
24. We measured the water depth at the bottom of the 12-inch (12") PVC sounding tube in the deep end of the swimming pool and found it to be approximately a half-inch (1/2") deep (See Figures 35, 36).

Figure 35: Photograph of the sounding tube.

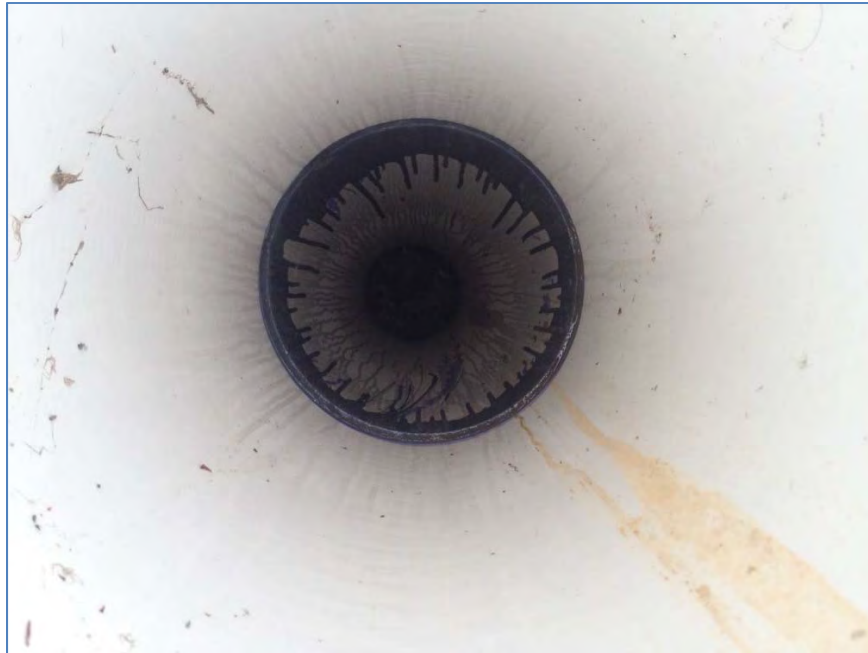
Figure 36: Photograph of the interior of the sounding tube.

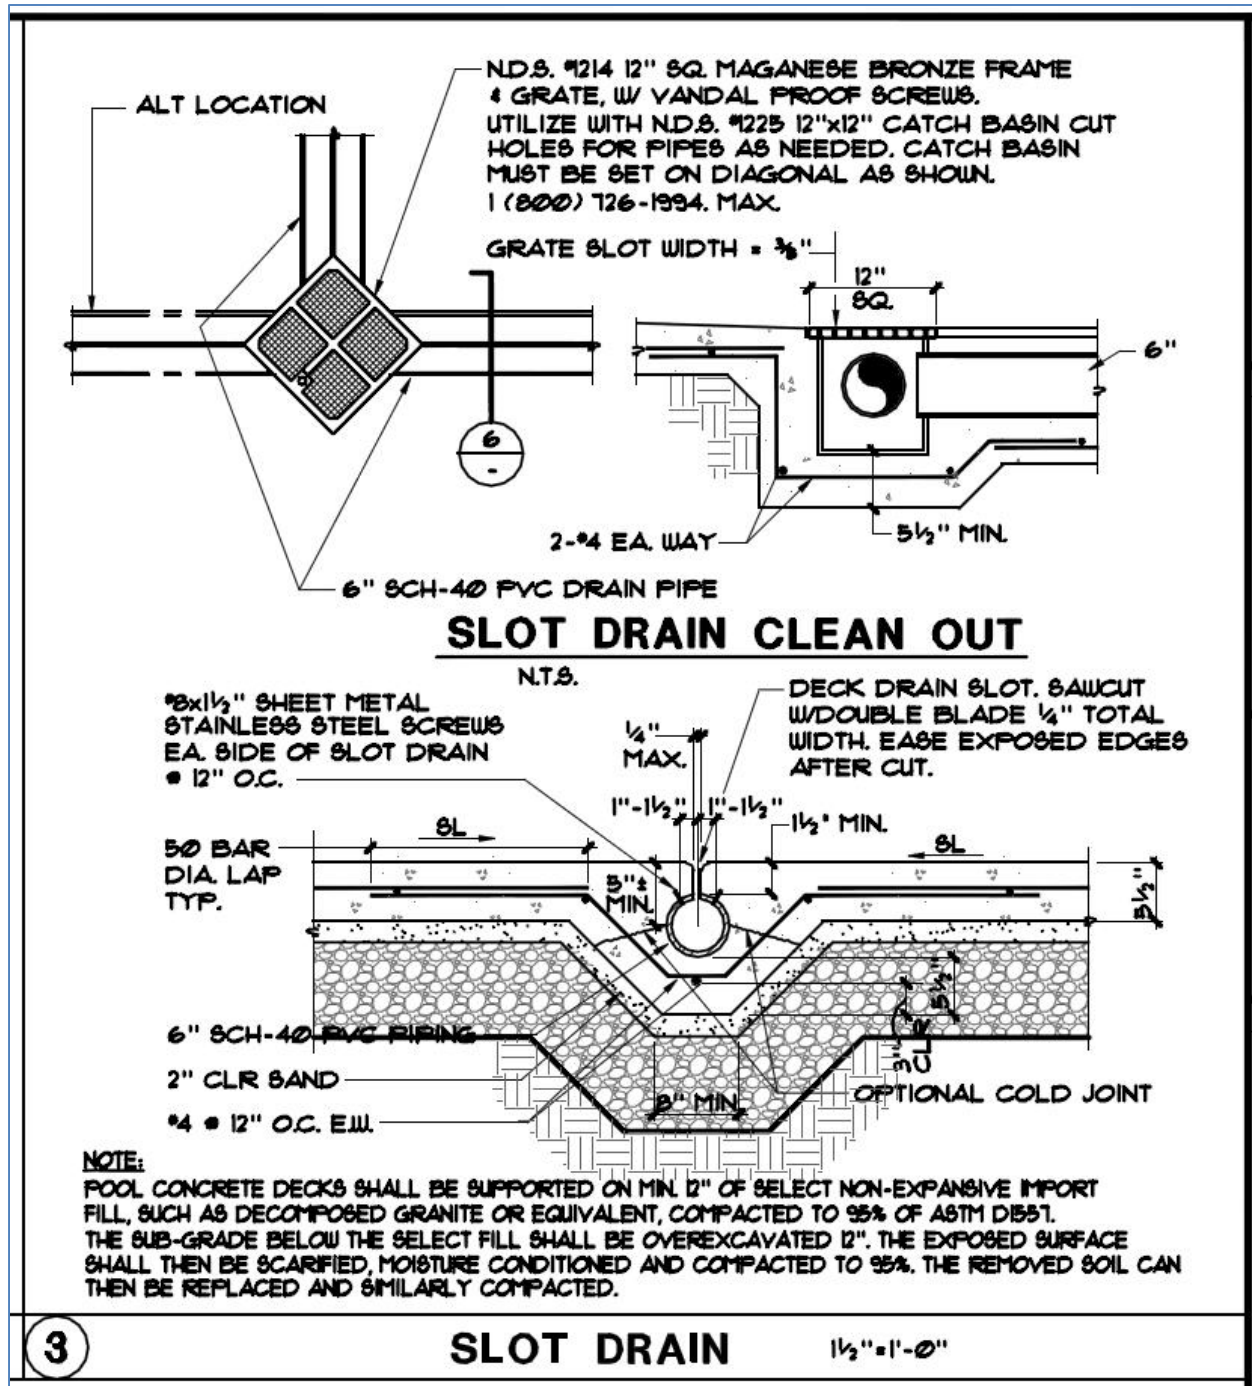
28. It appears that, for whatever reason, the contractor did not follow the design drawings with regard to the deck drainage system (the deck slot drain and slot drain clean out). Drawing SP-15 Detail 3 required Schedule 40 PVC pipe (which is always colored white) for the deck slot drain (See Figure 37). The type of piping used for the deck slot drain was not the required Schedule 40 PVC, but some kind of green thin-walled piping that is much thinner than Schedule 40 PVC (See Figures 38, 39).

Figure 37: Drawing SP-15 Detail 3 detailing the requirements of the slot drain and slot drain clean out (the slot drain clean out is also called the cleanout, the cleanout box, the deck drainage cleanout box, the collection inlet box, and the cleanout and drainage inlet box). The slot drain pipes were called out to be Schedule 40 PVC twice in this Detail. The slot drain clean out was to have 5.5 inches (5-1/2") of concrete and reinforcing steel or rebar around it. The Note also requires that the pool concrete decks be supported on a minimum of 12 inches (12") of select non-expansive import fill such as decomposed granite or equivalent.

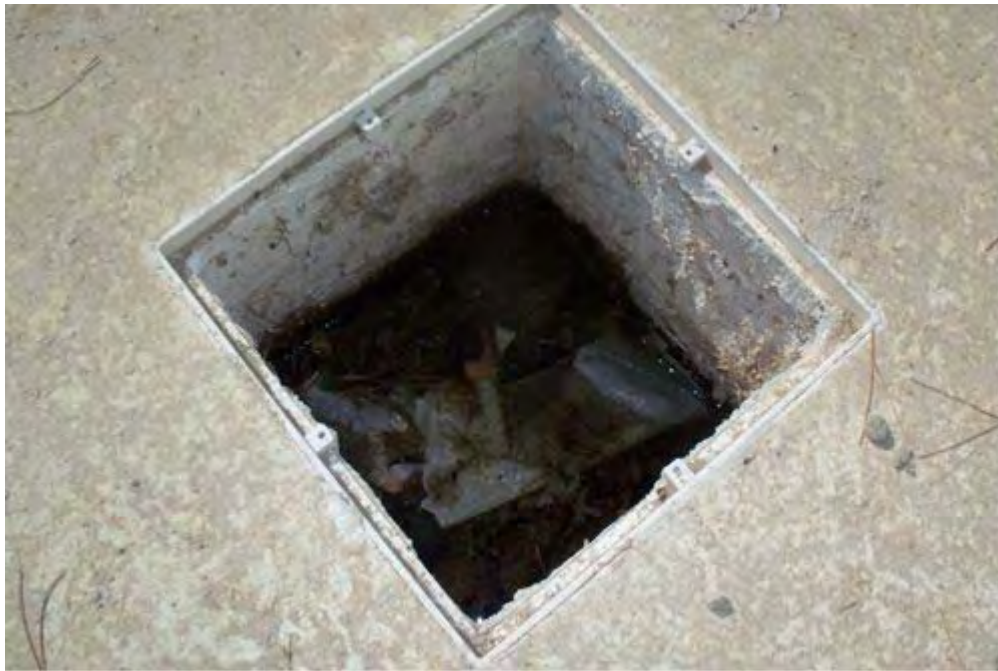
Photo No. 15 – Water in Main Pool Drain at Low End of Pool

- b. The main pool drain inlets at the low end of the pool have standing water (Photo No.15). No drainage outlet other than the pump suction line is provided and it is assumed the water is trapped water resulting from the pump shut off. These will need to be cleaned and examined for any deficiencies during reconstruction.

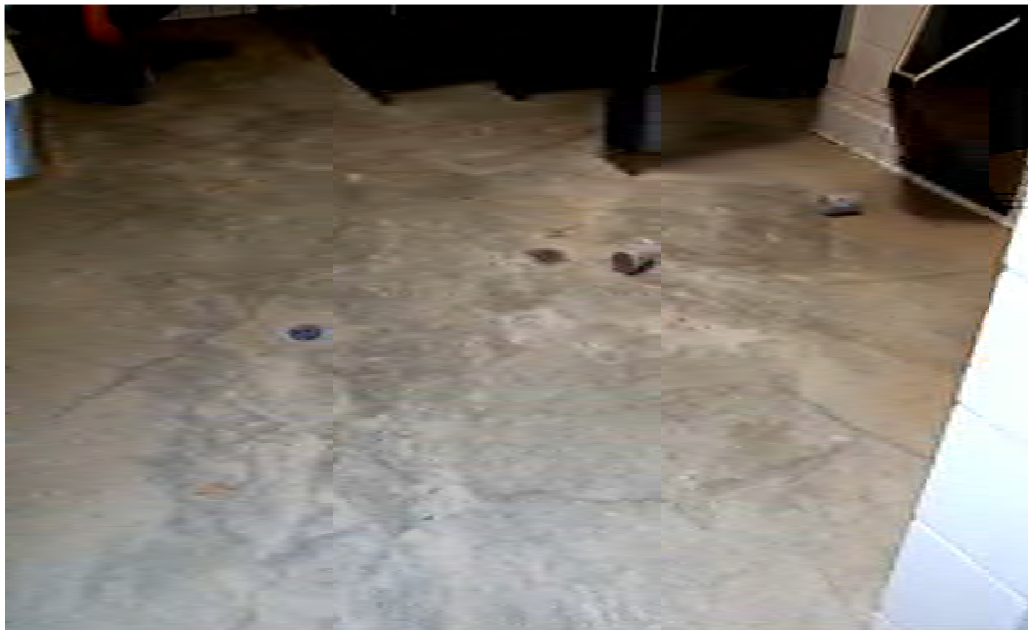
Photo No. 24 – Spider-like Cracking at Floor Drain in Women's Restroom

- b. Although no voids were discovered in the borings of reference FCI-GDR, there are spider-like cracking patterns surrounding the center floor drain in the Women's Restroom (Photo No. 24) that are similar to those in the Men's Restroom (Photo No. 23) suggesting that hydro-consolidation and slab settlement may have occurred there as well. To a lesser degree, similar cracks were observed near one central floor drain in the Pool Equipment Room. It is unclear if these floor drain associated cracks relate to leak caused hydro-consolidation resulting in settlement or to insufficient reinforcement of the slab in the area of the penetrations.

- e. The cracking in the internal slab-on-grade that exceeds standard temperature cracking shall be epoxy injected and repaired. This is especially important in the bathrooms where wet patrons, plumbing mishaps and daily wash-downs are expected in the future.
- f. Daily wash downs occur in the restrooms within the building envelope. This water is then drained by the bathroom floor drains. Further investigation may be required to verify that these connections are not leaking water into the building pad on a daily basis during normal operation.

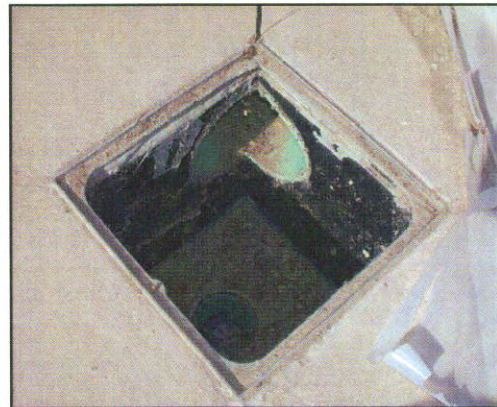
4. The slot drains and cleanouts that were installed on the North and West ends of the main pool are subject for possible long term water intrusion below the pool decks. It was documented during site observations that the installation of the details provided by the construction documents were not sealed properly at cleanouts.
