Santa Barbara County
Flood Control and Water Conservation District
**Final Updated Debris Basin Maintenance
and Management Plan**
September 2022

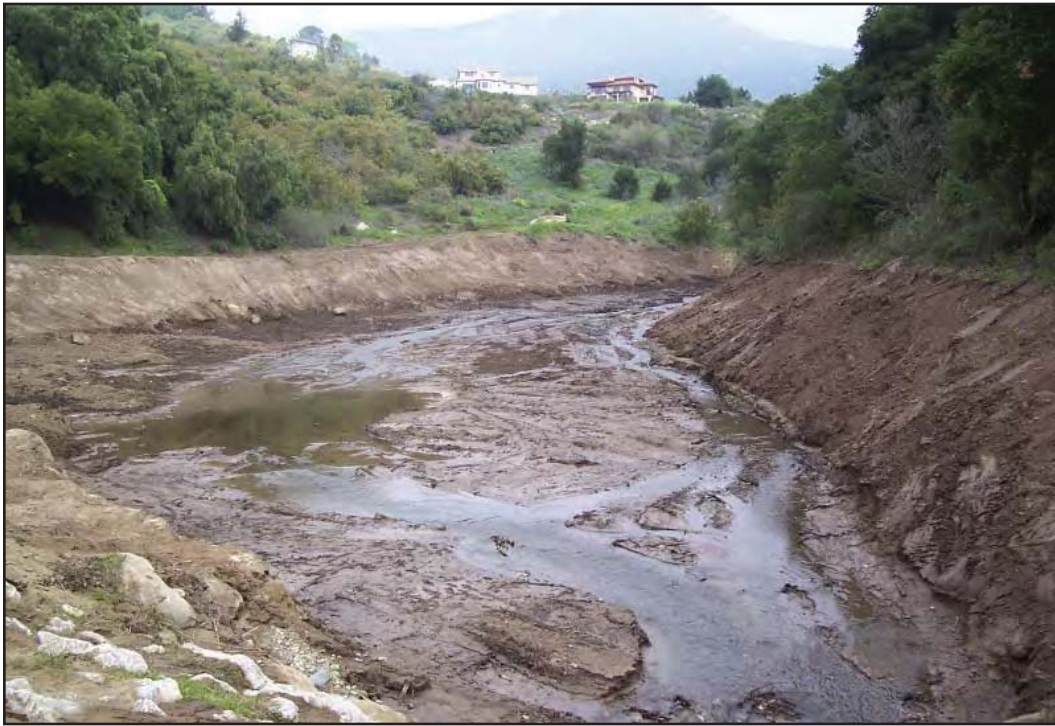
PHOTOGRAPH 2-1
San Roque Creek 2005 Desilting

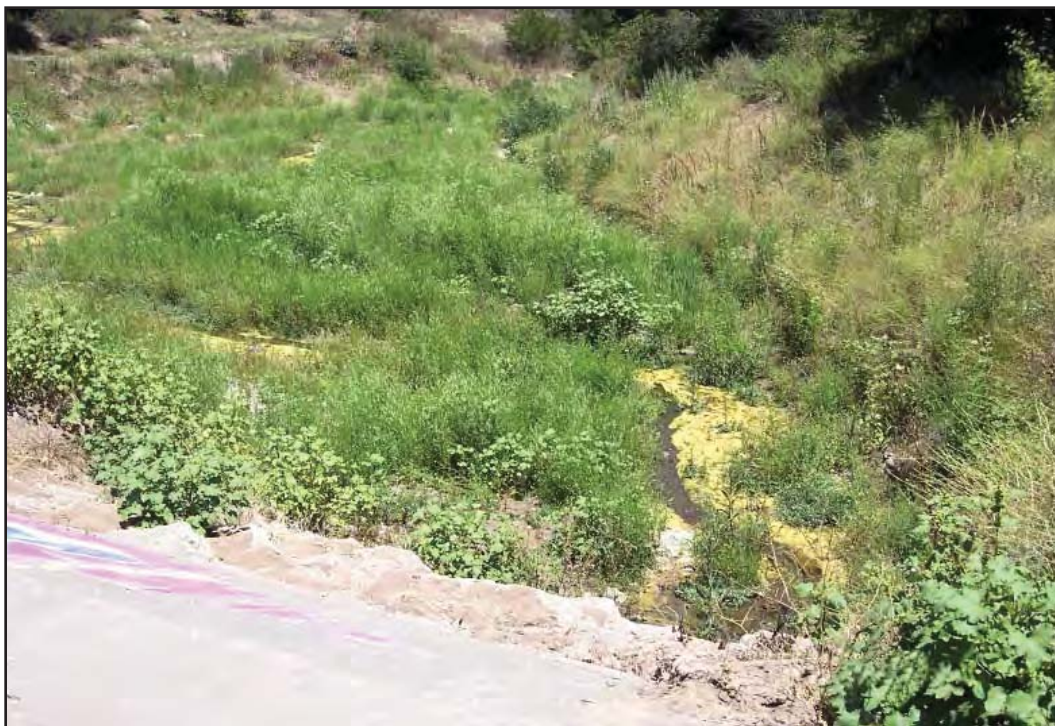
PHOTOGRAPH 2-2
Growth 6 Months after the 2005 Desilting

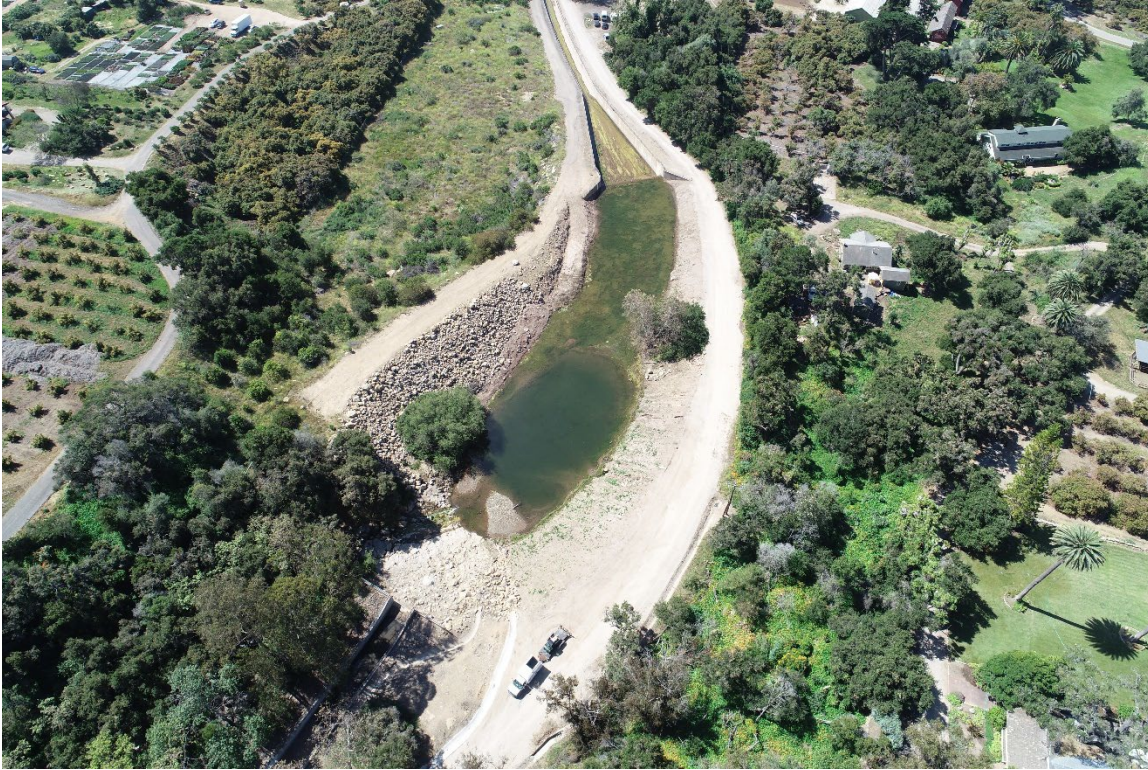
Photograph 6.4-1: Santa Monica Creek Debris Basin Plunge Pool Below Basin
