LILLINGSTON CANYON CREEK DEBRIS BASIN ADDENDUM TO THE PROGRAM EIR FOR SANTA BARBARA COUNTY FLOOD CONTROL ROUTINE MAINTENANCE

**Lillingston Canyon Debris Basin
4-year Phased Removal, 2010-2013
Pre-project Photographs**

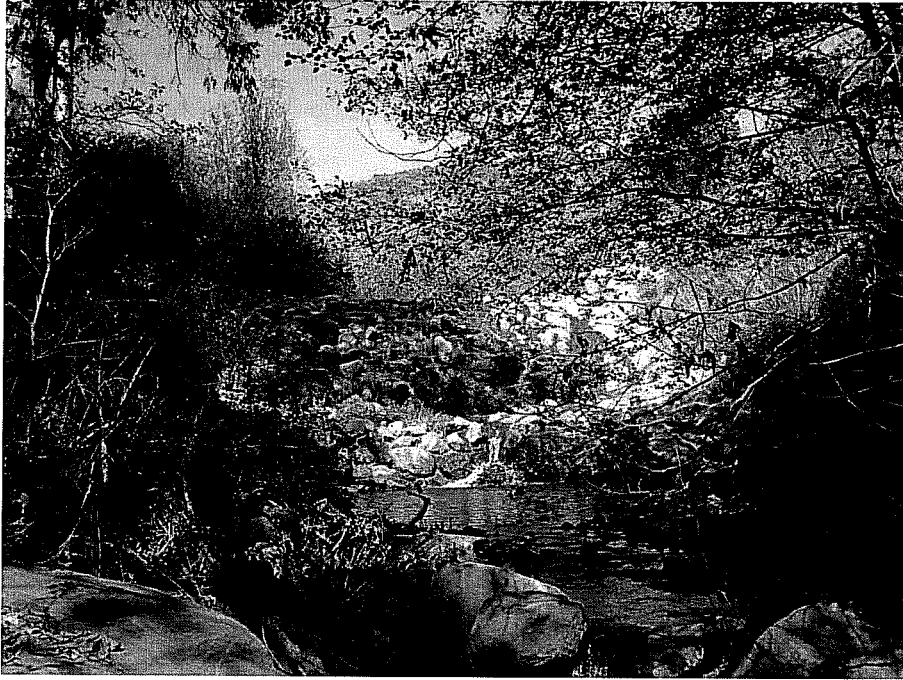
Looking upstream at the basin embankment

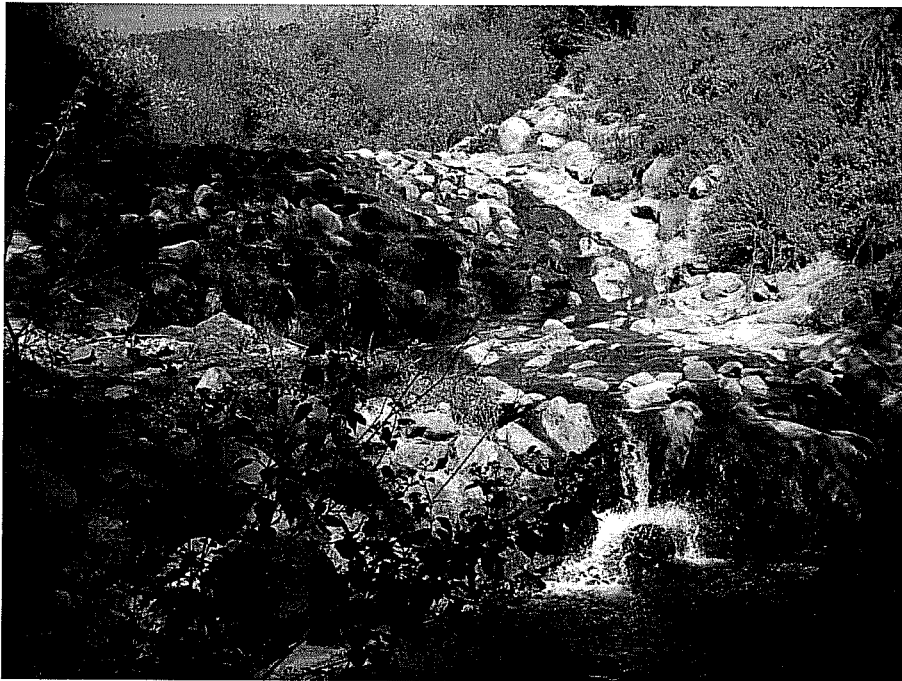
Looking upstream at the basin embankment

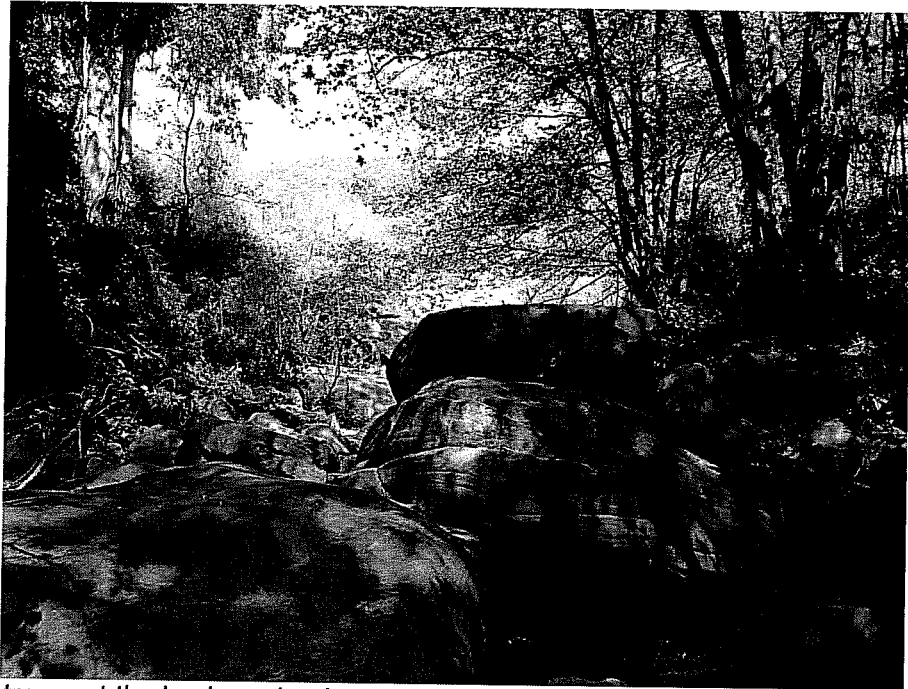
Looking upstream at the basin embankment showing impassable boulders. The access road transitions from the creek invert up onto the east bank approximately 75 feet downstream of these boulders.

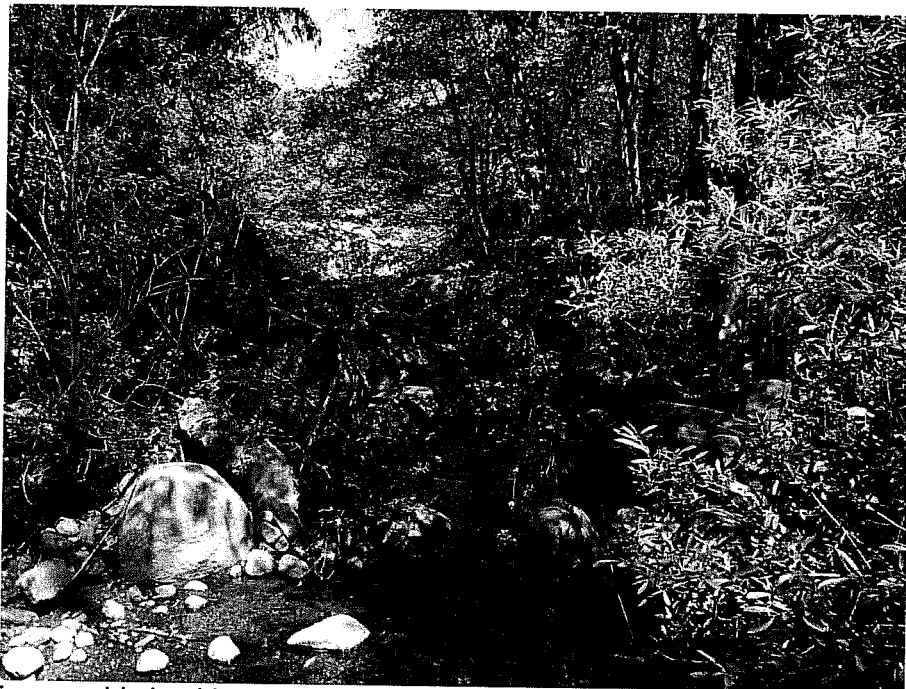
View of the impassable boulders from downstream at the location where the access road transitions to the east bank.

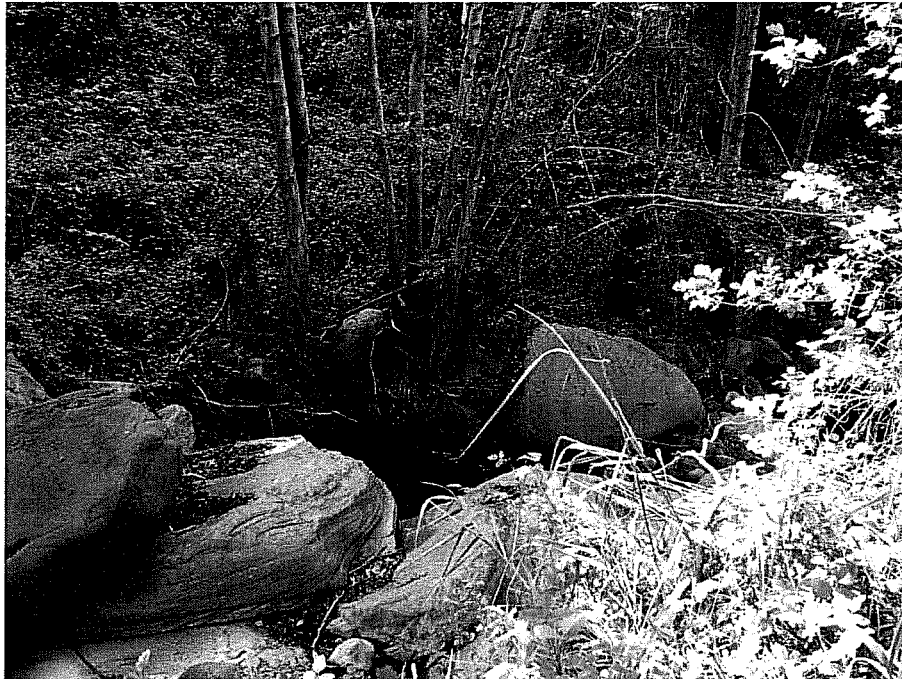
View from the west bank of the impassable boulders. The access road will be on the east bank behind the alder trees within the green ivy area.

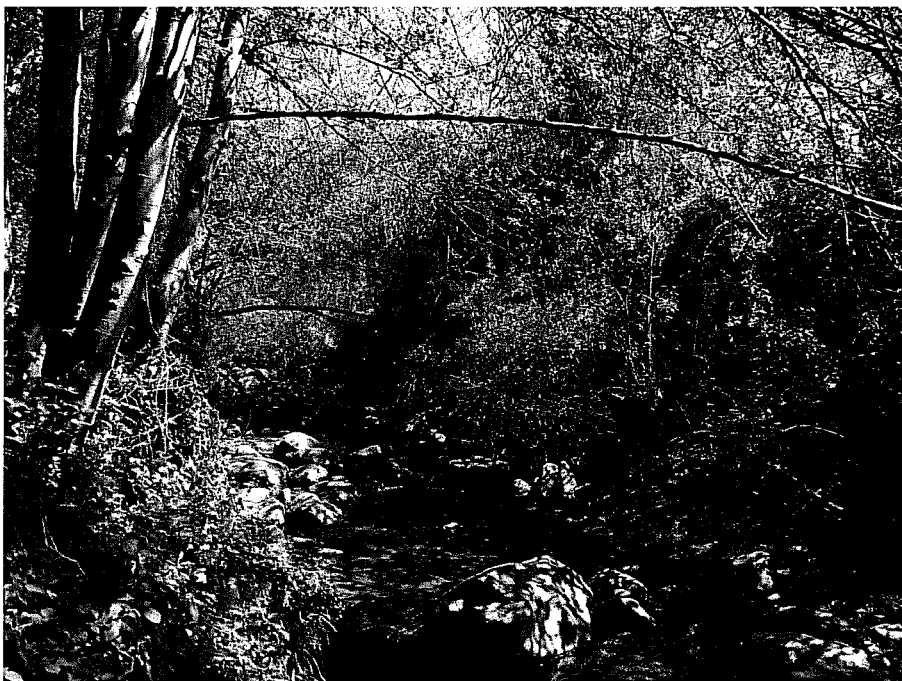
Representative view of the streambed downstream of the basin showing the unvegetated creek invert and scattered rocks that will be moved to the sides of the channel for access. Access road will be in the streambed at this location.

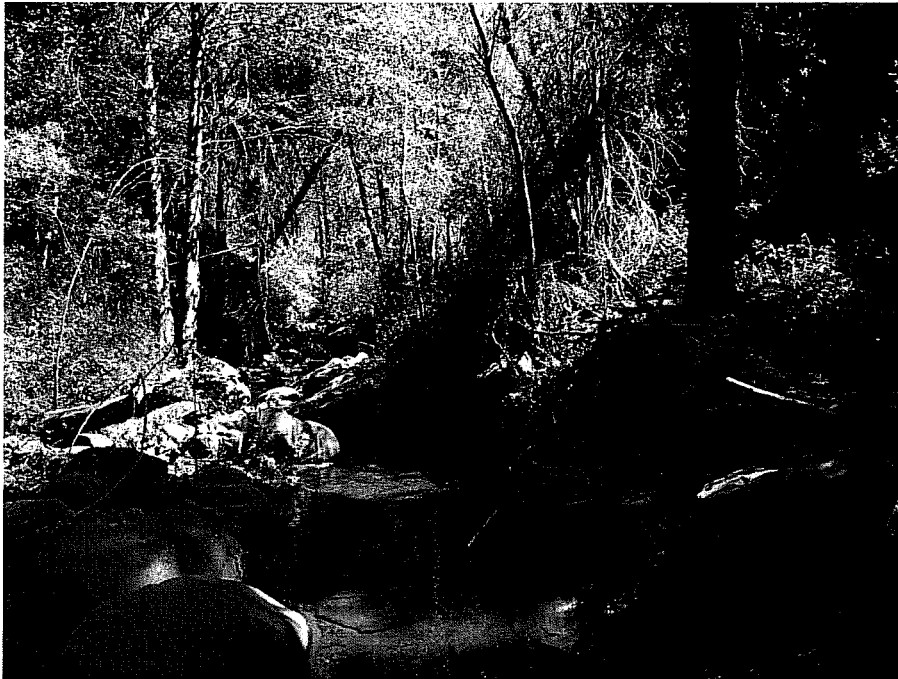
Representative view of the streambed approximately 300 feet downstream of the basin showing the unvegetated creek invert and scattered rocks that will be moved to the sides of the channel for access. Access road will be in the streambed at this location.

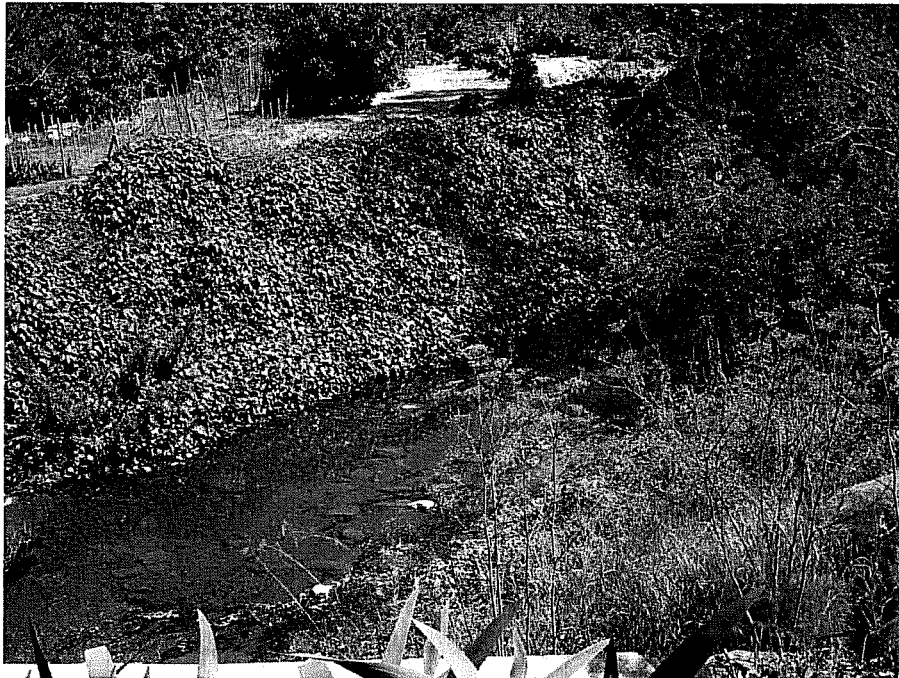
Debris Rack location.

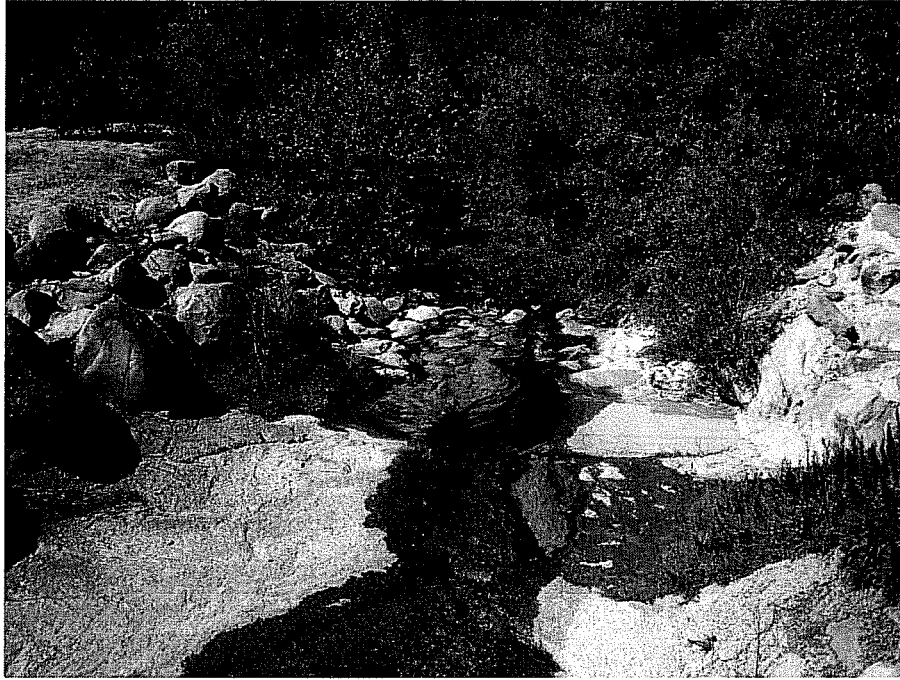
View looking downstream from the debris rack location.
