Phase 1-2 Cultural Resources Study, Historic Resources

**83 Eucalyptus Lane (All Saints By-the-
Sea Church), Montecito, California
(APN 009-332-009)**

Post/Hazeltine Associates
2607 Orella Street
Santa Barbara, CA 93105
(805) 682-5751
posthazeltine@cox.net

August 27, 2015

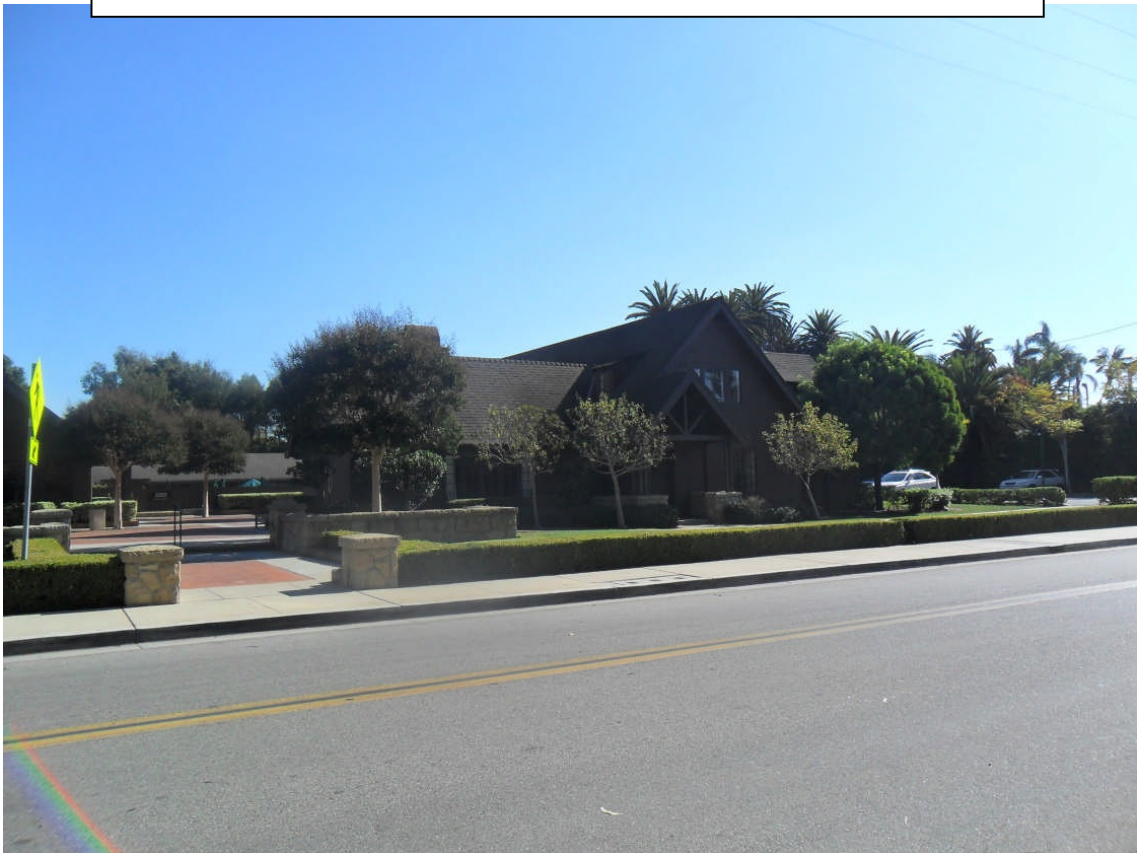
Figure 9
All Saints By-the-Sea Church at 83 Eucalyptus Lane, Montecito
Looking northeast

Improvements to the property include, in addition to the church (Figure 9), a detached Parish Hall (built 1929); a detached Centennial/Parish House (formerly the Rectory, built in 1934 and remodeled in 1998-1999); as well as a detached Friendship Center/Sunday School (originally built as a Sunday school in 1949, additions were made in 1951, 1958, with additions and renovations in 1998-1999) (Figures 10,10a & 10b). The property's designed landscape features a paved

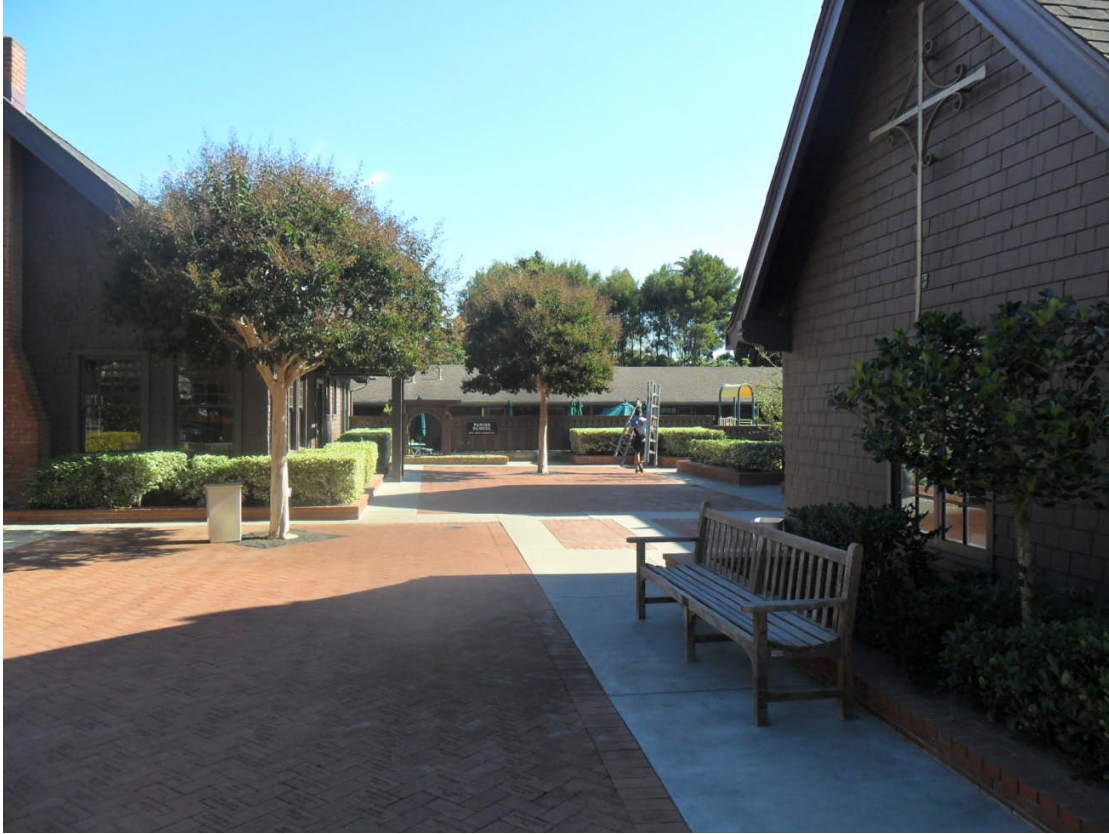
Figure 10
Centennial Hall/Parish House at
All Saints By-the-Sea Church at 83 Eucalyptus Lane, Montecito
Looking southeast

In addition to the church the property is developed with several buildings, including the Centennial/Parish House (built 1934; renovated 1998-1999) located just to the south of the church, the Parish Hall (1929) located to the rear (east) of the church and a Sunday School/classroom building (1949) located to the southeast of the church (see Figures 9 - 22). An asphalt-paved parking area is located to the north of the church, while another paved parking lot is located at the southwest corner of the property. The street frontage on Eucalyptus Lane is landscaped with shrubs and lawn. Off the front of the church a semi-circular concrete walkway leads from the sidewalk to the entry porch. On its north side the walkway is flanked by brick paving that provides access to a parking lot. Informal brick-paved walkways set into expanses of lawn lead around all four

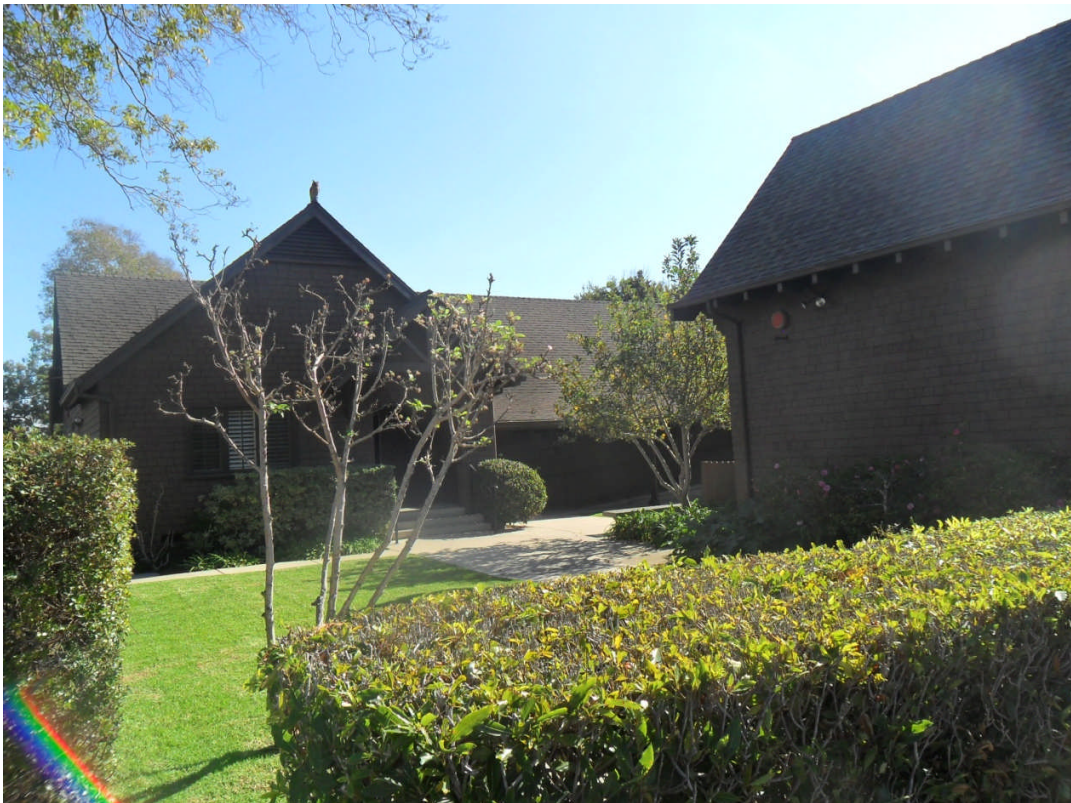
Figure 10a
Classroom Building, looking east

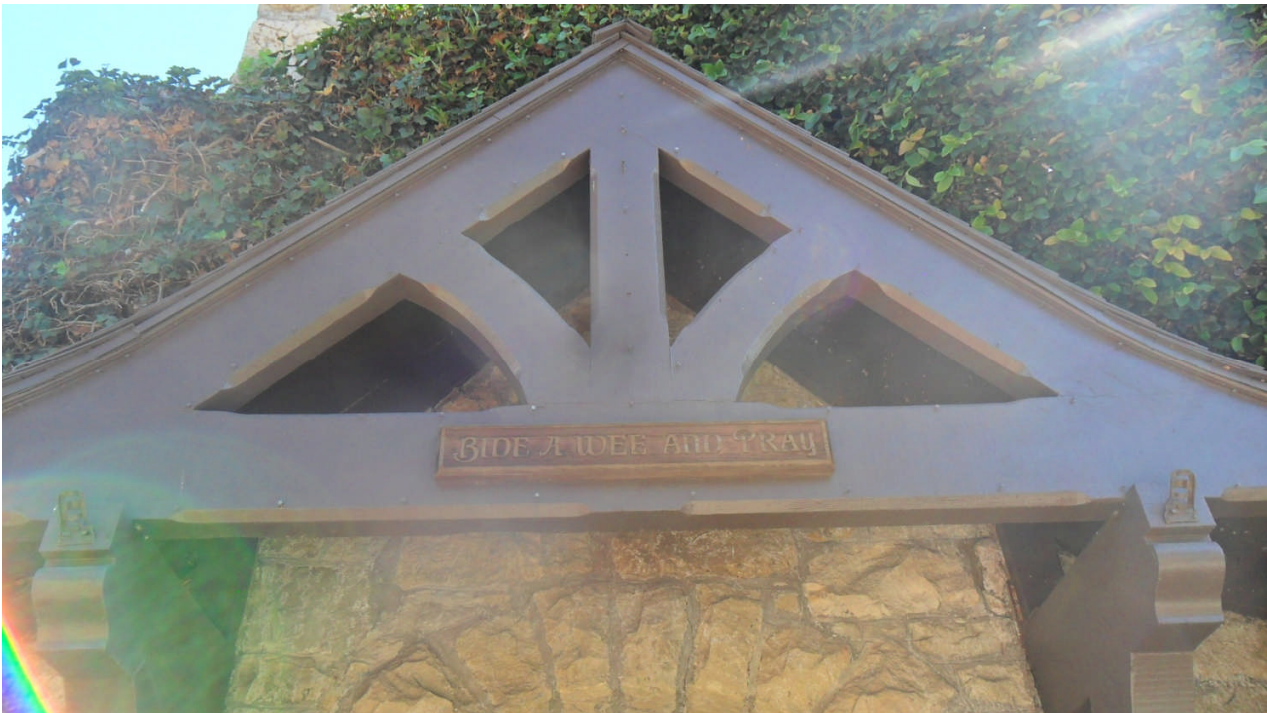
Figure 11
All Saints By-the-Sea Church at 83 Eucalyptus Lane, Montecito
West elevation of the church (primary façade)
Looking east

Built in 1900, the wood-framed and masonry Craftsman style church incorporates Gothic Revival style motifs (Figure 11). The church, which is essentially rectangular in configuration, is aligned on a west to east axis with the vestibule at its west end, opening into the narthex and baptistery. The narthex opens into the nave which extends east to the sanctuary, which is flanked on its south side by the vestry and a small chapel. The church's picturesque massing, composed of steeply pitched roofs and a masonry bell tower set at the northwest corner of the building, is designed to emphasize the domestic scale of the building which recalls the appearance and character of a rural Gothic Revival English church as filtered through the sensibilities of Arthur Benton's interpretation of the Craftsman style.

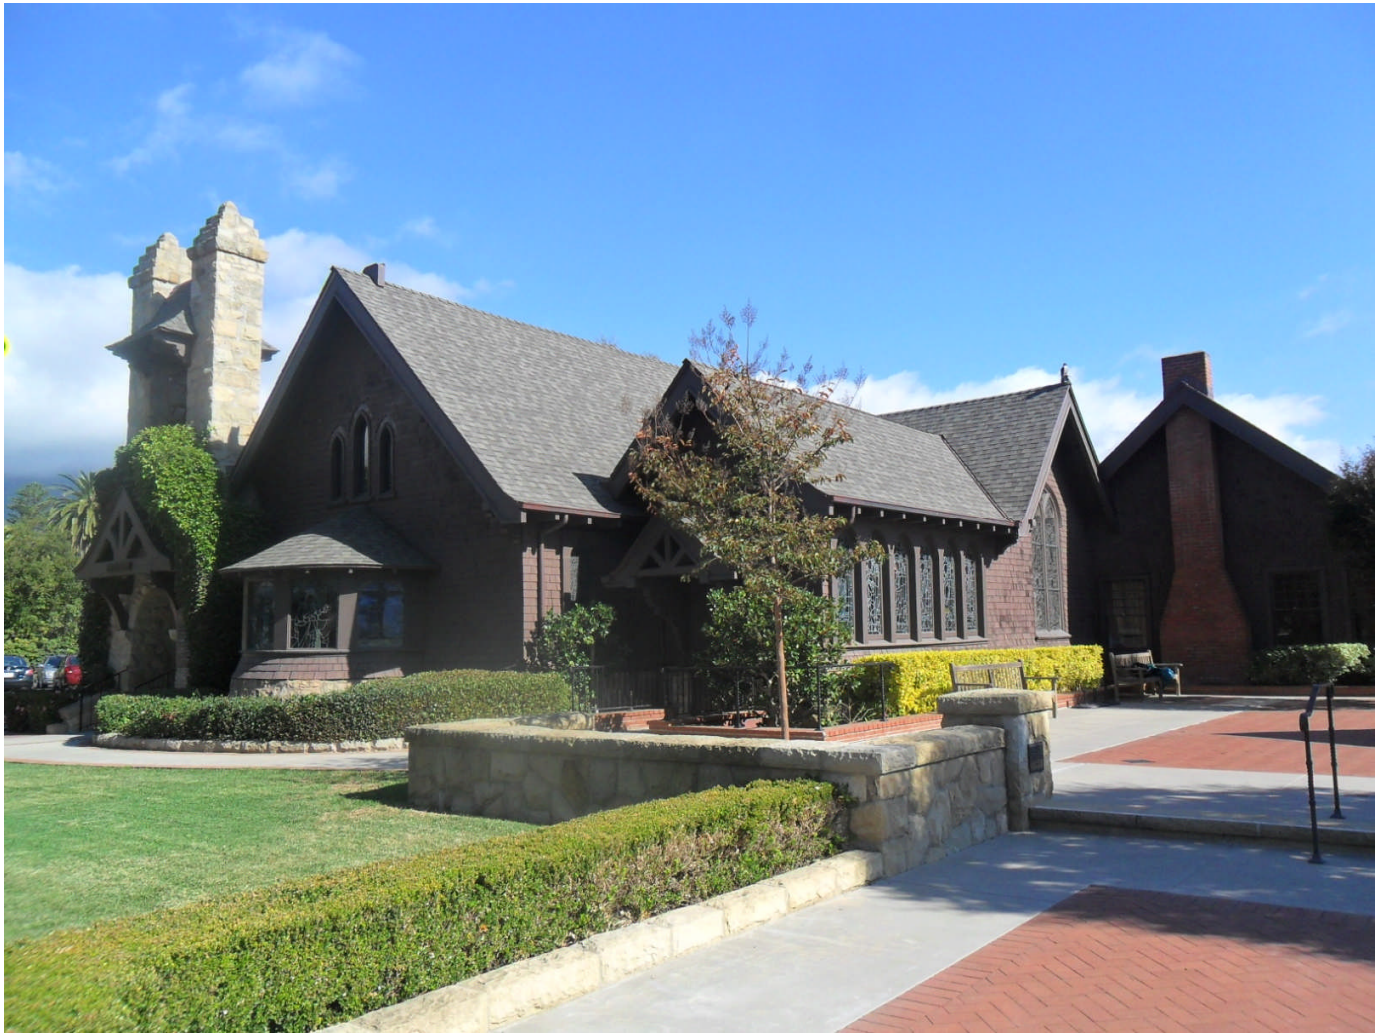
Figure 13
All Saints By-the-Sea Church at 83 Eucalyptus Lane in Montecito
North end of the west elevation (primary façade)

The west elevation is the entrance façade of the building (Figures 12 - 14). Its picturesque massing is defined by the asymmetry of the elevation with the main front gable roof flanked on its north by a masonry bell tower composed of rectangular sandstone blocks housing a recessed entry porch at its base and a belfry. A series of steeply-pitched front gable roofs cap the main block of the church and the two recessed wings set off the south side of the elevation. The central gable is capped by a Celtic style cross. Wide wood plank fascias sheath the slightly projecting roof eaves. A semi-circular apse-like projection housing

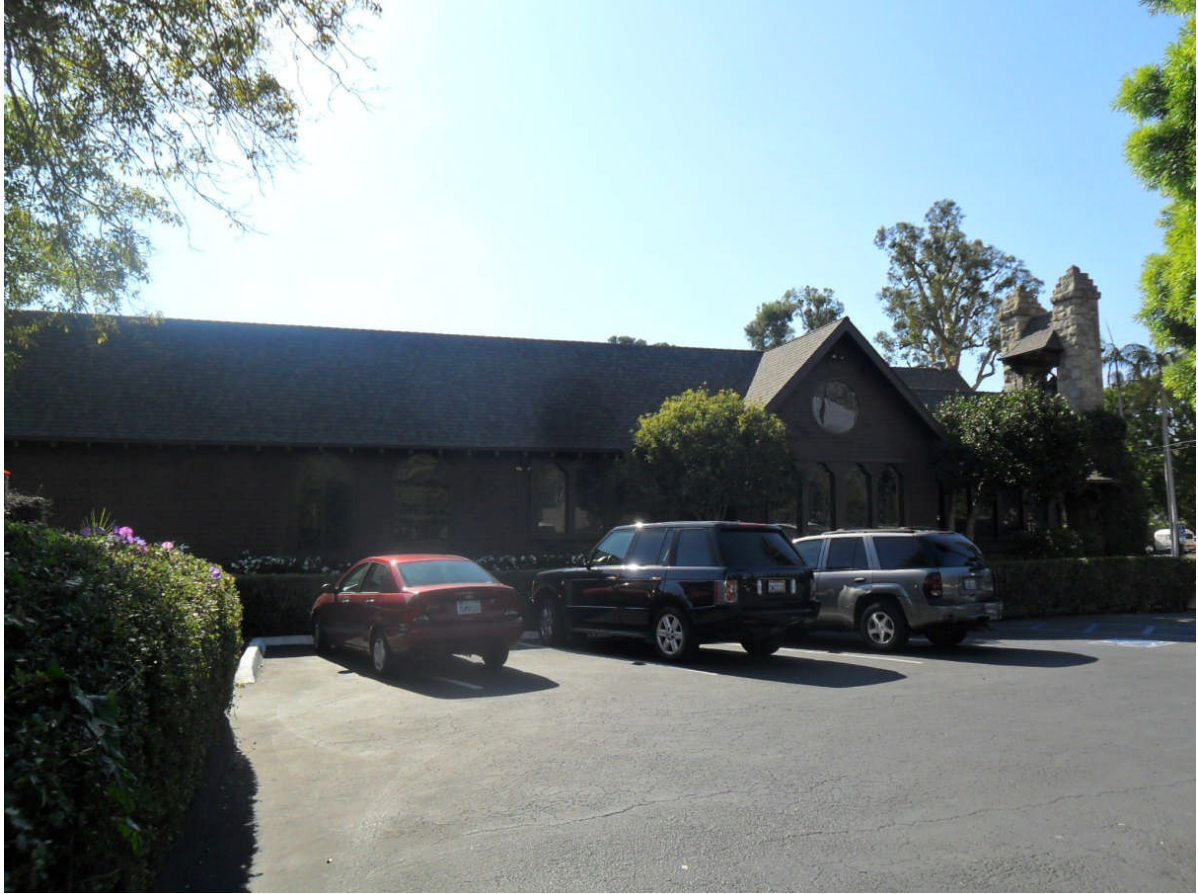
Figure 14
All Saints By-the-Sea Church at 83 Eucalyptus Lane in Montecito
west and south elevations, looking northeast

The south elevation is L-shaped in configuration and is flanked on its east by a projecting wing built in 1916 housing a study for the rector and a choir room (Figures 21 & 22 and see Figure 14). The nave and aisles of the church are capped by a steeply-pitched side-gable roof; its fenestration is composed of stained glass windows set in arched reveals. The choir room and study are capped by a steeply-pitched side gable roof. A porch, capped by a front-gable roof supported by corbelled wood timbers, shelters a glazed wood-paneled door that provides access to the choir room.

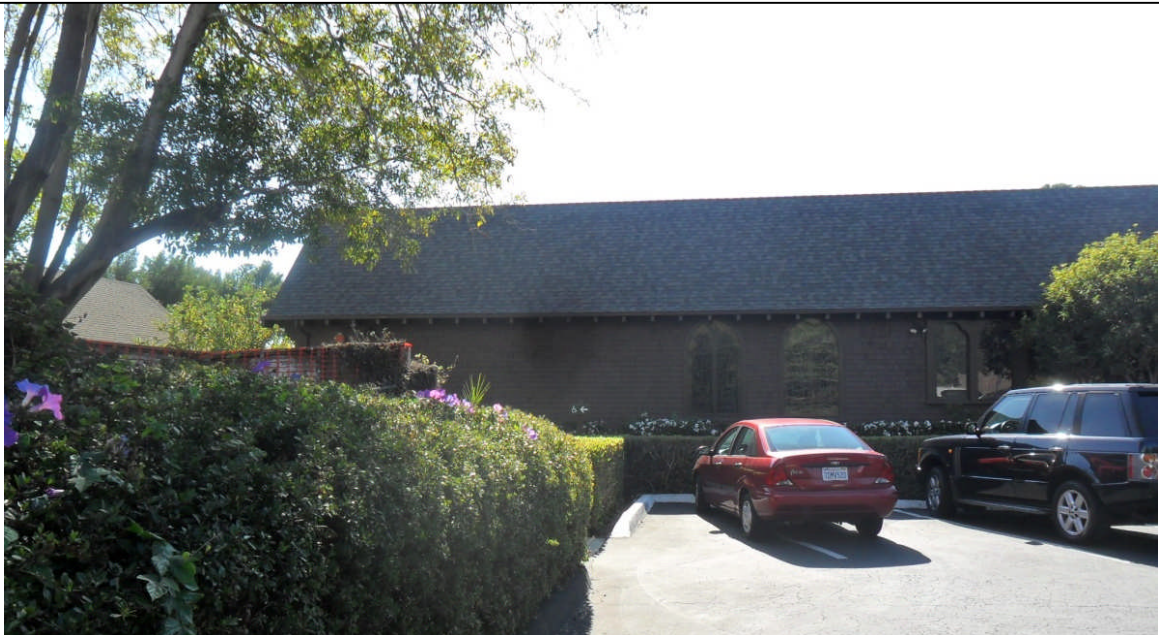
Figure 15
All Saints By-the-Sea Church at 83 Eucalyptus Lane, Montecito
North elevation
Looking southwest

The north elevation is L-shaped in configuration, with the entry porch and belfry flanked on their east by an extension to the nave added in 1921 that has a front-facing gable roof (Figures 15 -18). At its east end the addition is flanked by the remaining section of the original exterior wall of the church, which is capped by a side gable roof. This part of the elevation features a base of sandstone blocks capped by a shingled wall. Fenestration is comprised of a series of stained-glass windows set in arched openings. A circular stained glass window, added in 1921, is set in the gable end of the wing.
