Santa Barbara County  
Flood Control and Water Conservation District  
**Final Updated Debris Basin Maintenance  
and Management Plan**  
February 2021

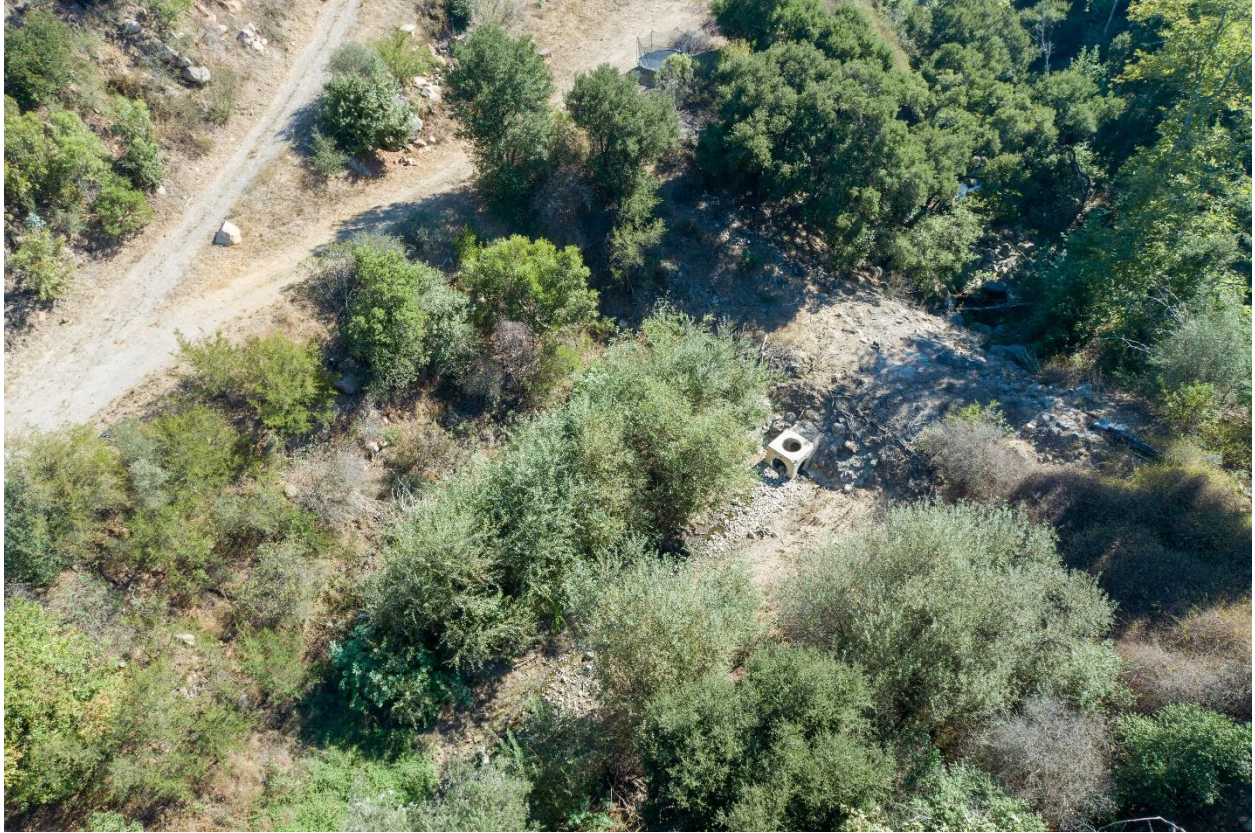
Photograph 5.2-1: Mission Creek Debris Basin

The 48-inch outlet pipe and the grouted rip-rap spillway will be maintained on an as-needed basis. Typically, maintenance consists of repairing the RCP outlet pipe and spillway when they are cracked or chipped by pouring more concrete and adding rip-rap.

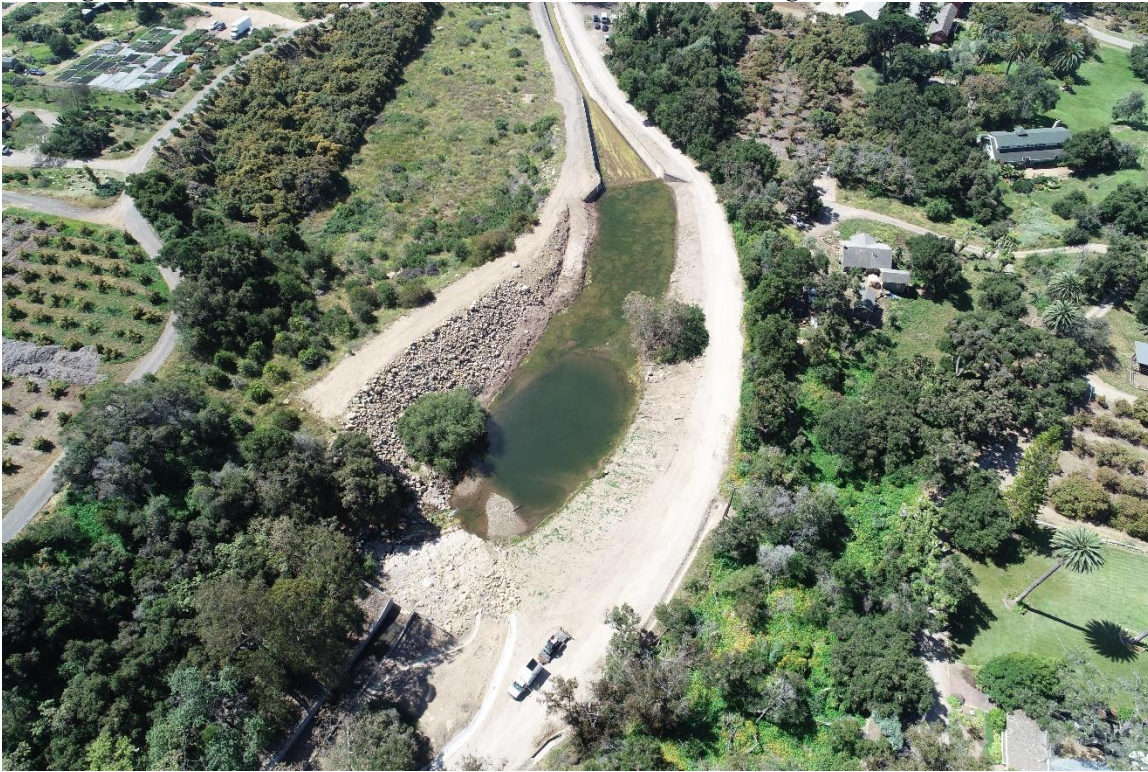
Photograph 6.4-1: Santa Monica Creek Debris Basin Plunge Pool Below Basin
