Earthquake Vulnerability of Buildings in Santa Barbara County

The State of California and Santa Barbara County have significant areas of land with high seismic activity that are capable of producing significant earthquakes. The purpose of this report is to describe earthquake hazards and to review building types that are at risk during an earthquake in Santa Barbara County. It will also identify courses of action that can be taken to lessen impacts to structures and injuries to inhabitants.

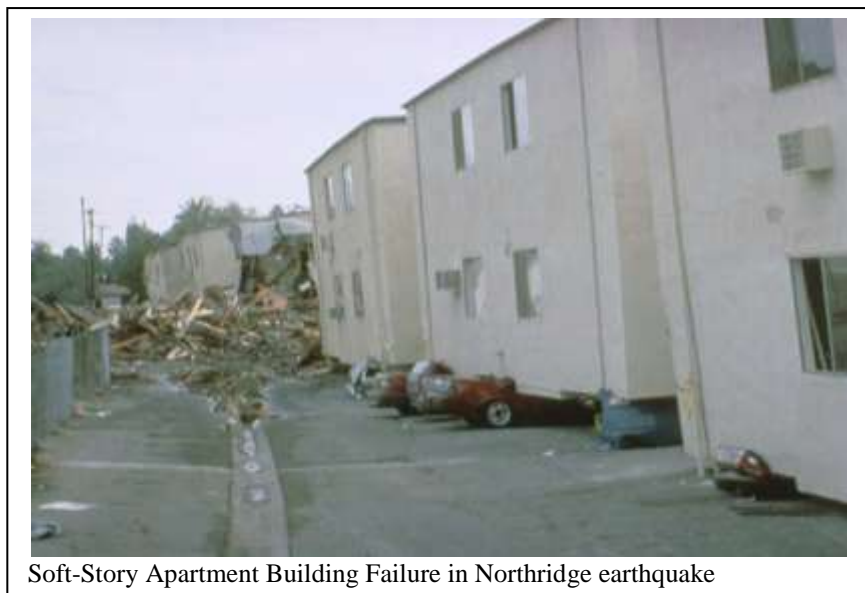
Soft-story buildings typically have drastically reduced stiffness at certain floors (called soft or weak floors). Usually, the soft story is caused because the walls that resist earthquakes are eliminated at the soft or weak floor to provide for open floor plans. A common type of soft-story building is an apartment building with tuck under parking. The soft floor sustains most of the building deflection and damages. Many early apartment buildings were built without any earthquake design

Soft-Story Apartment Building Failure in Northridge earthquake

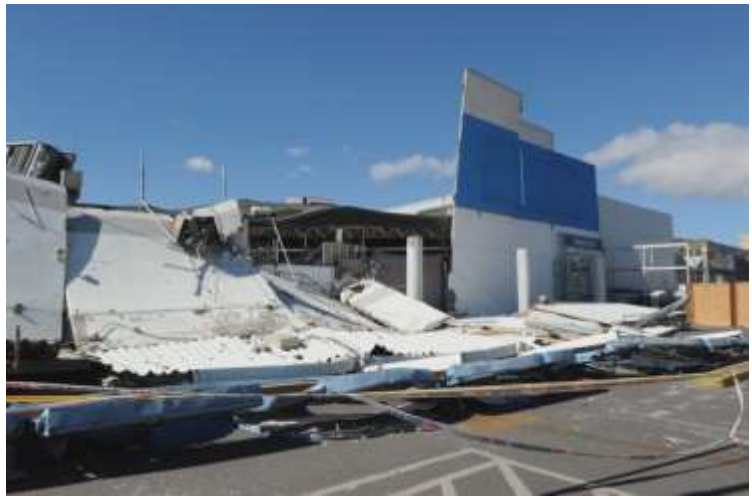
Concrete and concrete masonry buildings constructed prior to the standards that became effective with 1973 edition of the Building Code, typically had vulnerability to earthquake forces at the connections of walls to roofs and floors. Plywood of roofs and floors of these buildings were typically connected to walls with nails to a wood ledgers and wood ledgers were connected to wall with steel anchor bolts. This connection caused the ledgers to be stressed in the weak axis during earthquake, causing failure of the ledger and separation of the roof and floor from the walls. In an earthquake, these buildings often experience partial or total collapse of walls and collapse of roofs that were supported by the wall.

Tilt-up Building Collapse

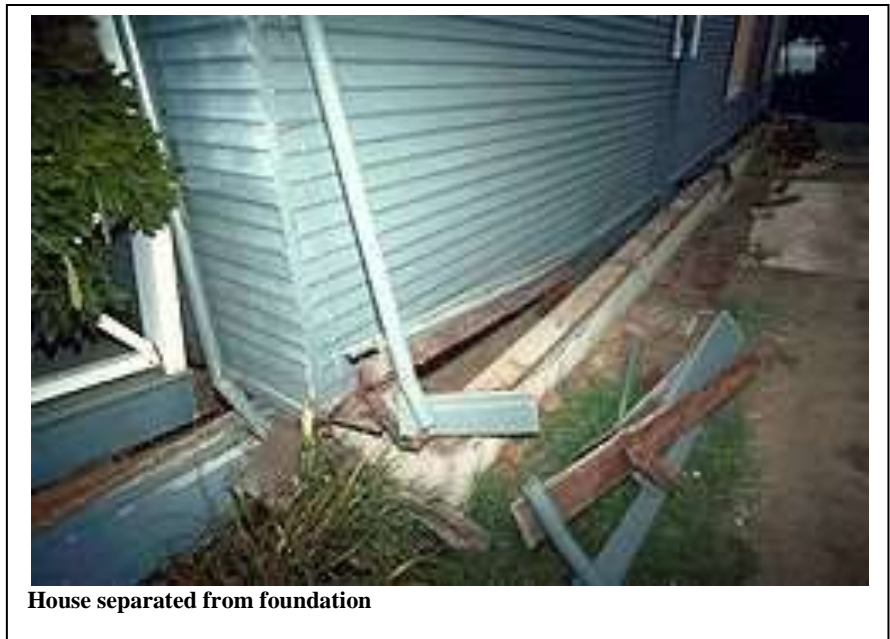
Many pre-1950 houses do not have proper bracing walls in the crawl space and/or walls are not secured to the foundation causing them to deflect excessively and fall off the foundation during a medium to strong earthquake. These weaknesses are exacerbated on hillside houses with taller cripple walls. Cripple walls are that portion of the exterior wall between foundation and the first floor. In pre-1950 houses, cripple walls typically have no sheathing on their interior face and are commonly weaker than the portion above the first floor.

These types of buildings constitute the majority of earthquake vulnerable buildings in the County. Retrofitting is relatively simple and consists of applying plywood to the walls of crawl spaces and bolting the sill plate of these walls to their foundation. The performance of these types of buildings can improve significantly once retrofitted. Although most owners opt to retrofit their house during major additions or alterations, there is rarely any proactive seismic retrofit.

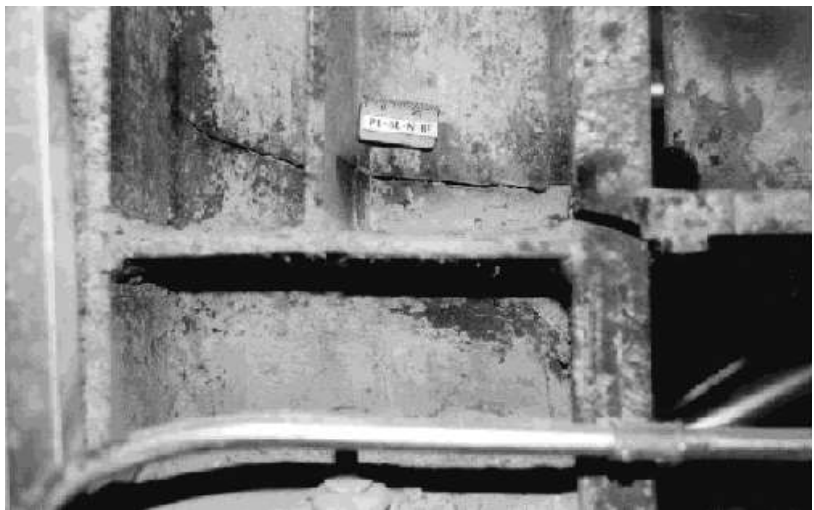
The Northridge Earthquake revealed a serious weakness in connection of steel frames. Following the Northridge earthquake the building code has been changed to disallow these type of connections. Multi-story buildings with this type of connection can collapse in a large earthquake. Shorter buildings with this type of connection can also sustain damage in a major earthquake, but their collapse is less likely.

Steel Moment Fracture Due to Earthquake

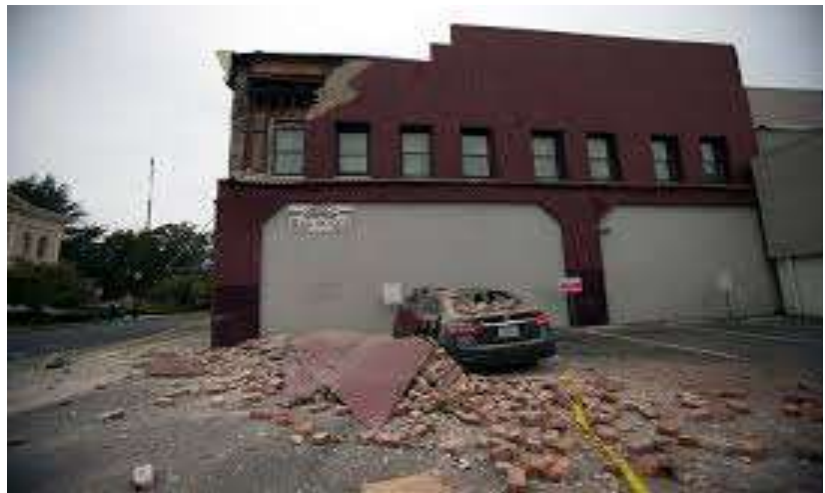
Unreinforced Masonry Buildings (URMs) are early 19th and 20th century buildings made of brick bearing walls with wood floors and roofs. A great number of these types of buildings were damaged and subsequently demolished in the 1925 Santa Barbara earthquake. The biggest hazard posed by these buildings is the separation and collapse of parapet walls (wall extending above a roof) and walls from the roof and floor.

Failure of URM Building
