**COUNTY OF SANTA BARBARA  
PLANNING AND DEVELOPMENT**

**MEMORANDUM**

**RE:** Pearl Chase Society Appeal (Case No. 14APL-00000-00006) of Decision by Historic Landmarks Advisory Commission Regarding County Landmark #34, Juarez-Hosmer Adobe, First Supervisorial District

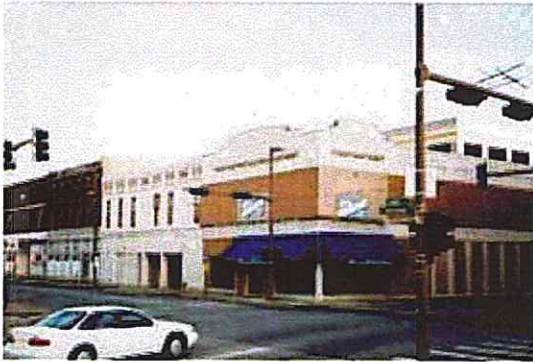
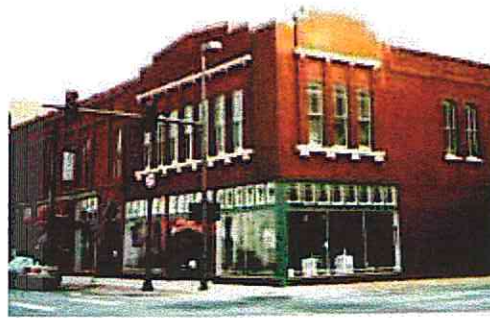
*This two-story brick commercial building—with its corner storefront—was originally constructed ca. 1876, then remodeled in 1916 in the Craftsman style and given a new, distinctive roofline. It served a number of uses, including a hotel, boarding house, saloon, restaurant, liquor store, warehouse, and office furniture showroom. The red brick walls had been painted several times over the years. Rehabilitation work included removal of multiple paint layers using a chemical stripper and thorough water rinse; spot repointing with matching mortar; and appropriate interior alterations. The building is now being used as a retail shop. Photos: NPS files.*

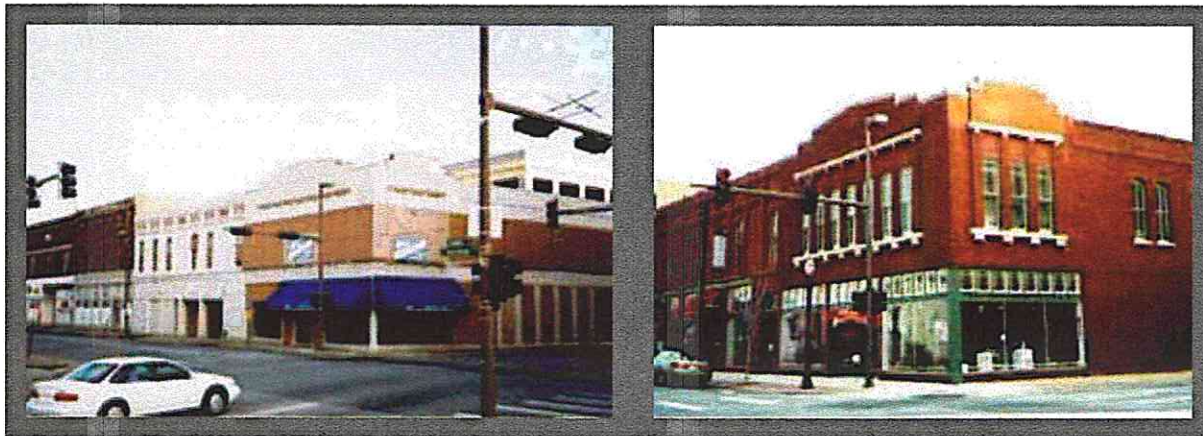
*This two-story brick commercial building--with its corner storefront--was originally constructed ca. 1876, then remodeled in 1916 in the Craftsman style and given a new, distinctive roofline. It served a number of uses, including a hotel, boarding house, saloon, restaurant, liquor store, warehouse, and office furniture showroom. The red brick walls had been painted several times over the years. Rehabilitation work included removal of multiple paint layers using a chemical stripper and thorough water rinse; spot repointing with matching mortar; and appropriate interior alterations. The building is now being used as a retail shop. Photos: NPS files.*

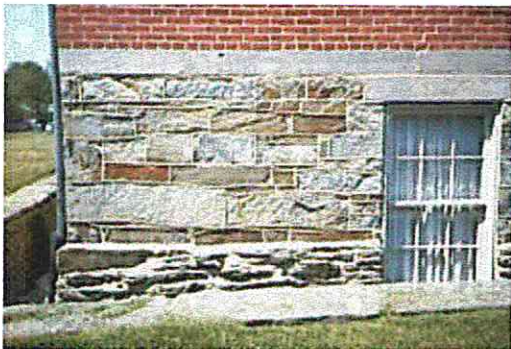
*The variety and arrangement of the materials is important in defining the historic character, starting with the large pieces of broken stone which form the projecting base for the building walls, then changing to a wall of roughly rectangular stones which vary in size, color, and texture, all with projecting beaded mortar joints. Changing the raised mortar joints, for example, would drastically alter the character. Photo: NPS files.*

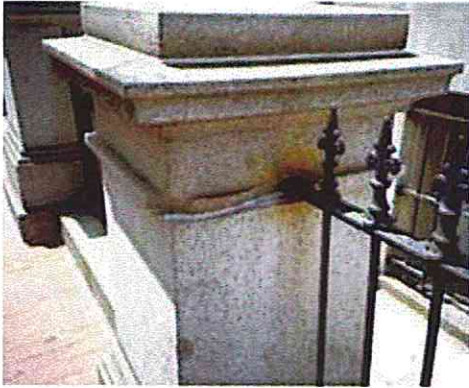
*The iron stain on this granite post may be removed by applying a commercial rust-removal product in a poultice.  
Photo: NPS files.*

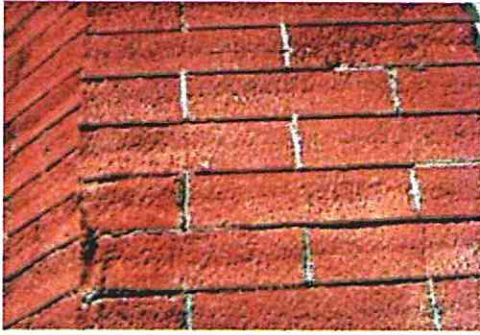
*Abrasive cleaning methods include all techniques that physically abrade the building surface to remove soils, discolorations or coatings. Sandblasting has permanently damaged this brick wall. Photo: NPS files*

Cleaning masonry surfaces without testing or without sufficient time for the testing results to be of value. Historic brick damaged by sandblasting.

Sandblasting brick or stone surfaces using dry or wet grit or other abrasives. These methods of cleaning permanently erode the surface of the material and accelerate deterioration.

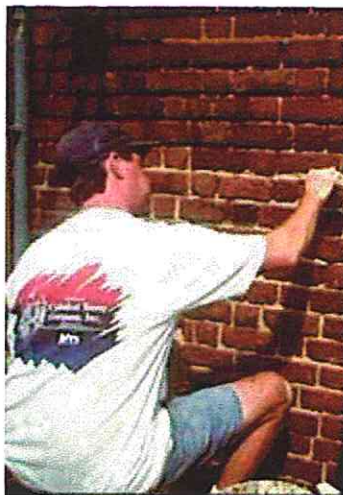
*Mortars for repointing should be softer or more permeable than the masonry units and no harder or more impermeable than the historic mortar to prevent damage to the masonry units. This early 19th century building is being repointed with lime mortar. Photo: John P. Speweik.*

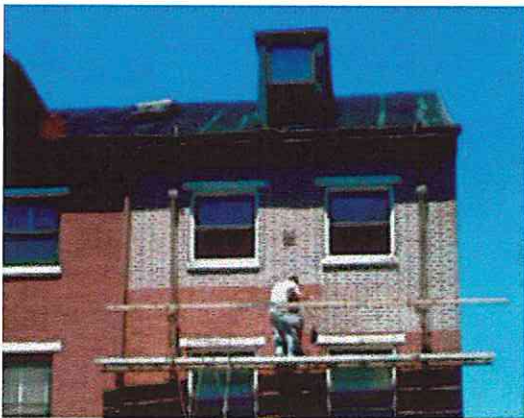
*Some aspects of a building's visual character are fragile and are easily lost. This is true of brickwork, for example, which can be irreversibly damaged with inappropriate cleaning techniques or by insensitive repointing practices. The historic character of this front wall is being dramatically changed from a wall where the bricks predominate, to a wall that is visually dominated by the mortar joints. Photo: NPS files.*
