From:	Paulina Conn <pconnt43@cox.net></pconnt43@cox.net>
Sent:	Tuesday, February 17, 2015 8:43 AM
То:	Carbajal, Salud; Wolf, Janet; Farr, Doreen; Adam, Peter; Lavagnino, Steve; sbcob
Subject:	Mission Canyon safety and frustrations

February 17, 2015

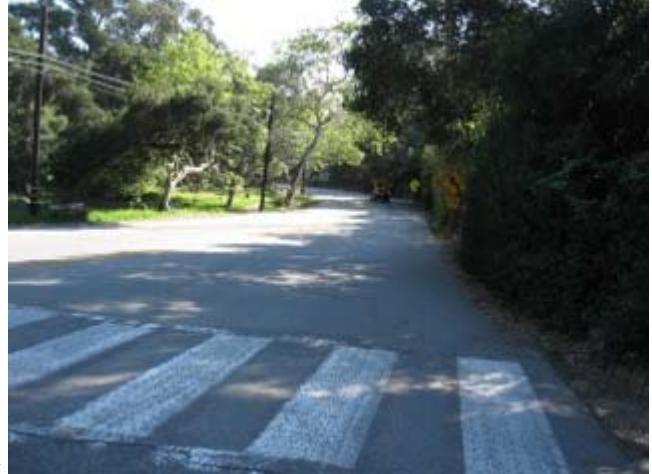
#1. IMG_7460 photo by paulina 2-16-15, 2:45 PM. Looking south on Mission Canyon Rd. at the south crosswalk at Las Encinas Rd. Vehicles are going at least 35 MPH at this intersection and often faster. There is only about 250 feet, maybe 300 feet between the

single partially hidden 20MPH CURVE sign and the curve. Brake lights are not put on until going past the curve. Paved road is too wide here so drivers go too fast. Hedge hides 20MPH sign. Crosswalk to Museum at Puesta del Sol is seen in the distance with yellow Ped. Xing sign. Note arrow sign too, indicating road goes left. A huge 20MPH sign should be here as it is visible from way up Mission Canyon Rd. The stegosaurus wall that has been hit several times in the last year begins at the arrow sign.

1. Stop vehicles from crashing into the Stegosaurus wall.

a. Make the one and only 20 MPH CURVE sign visible. Add another giant 20 MPH CURVE at the ARROW sign at the Puesta del Sol intersection. This second sign would be visible for a long distance with nothing able to obscure it.

b. put in speed humps from the bridge all the way to Las Encinas Rd. on Mission Canyon Rd.

c. Do NOT change the camber of the road. This section is finally water free on rainy days. The rain drains through a hole in the stegosaurus wall on the west and into a drainage box at Rocky Nook Park on the

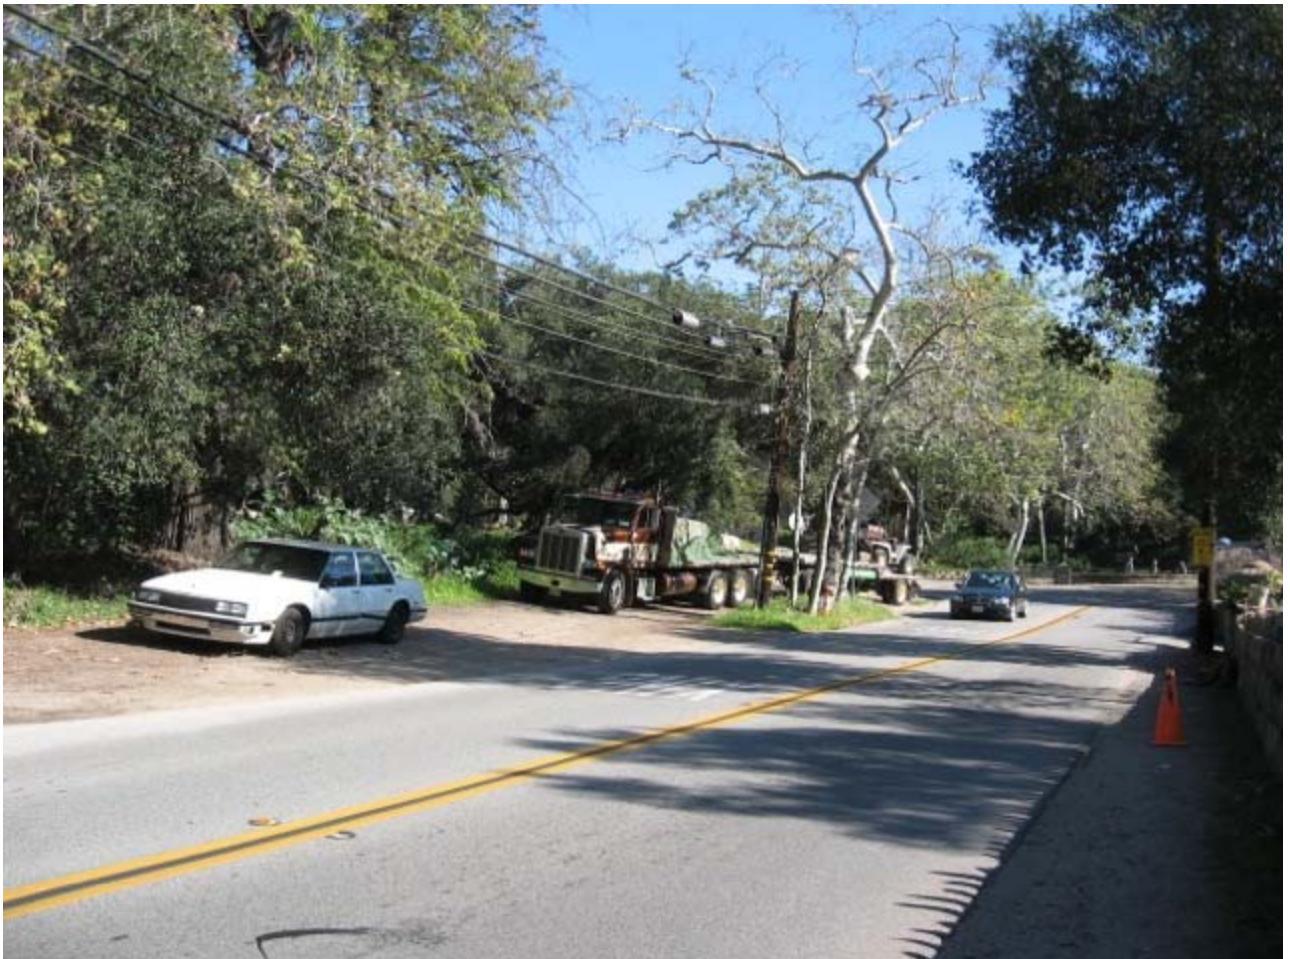
#2. IMG_7434 photo by paulina, 2-16-15, 2:45 PM. Looking south on Mission Canyon Rd. from the stegosaurus wall (being repaired) on the west side of the road. A few boulders placed along the road at the entry to this broad area in front of Rocky Nook Park would prevent vehicles from parking here, on the pedestrian path, without putting up no parking signs. It would be aesthetically acceptable as this is a scenic corridor on the Mission Canyon Community Plan.

2. Prohibit off-street parking along Mission Canyon Rd. especially at Rocky Nook Park. How?

a. Put some boulders in strategic places to prevent parking.

b. or put in drought tolerant plants that a fire truck could drive over in an emergency.

c. or put up a rustic removable fence.

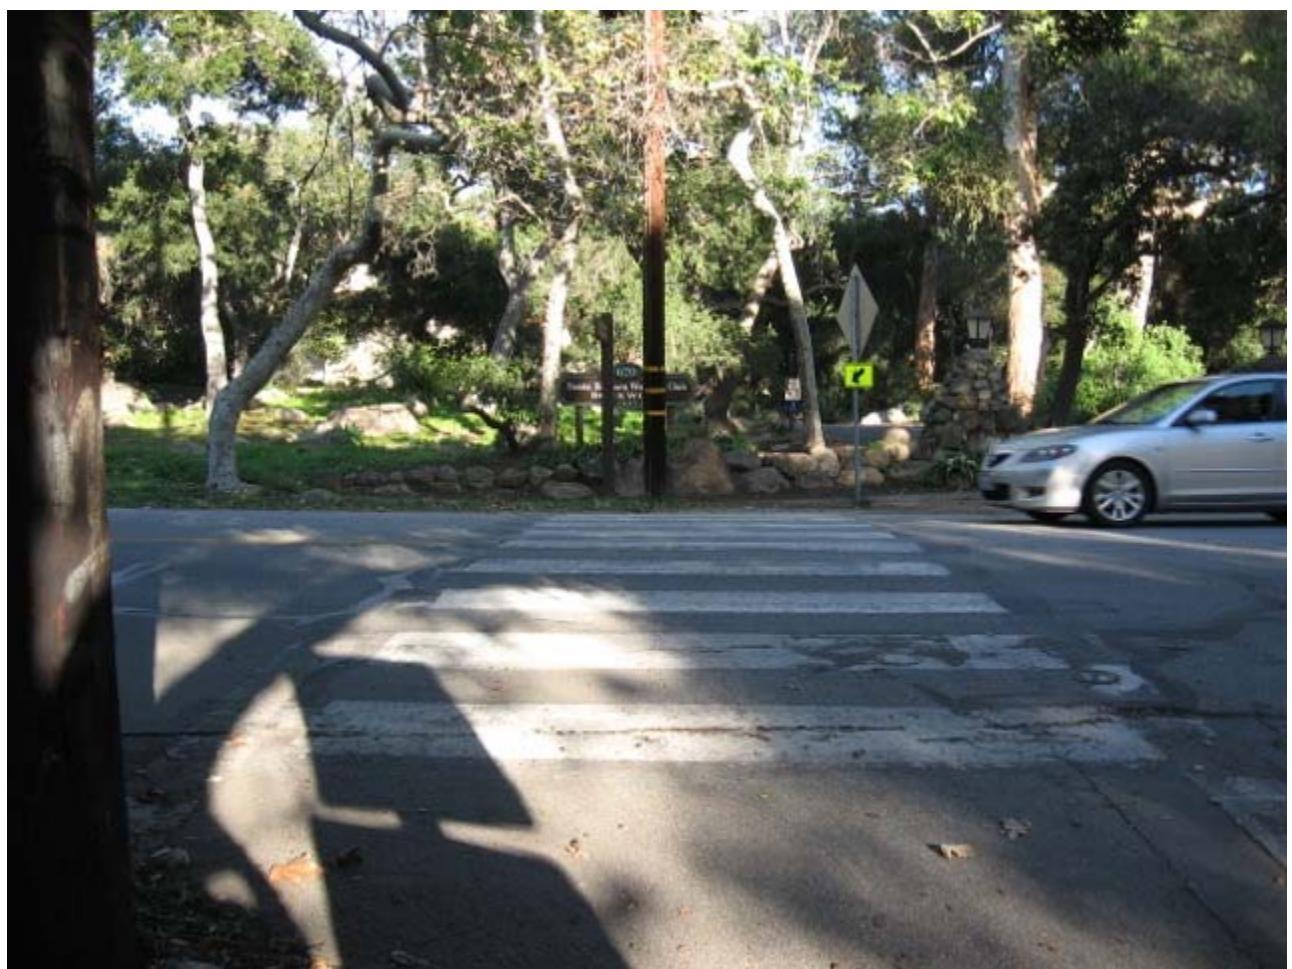
#3. IMG_7299 photo by paulina 2-9-15, 4:30 PM. Crosswalk to east side of Mission Canyon Rd from the north side intersection with Puesta del Sol. the Museum of Natural History is on the south west side of Puesta del Sol. Visible across the street in this photo is the Rockwood Woman's Club. Note that on the north west side from here there is a phone pole blocking visibility. Note that across the street there is also a phone pole and a sign pole in the line of sight. Vehicles speed here in both directions. To slow traffic down, the road could be visually and actually narrowed with fog lines, rustic fencing, boulders or plantings. A stop sign could be put in for south bound traffic on Mission Canyon Rd. at the Las Encinas intersection.

3. Make crosswalk at Puesta del Sol (Museum is on this road) and Mission Canyon Rd. a safer crossing.

a. Put in speed humps between the bridge and Puesta del Sol. But be careful not to block drainage should we ever get rain again.

b. Put speed humps between Puesta del Sol and Las Encinas on Mission Canyon Rd.

c. Improve visibility for pedestrians if possible. Tree canopies can be pruned. Phone pole and sign moving is more difficult and costly.

d. Narrow Mission Canyon Rd. visibly with fog lines and actually with barriers such a boulders, removable rustic fencing or drought tolerant plantings.

e. Put a stop sign on the north side of the Las Encinas intersection on Mission Canyon Rd. going south.

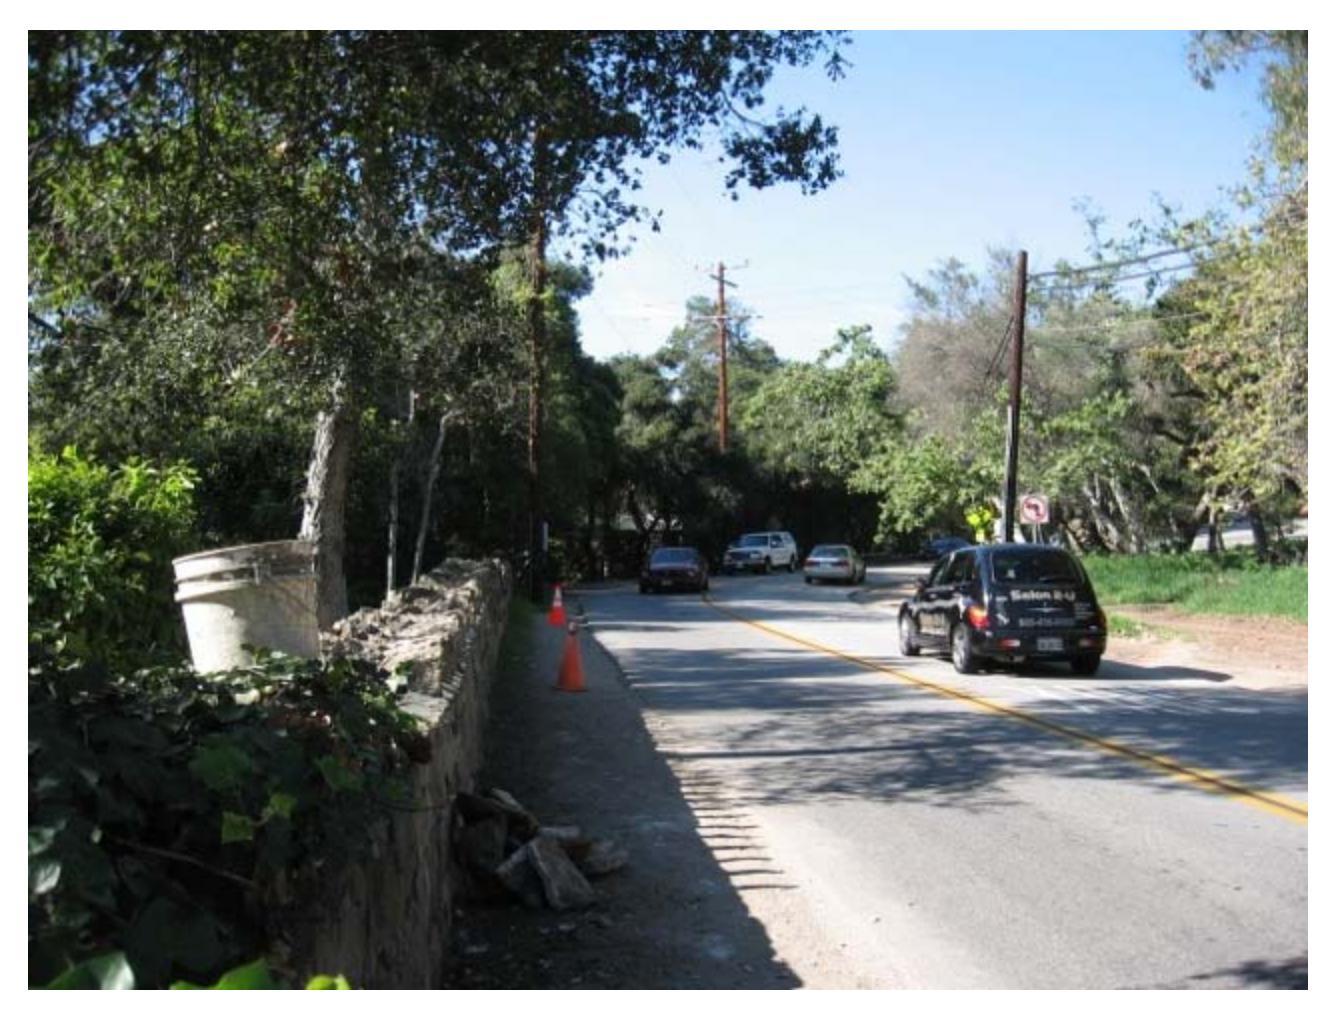
Photo for #1,#2,and #3. IMG_7436Photo by paulina 2-16-15, 2:40 PM Looking north on the west side of Mission Canyon Rd. in front of the stegosaurus wall at 609 MC Rd. Wall is being repaired after two accidents on 2-7-15. The wall is 48" high. Drivers do not obey the 20MPH Curve sign if they see it. There is only one sign and it is about 300 feet or less from the curve. The crosswalk to the Museum of Natural History is at the bend where the yellow diamond shaped sign is. The path on the right is often covered by parked cars.
