**GAP FIRE  
EMERGENCY WATERSHED RESPONSE PLAN  
August 2008**

**Santa Barbara County  
Public Works Department**

# Introduction

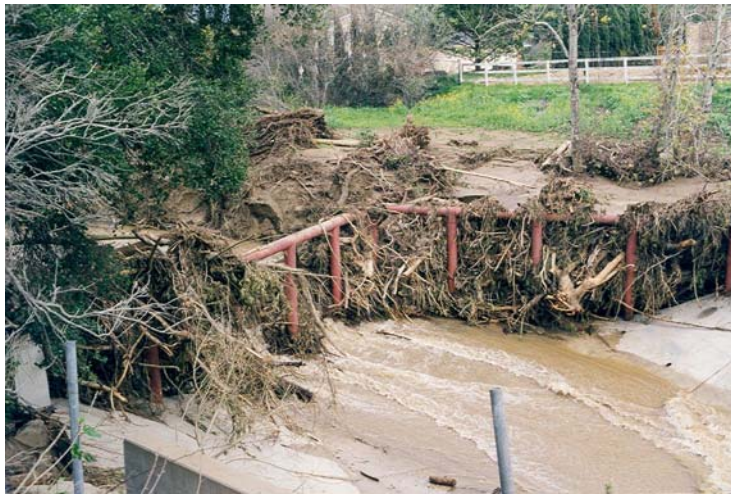
During the fall, additional debris rack locations may be identified based on risk and access. One rack currently exists on Tecolote Creek below Rancho Embarcadero; a photo of this facility is shown below in Figure 2.

**Figure 2 – Existing Debris Rack on Tecolote Creek during the 1998 Floods**

Prior to winter, five large woody debris racks, also called “Grizzlies,” are planned, one each on Ellwood Creek, Tecolotito Creek, Carneros Creek, San Pedro Creek, and Las Vegas Creek. The proposed locations of these facilities are shown in Appendix B. No debris rack is proposed on San Jose Creek because a relatively low percentage of the watershed was burned and San Jose Creek generally has a higher channel capacity and lacks restrictive culverts.

Throughout the winter, especially after individual storms, the debris racks will be inspected and cleaned of debris as necessary. The racks are cleaned using a small hydro-crane or cable winch truck. Captured vegetation will be temporarily stockpiled until it can be moved to a disposal site.

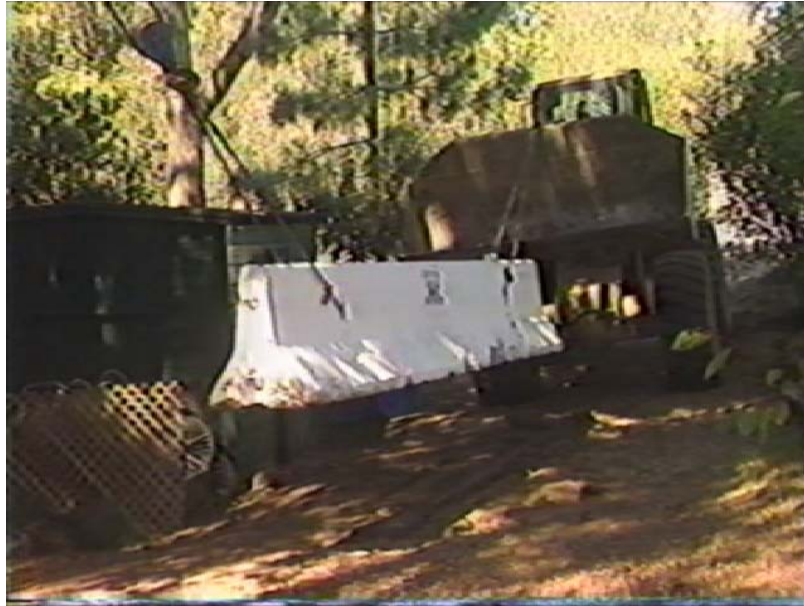
**Figure 3 – Placement of K-Rail after the Painted Cave Fire in 1990**

Three critical locations have been identified for additional protective measures. Criteria for locating protective measures are 1) a relatively high level of risk resulting from the proximity of the site to affected creek channels; 2) documented historic flooding problems; and 3) feasibility of treatments that will provide an increased level of flood protection. Currently, the areas proposed for additional protective measures are: Los Carneros Road area at Calle Real, along San Pedro Creek near Calle Real, and at the end of Camino Rio Verde. The treatments include the use of K-Rail barriers, sandbags, berms, and culvert improvements as appropriate. Additional treatment locations may be added in the future. Figure 3 below shows similar work undertaken after the Painted Cave Fire in 1990. Locations of the proposed protective measure sites are shown in Appendix C.

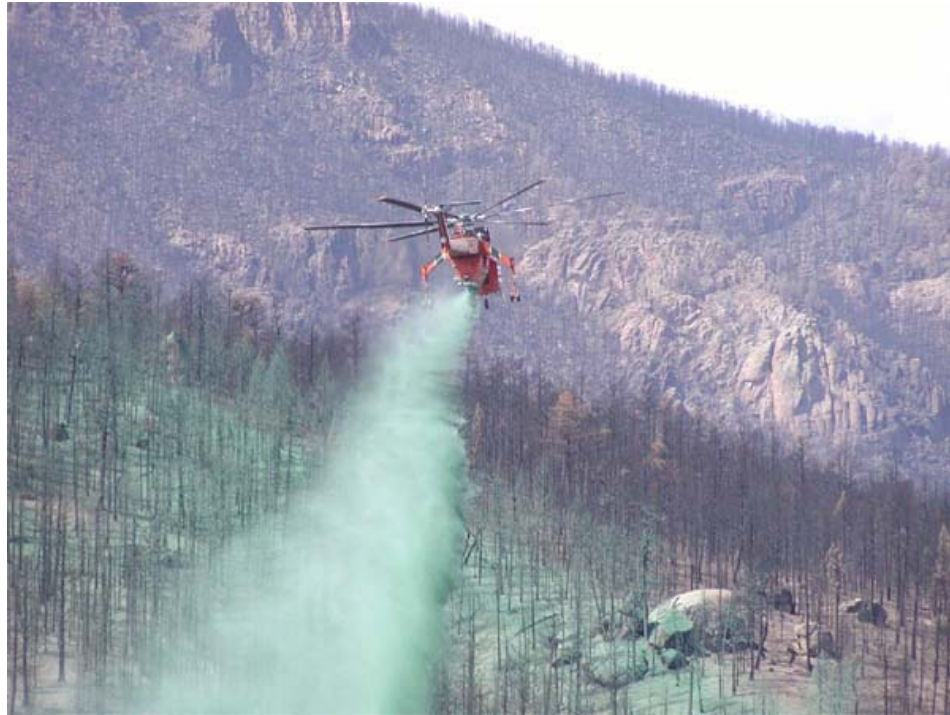
**Figure 4 – Aerial Hydromulching (USFS, Colorado 2002)**

One fire mitigation measure proposed by the USFS is hydromulching of federal lands within the burn area where slopes have a gradient of 60% or less. Hydromulching is a treatment of organic mulch with the addition of a tackifier to help bind the mulch in place. The hydromulch would be applied by air.

The USFS will be making arrangements with a contractor for the aerial hydromulching of federal lands and has indicated that they would also make this treatment available to qualifying lands outside the USFS jurisdiction on a reimbursable basis, using the same contractor and thus utilizing the economy of scale and mobilization. If approved by the NRCS (NRCS would cover 75% of the cost), aerial hydromulching is planned for non-federal lands where slopes are less than 60% and the land cover is not urban or orchards. The proposed area to be treated is subject to approval by land owners and funding made available by the NRCS. Figure 4 is a photo of the application of aerial hydromulch by the USFS in Colorado.

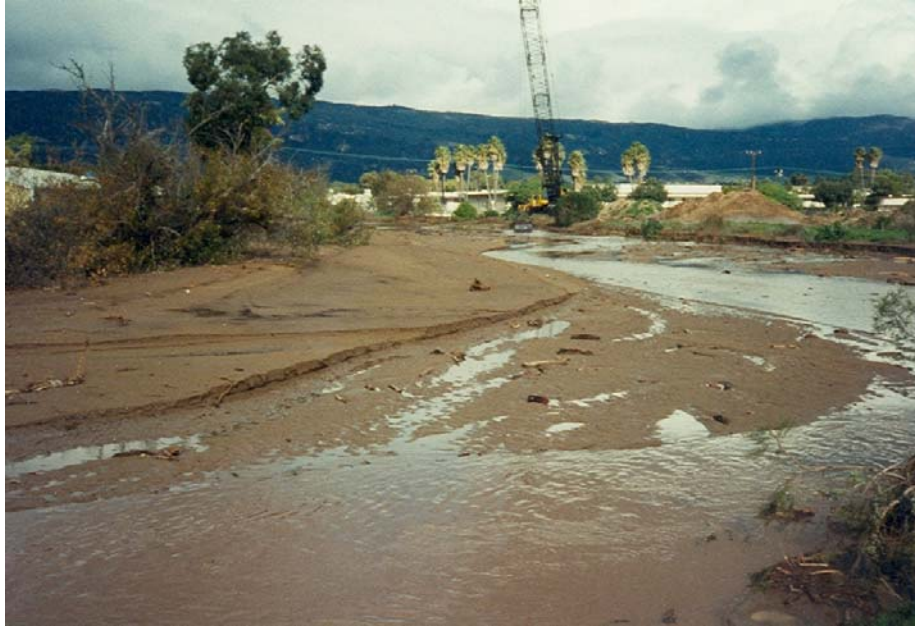
Figure 5 below shows desilting of the Carneros Sediment Basin in 1995.

**Figure 5 – Carneros Creek Sediment Basin, 1995**

On-going dredging of the airport sediment basins will be a necessary and essential element of this winter's response efforts. Without active dredging, the channels will clog with sediment, resulting in reduced capacities. It is possible that the basins could be overwhelmed in a single rain event, in which case immediate emergency desilting will be required.

Excavation of the basins is accomplished by large heavy cranes and possibly assisted by larger long-reach excavators. Sediment is temporarily stockpiled and then removed to make room for more material as the operation continues.
