# **SOILS ENGINEERING REPORT AND ENGINEERING GEOLOGY INVESTIGATION**

October 7, 2015  
Project No. SB00314-3

Subject: **Response to Design Modifications - Revised Building Locations and Grading Design**  
Tajiguas Resource Recovery Project  
Tajiguas Landfill, 14470 Calle Real, Santa Barbara County, California

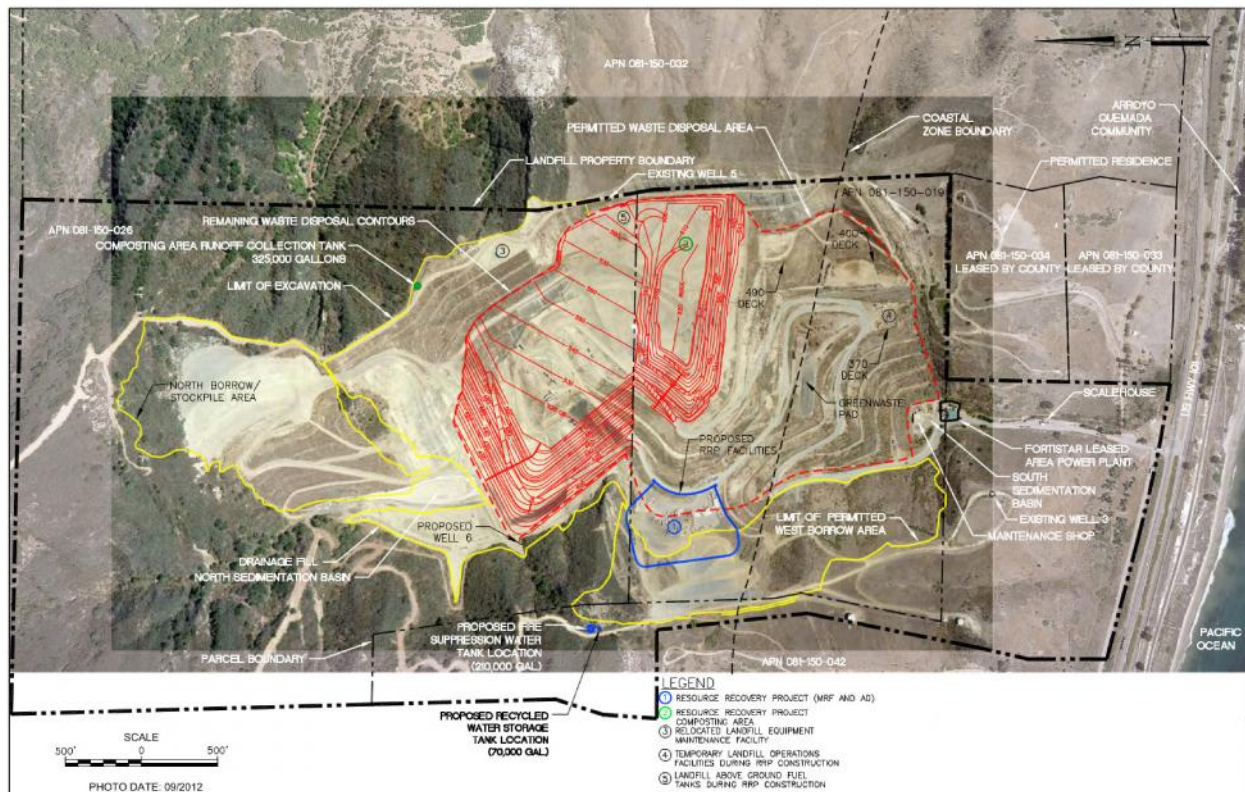
**Figure 2: Project Facilities Plan**

The Tajiguas Resource Recovery Project would modify current waste management operations at the Tajiguas Landfill by the addition of a Materials Recovery Facility (MRF) and Dry Fermentation Anaerobic Digestion (AD) Facility.

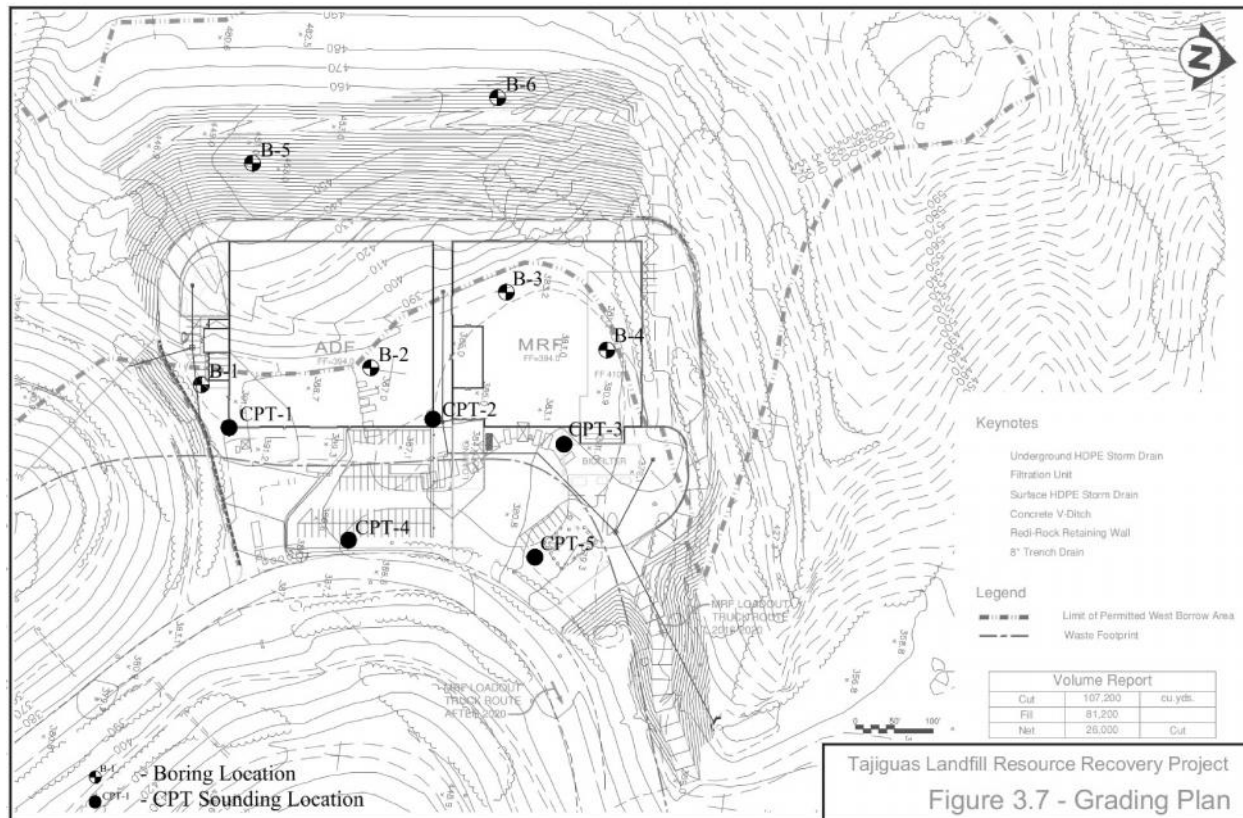
**Figure 3: CPT and Boring Locations**

Five CPT soundings were performed for this investigation on the operations deck. Two soundings were pushed within the refuse limits and three were pushed along the center of the operations deck. Soundings were pushed to termination depths varying from 33 to 107 feet bgs. Soundings were backfilled with bentonite chips.

Six borings were drilled during the investigation for this field study to determine the depth to formational units at the operations deck. The boring logs are presented in Appendix A. Boring B-1 encountered artificial fill in a slightly moist condition to a depth of 10 feet bgs. Boring B-2 encountered artificial fill to a depth of 25 feet bgs. Methane gas was detected in the four gas monitors while drilling Boring B-2. Boring B-3 encountered artificial fill to a depth of 25 feet bgs. Boring B-4 encountered artificial fill to a depth of 35 feet bgs underlain by siltstone units of the Rincon Formation to a termination depth of 40 feet bgs. Boring B-5 and B-6 were drilled utilizing NQ rock coring equipment on the upper bench of the west borrow slope. Boring B-5 encountered Rincon Shale from the surface to a termination depth of 65 feet bgs. Boring B-6 encountered Rincon Shale from the surface to a termination depth of 75 feet bgs. Borings were backfilled with bentonite powder and native cuttings.

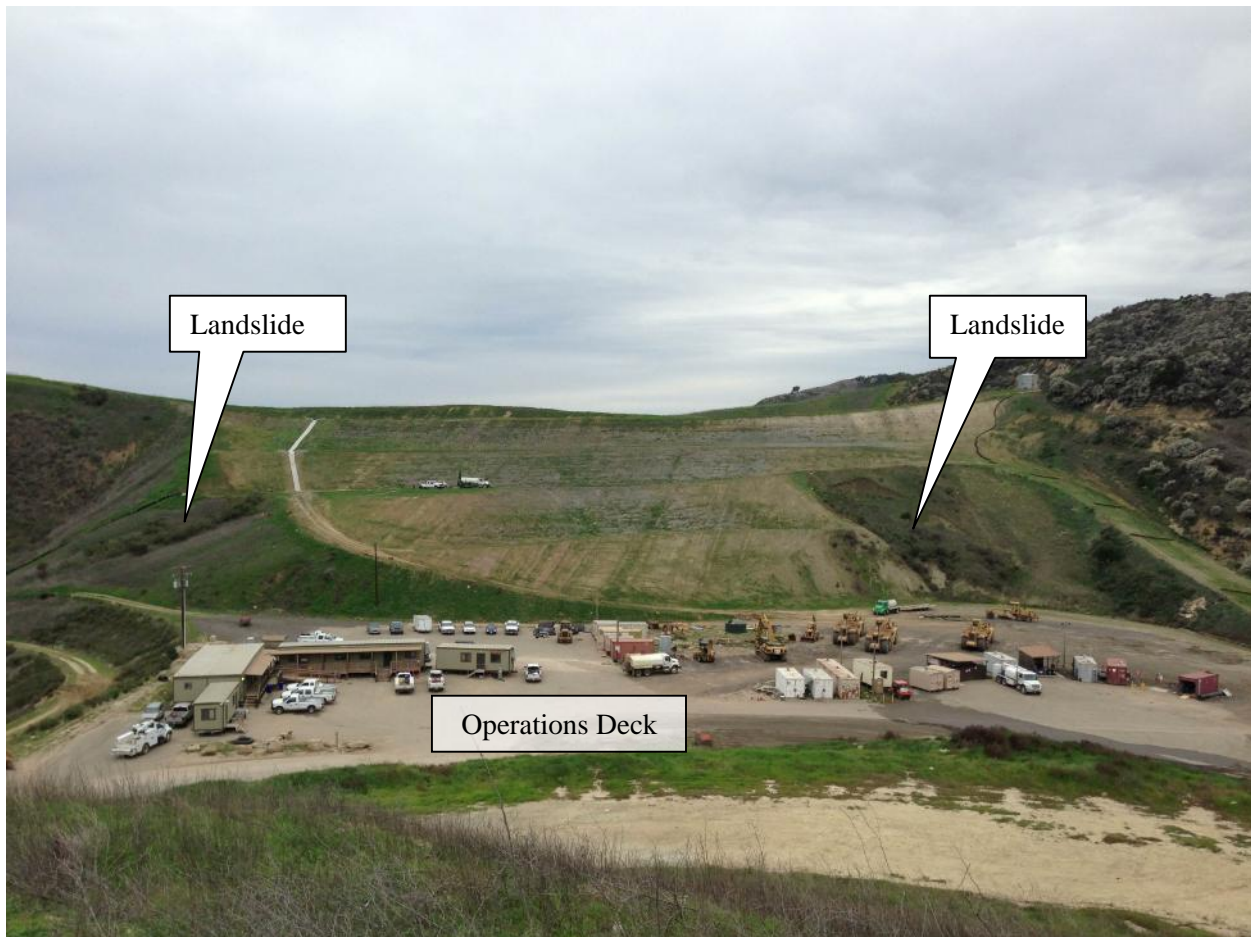
**Figure 4: Photograph of the West Borrow Slope**

The Rincon Shale is generally a weaker unit and prone to landslides when saturated, therefore within the Rincon Shale units there is a moderate potential for landslides. A slope stability analysis was performed on the proposed western cut slope and provides recommendations to maintain the stability of the slope as discussed in Section 6.0. Due to the character of the Vaqueros Sandstone and Sespe Formation, there is a low potential for landslides within these units.

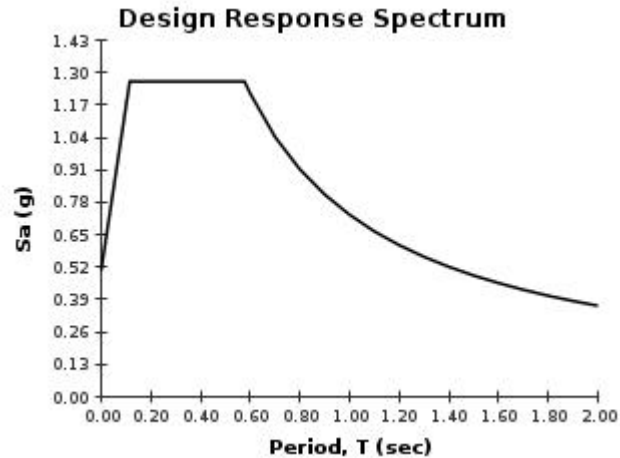
Figure 6: Design Response Spectra – 2010 CBC

According to section 11.4.5 of ASCE7 (ASCE, 2006), a design response spectrum for a site may be required in order to design structures to resist lateral forces caused by ground motions at the Site. The design spectral response acceleration parameters, listed in Table 3: 2010 California Building Code, Chapter 16, Structural Design Parameters, are used to produce the design response spectrum. The U.S. Seismic Design Maps application (USGS, 2012) was used to construct a design response spectrum for the Site, which is shown in Figure 6: Design Response Spectra – 2010 CBC.

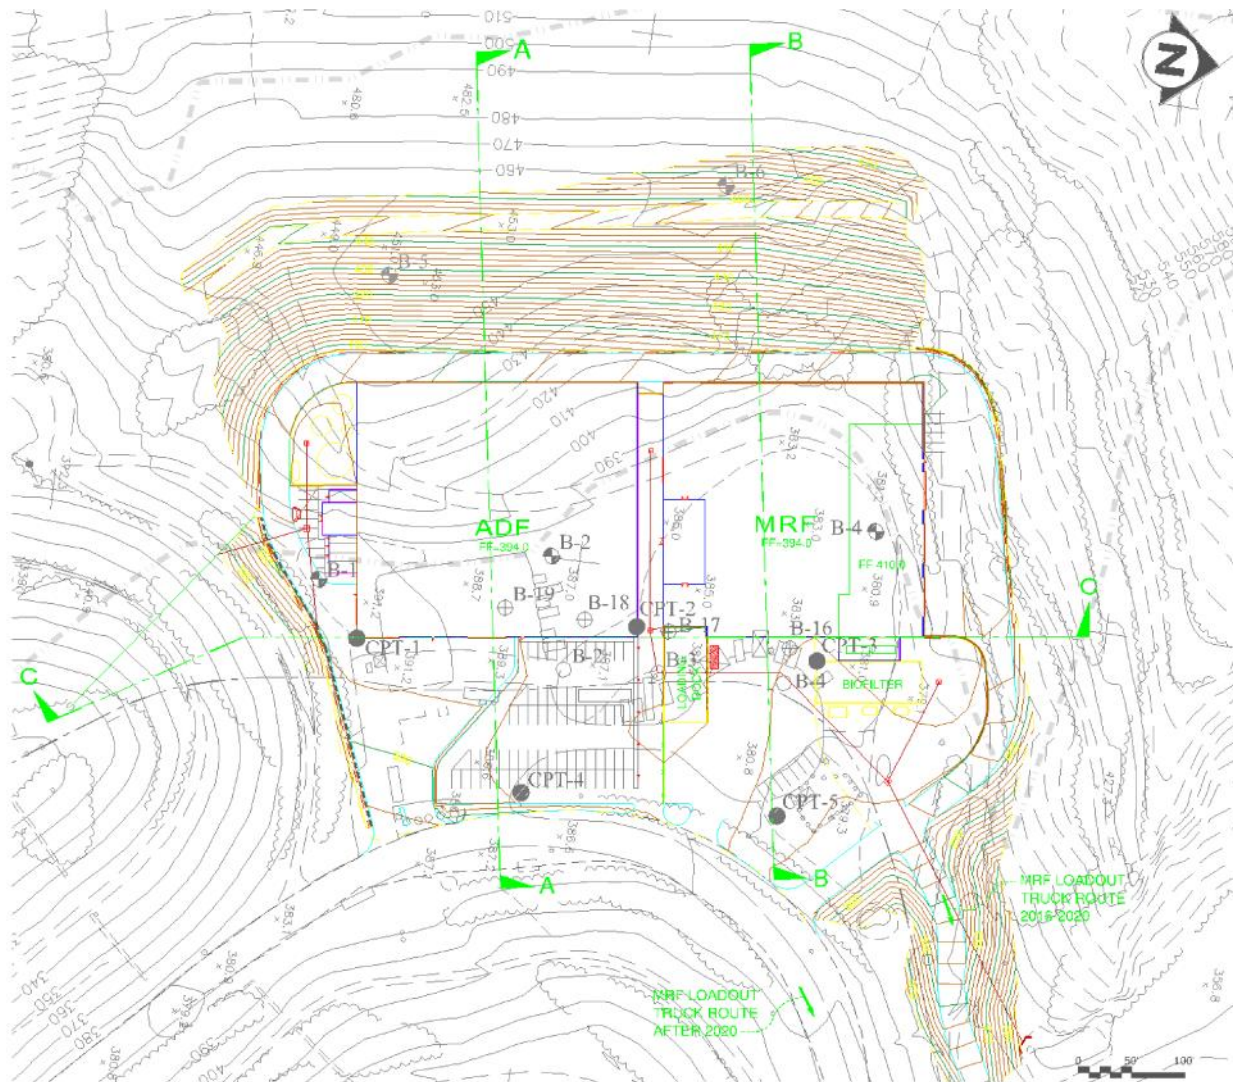
**Figure 7: Location of Cross Section Profiles through the Operations Deck.**

The numerical slope stability analysis was conducted for the site utilizing subsurface information derived from exploratory borings and CPT soundings, as illustrated on Figure 3. The slope stability analysis was conducted to ascertain stability of the subsurface materials. Profile A-A' and B-B' were obtained traversing through the west borrow cut slope (see Figure 7). Profile C-C' traverses through the proposed fill slope south of the operations deck (see Figure 7). Profile D-D' traverses through the existing fill slope west of the proposed maintenance building located on the eastern side of the canyon and the landfill. (see Figure 8).

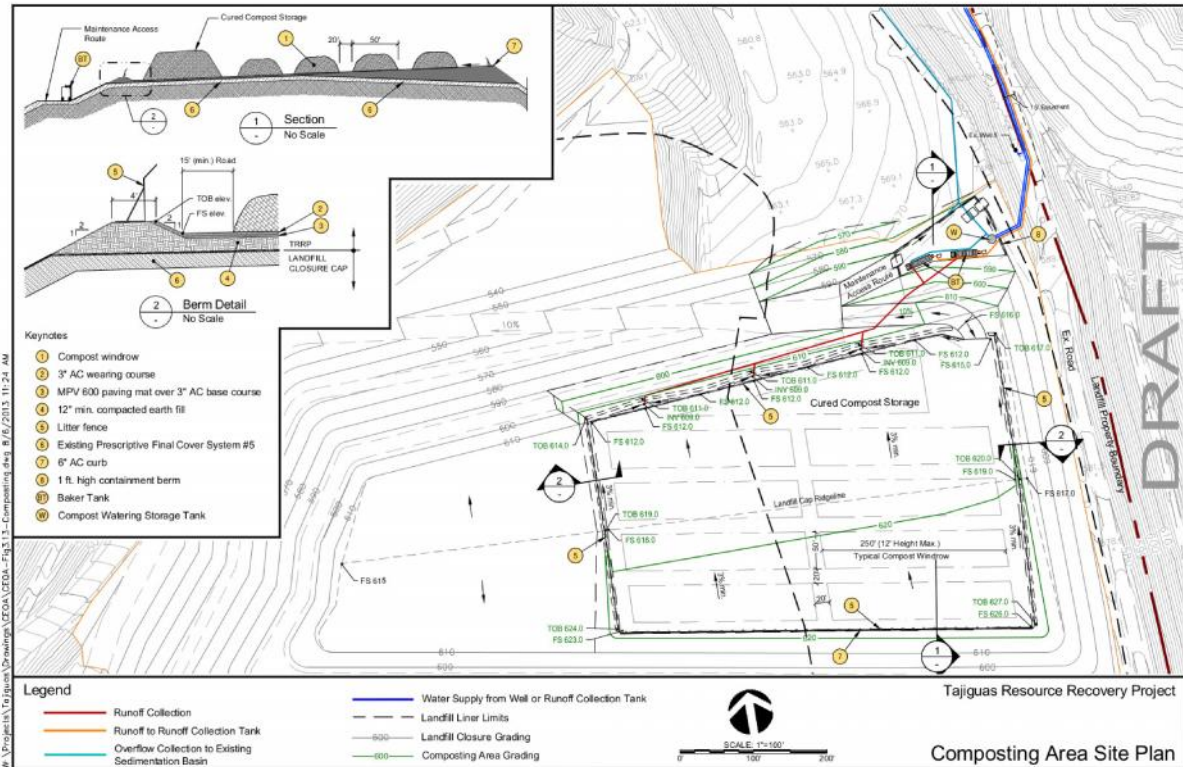
Figure 11: Composting Area

The composting area is located within an area of active landfilling. It is our understanding the composting area, also identified as the top deck, will receive up to 80 more feet of refuse and a final closure cover prior to be converted to a compost surface. Settlement monitors were installed along the west and south boundaries of the proposed top deck in January, 2012. Figure 11, depicts the proposed compost area.

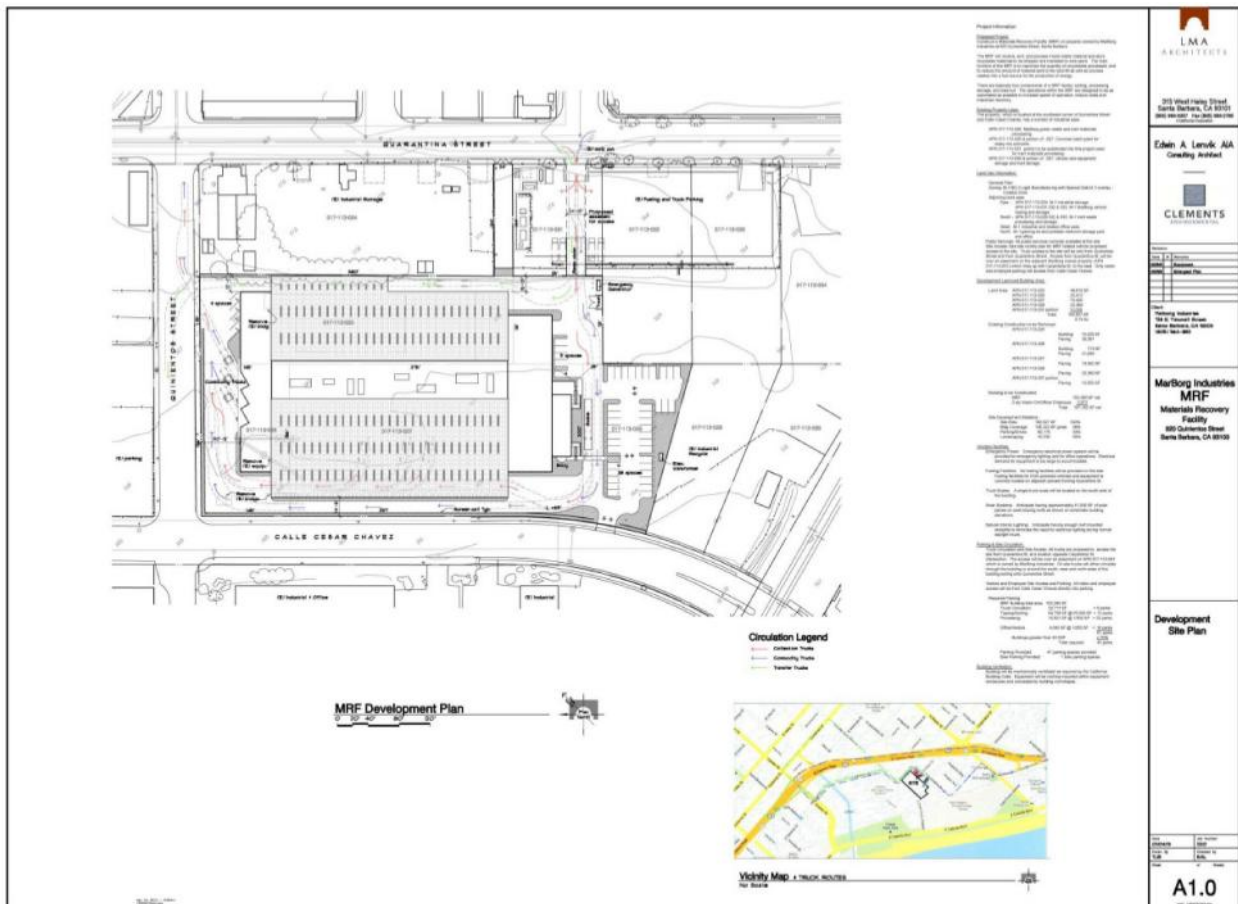
**Figure 12: Alternative B – MarBorg Industries Site Plan**

Grading quantities are based on the Conceptual Grading Plan by Penfield and Smith. Construction of the site will require import of approximately 13,950 C.Y. of soil or other structural fill to bring the building to the subgrades shown. There is no known contamination of the site.

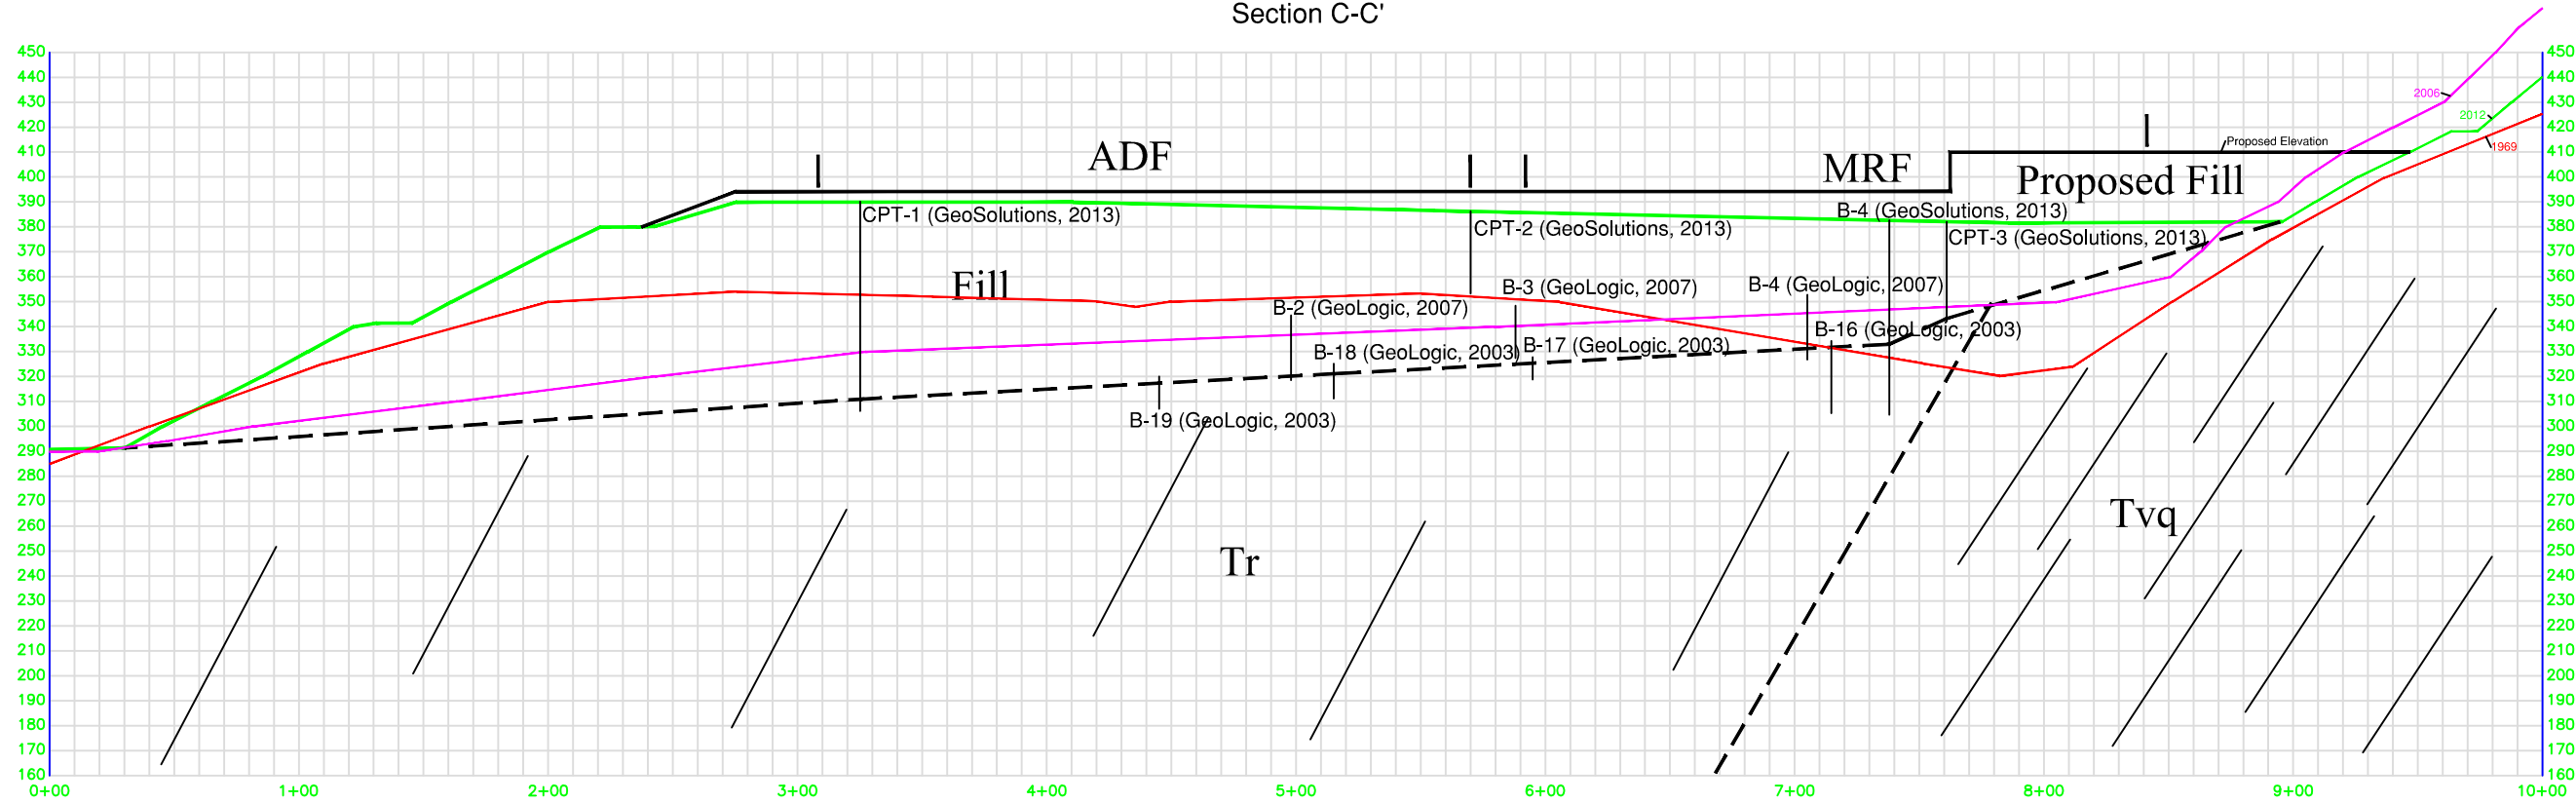
Section C-C'

- Legend**
- Fill Artificial Fill
  - Tr Rincon Shale
  - Tvq Vaqueros Sandstone
  - Contact (dashed where approximate)
