ATTACHMENT 11

Goleta Beach Storm Events and Park Loss

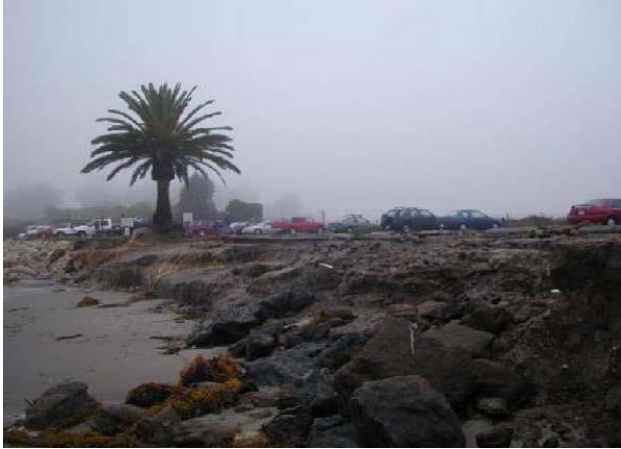
Storm wave action –
34 parking spaces lost

Approximately 9,100 square feet of paving comprising 34 parking spaces had eroded away completely. With damages that occurred during the January 2005 El Nino event, Parks and Public Works received FEMA funding to repair and reconstruct the remaining parking area. Emergency rock revetment was placed along the western end of the park to protect remaining parking area from further erosion.

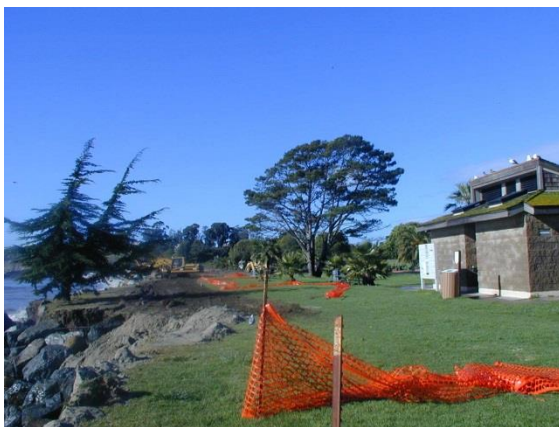
Park Erosion at existing restroom – 2002

The above picture illustrates a loss of approximately 41,000 square feet of lawn (almost one acre).

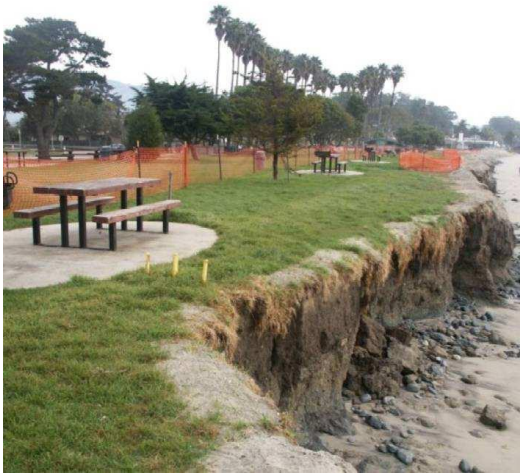
Family Picnic Tables and adjacent storm damage

There were 21 picnic sites at the park, many of which are reserved for group activities during the year. Eight of those family picnic sites have been permanently lost since 1998. In 2000, three picnic sites and an accessible viewing area were lost completely due to the erosion experienced during the storm season. These tables were permanent structures (i.e. non-removable) and have since been replaced with removable tables in other areas of the park.
