DOS PUEBLOS CREEK RESTORATION, MAINTENANCE AND MONITORING PLAN

JUNE 2015

PREPARED FOR:
California Rangeland Trust
1225 H Street
Sacramento, California 958149

PREPARED BY:
DUDEK
621 Chapala Street
Santa Barbara, CA 93101

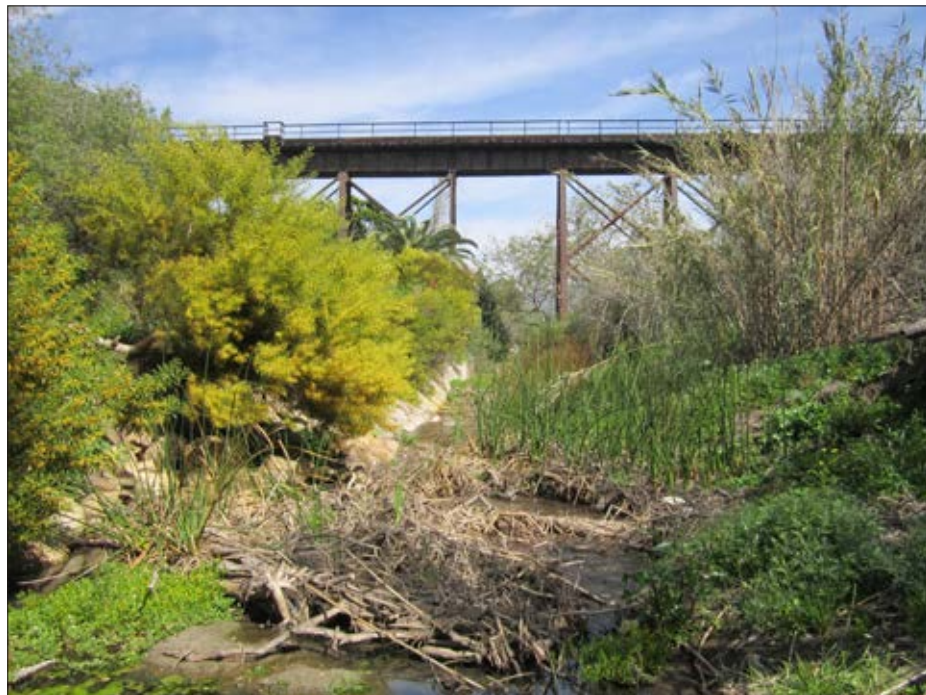
Photo 4: Concrete channel exotics giant reed and acacia looking north towards tressle

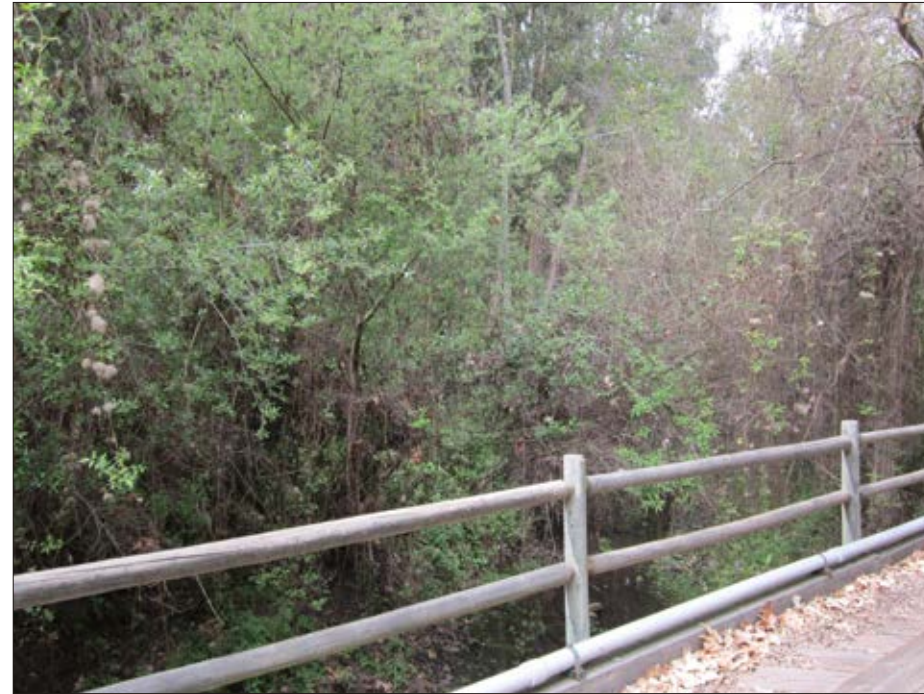
Photo 2: Upstream of beach access road bridge

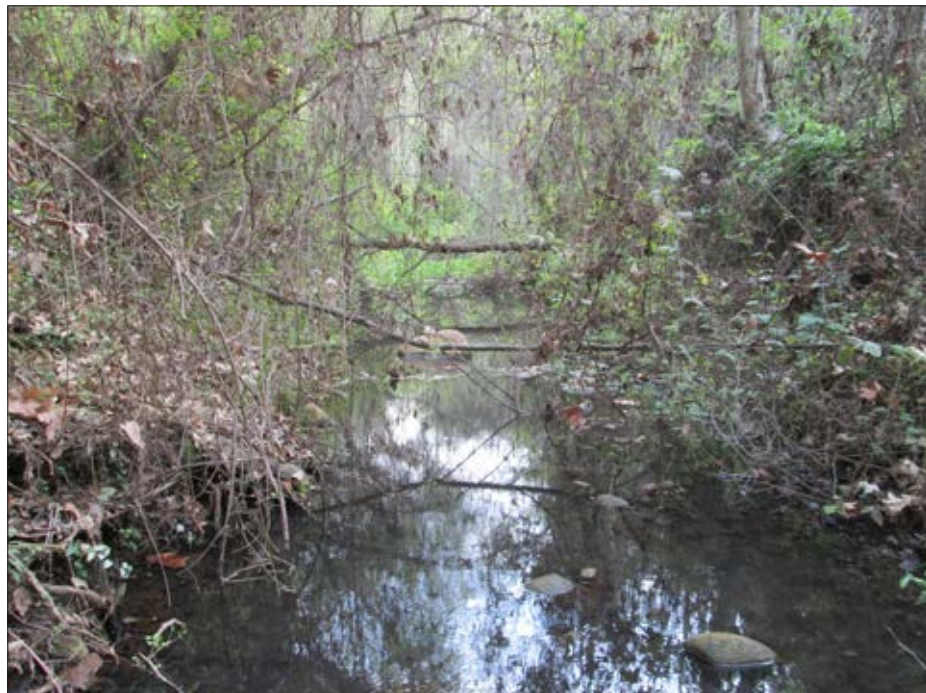
Photo 4: Looking upstream at lower creek area

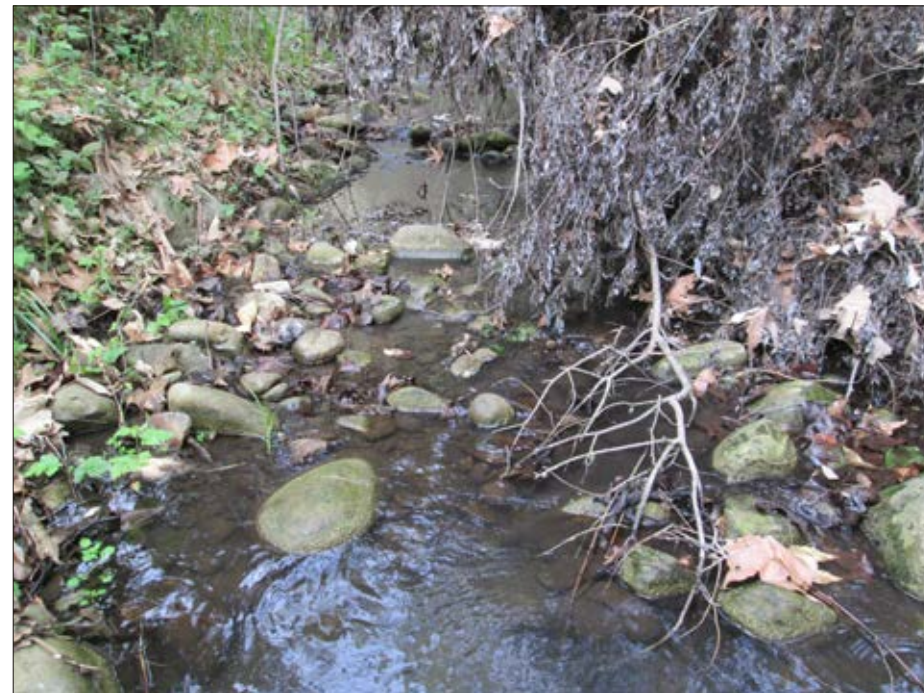
Photo 5: Typical creek condition

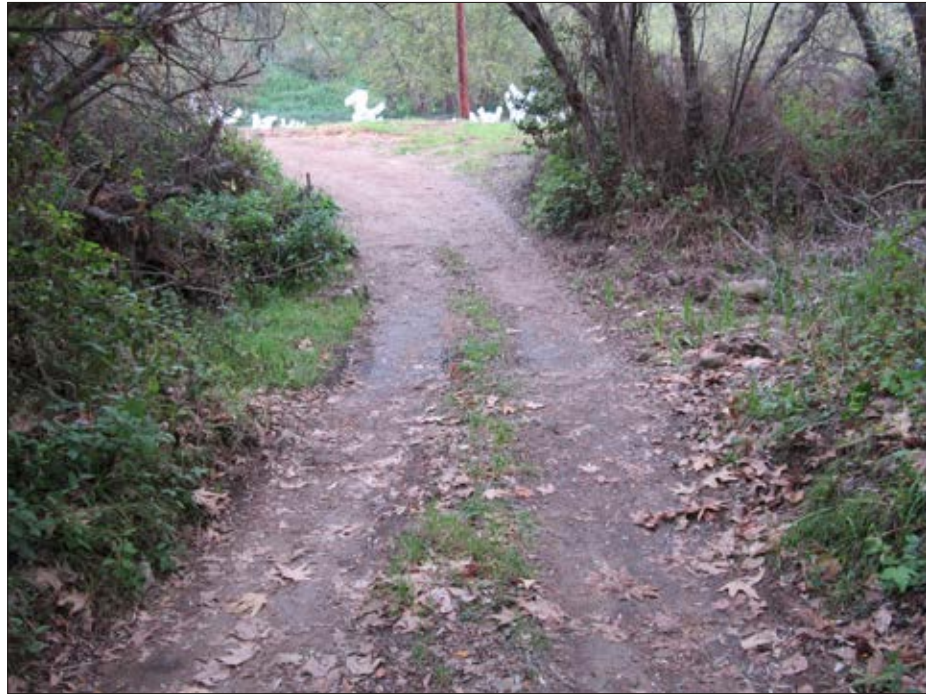
Photo 1: View of unpaved low water crossing looking east

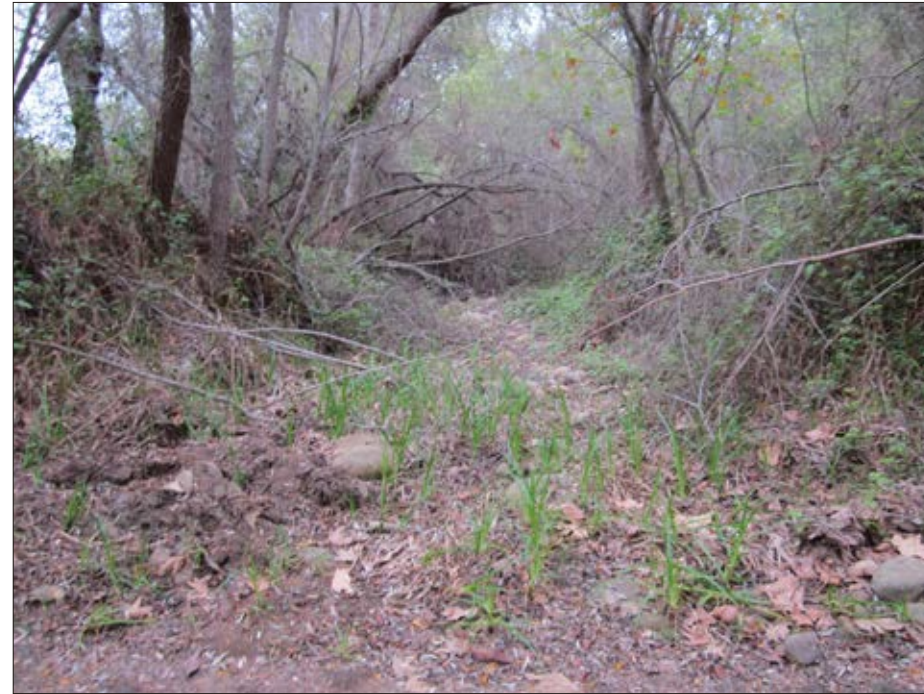
Photo 2: View of unpaved low water crossing looking upstream (north)

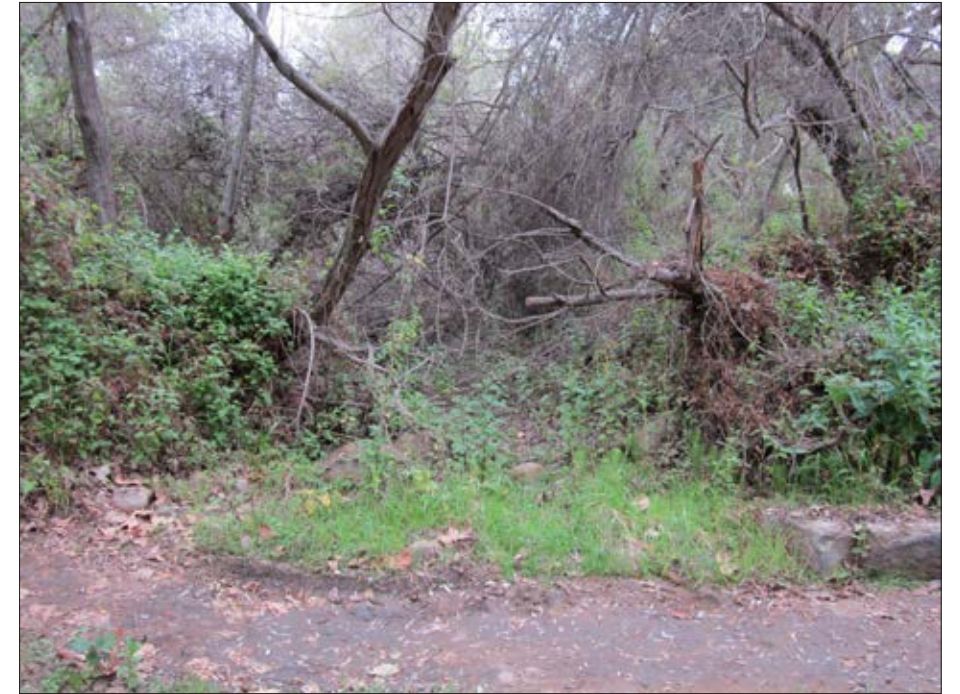
Photo 3: View of unpaved low water crossing looking downstream (south)

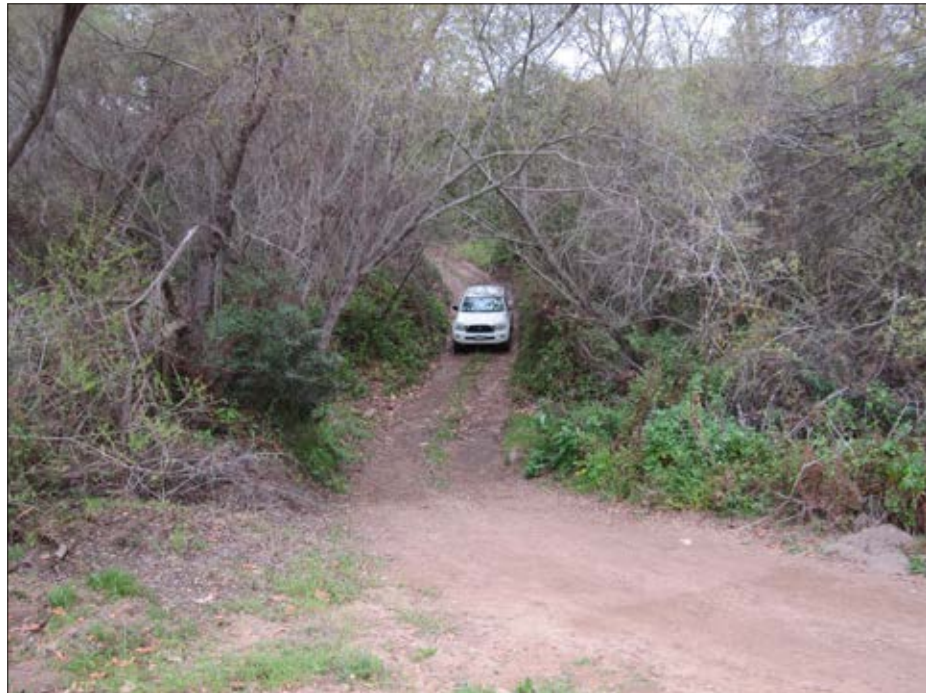
Photo 4: View of unpaved low water crossing looking west

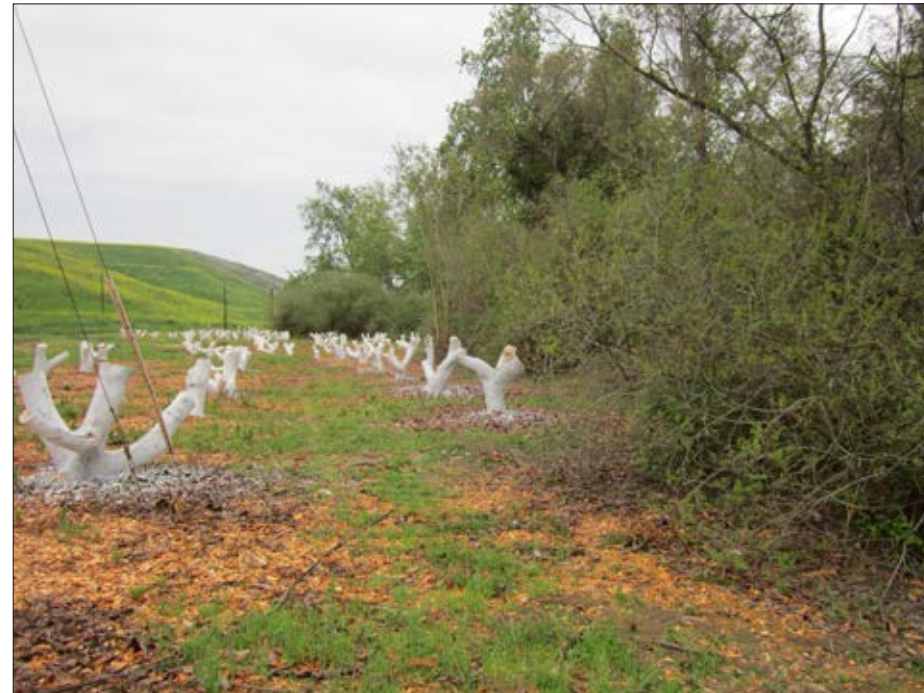
Photo 5: View of avocado grove southeast side of creek

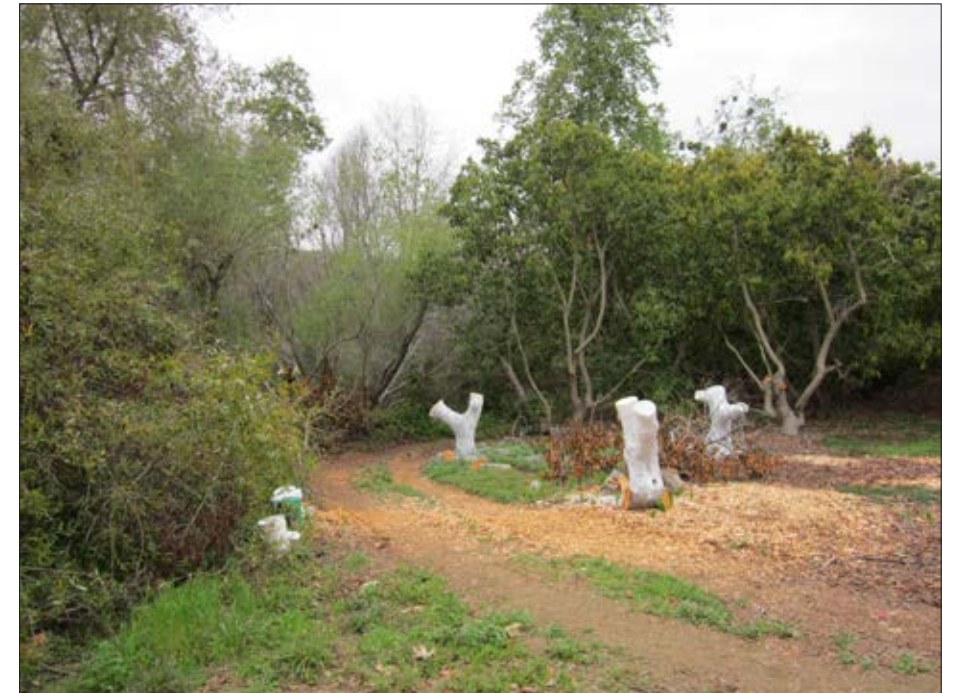
Photo 6: View of avocado grove northeast side of creek
