PROPERTY CONDITION ASSESSMENT

SANTA BARBARA COUNTY DETENTION CENTER

**4434 Calle Real
Santa Barbara, California**

October 29, 2015

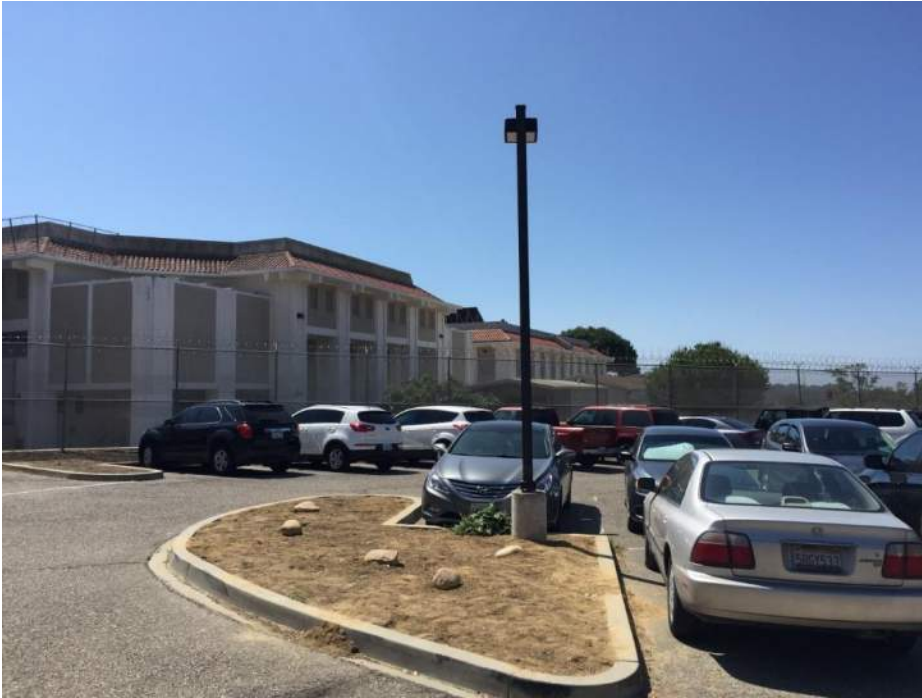
Photograph #1

Overview of the Honor Farm parking lot, landscaping and lighting.

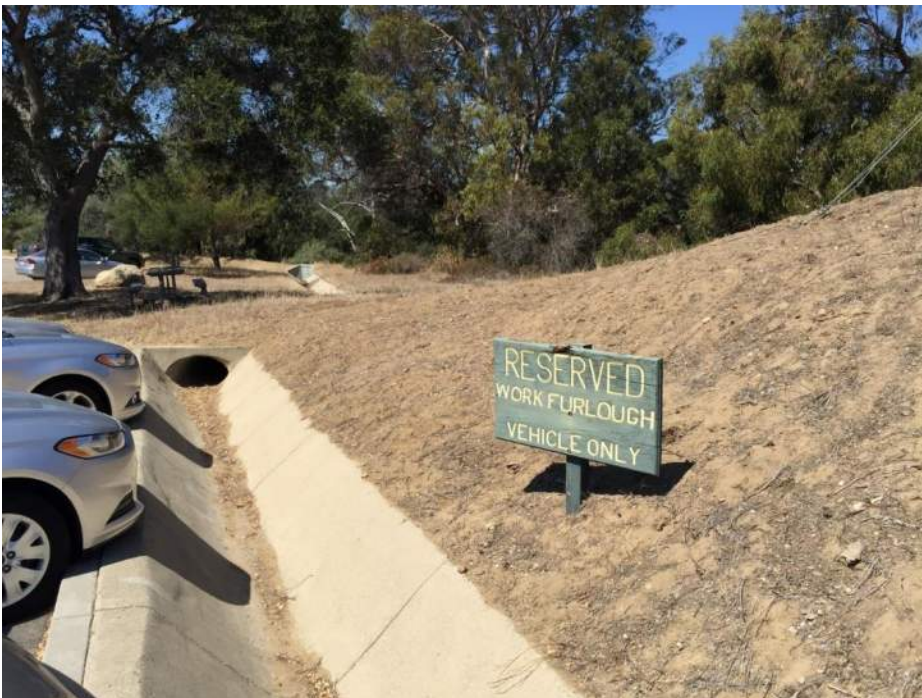
Photograph #2

Storm drainage swale on the west edge of the Honor Farm parking lot.

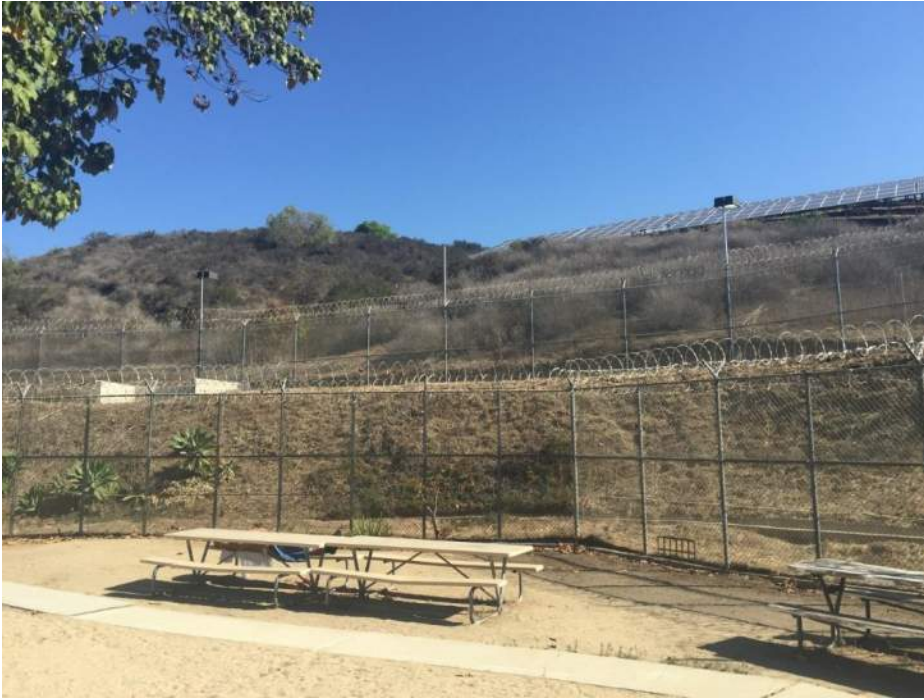
Photograph #3

The Honor Farm north fence and hill beyond.

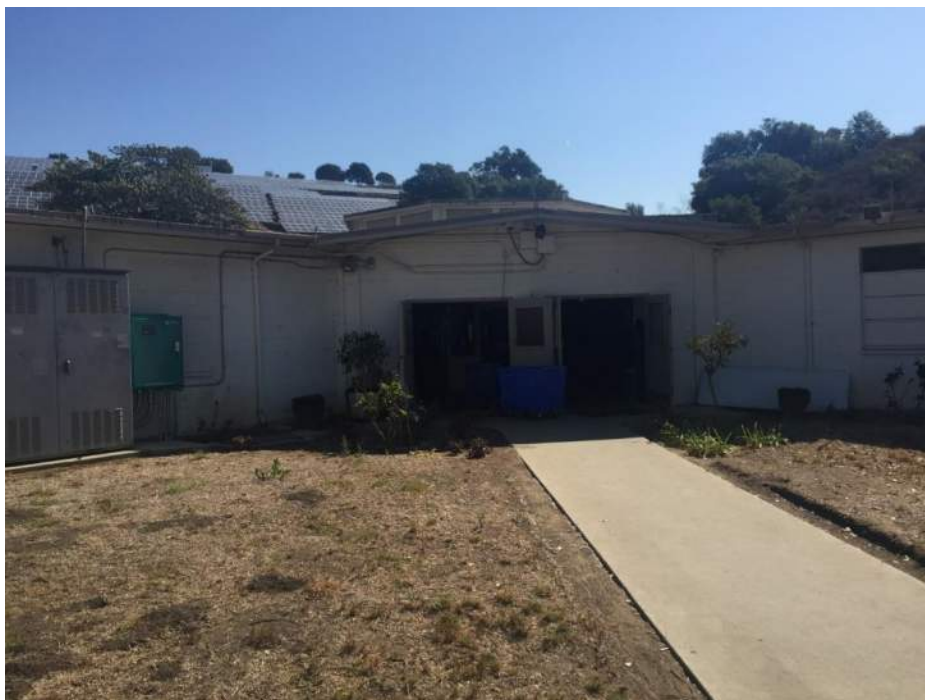
Photograph #5

Main entrance walk
and landscaping at
the Honor Farm.

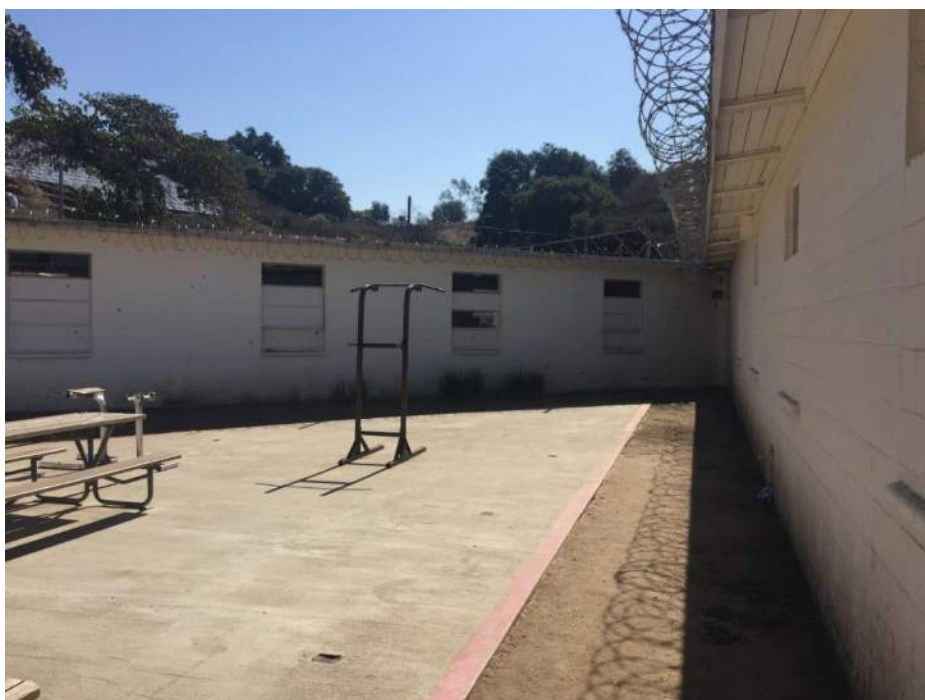
Photograph #6

Recreation Yard at
the Honor Farm.

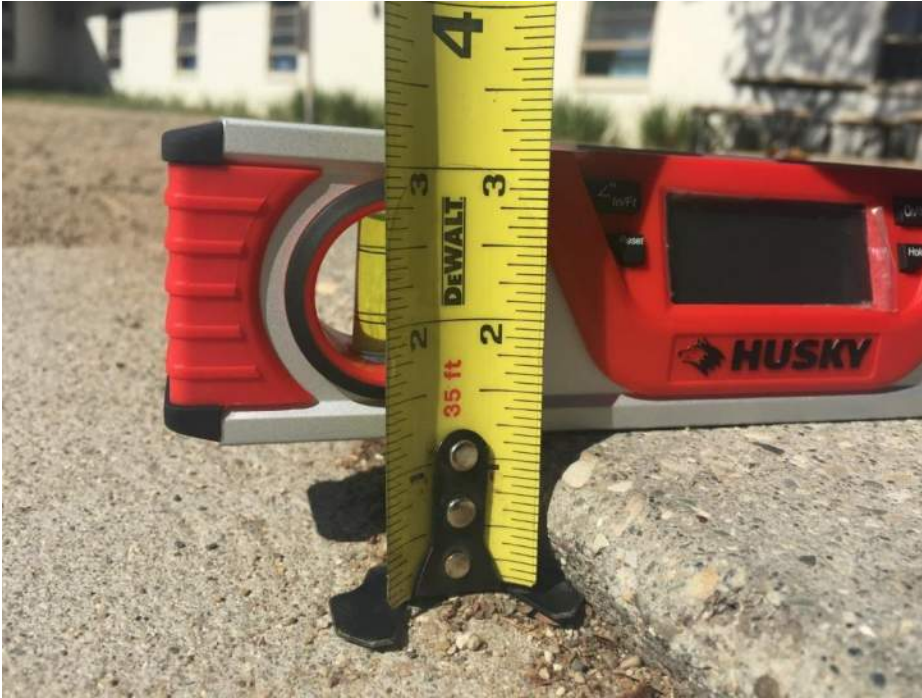
Photograph #7

Differential settlement was noted at several sidewalks at the Honor Farm.

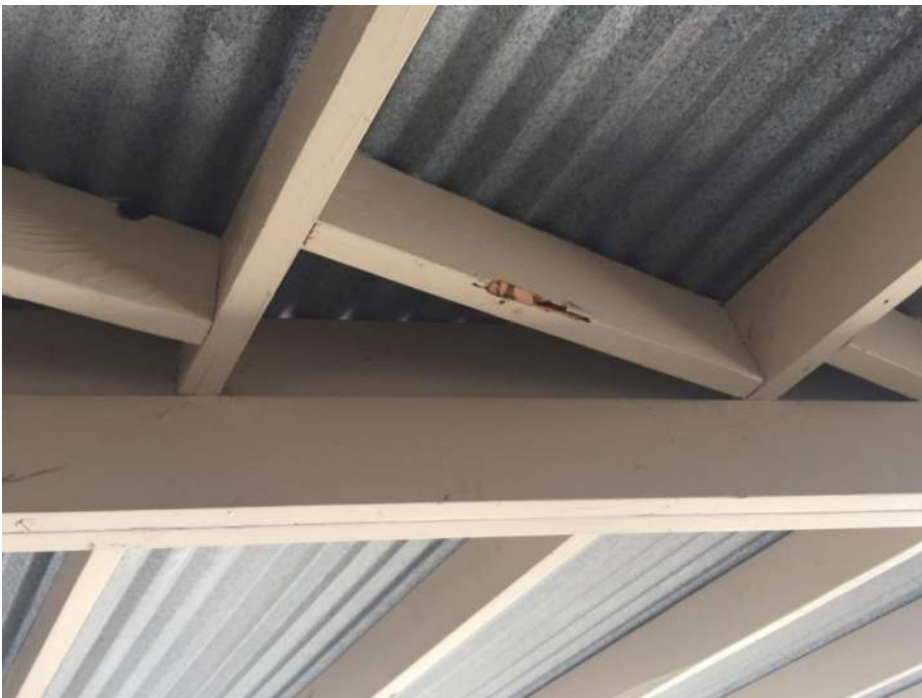
Photograph #8

Minor areas of termite damage were noted at the shelters in the recreation yards at the Honor Farm.

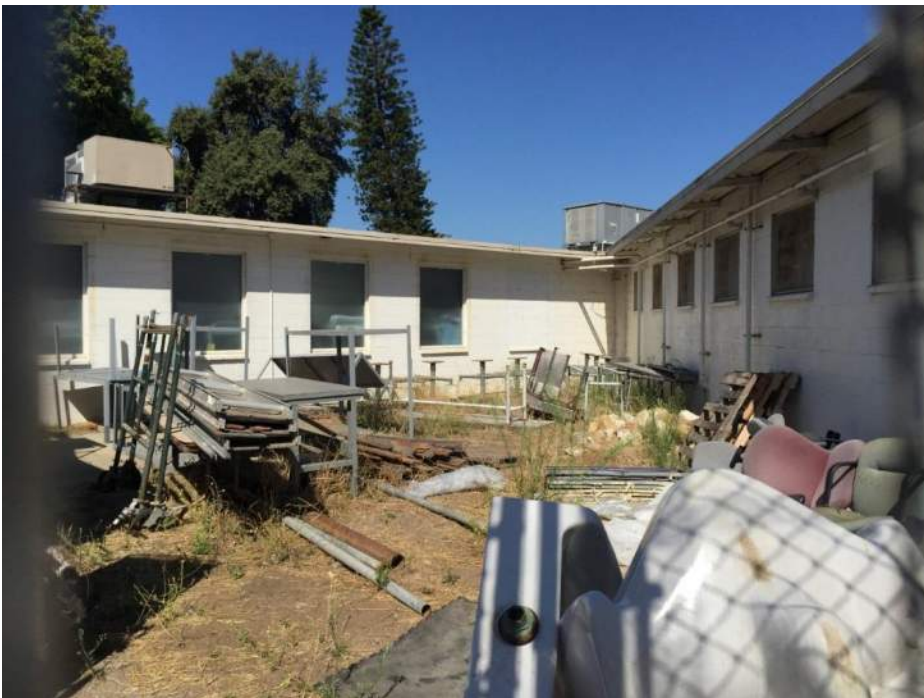
Photograph #10

Miscellaneous items are stored in side yards and are in the process of being removed at the Honor Farm.

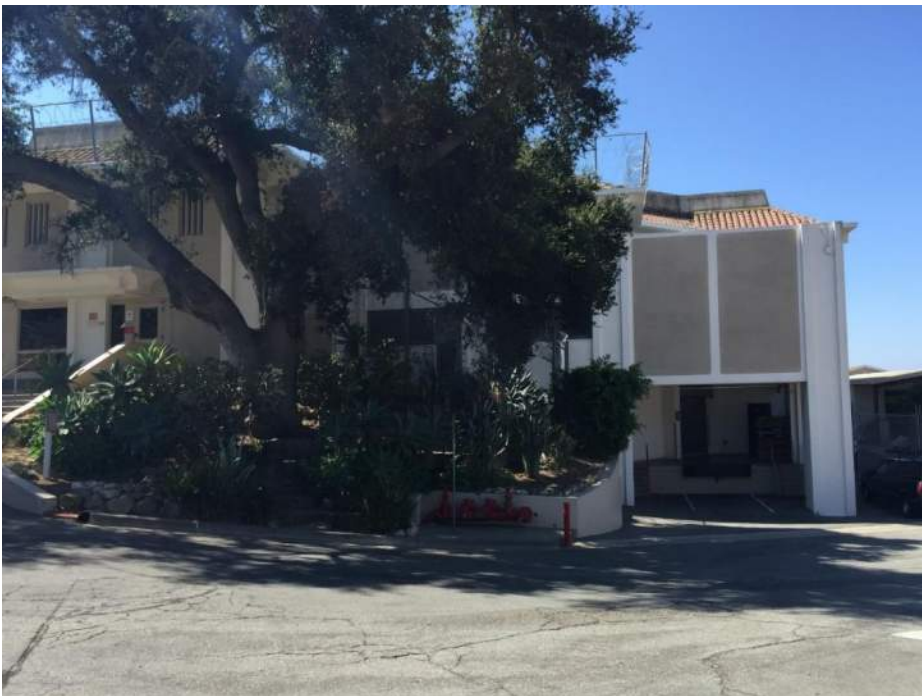
Photograph #12

Overview of the north elevation of the Northwest Building as seen from the Honor Farm.

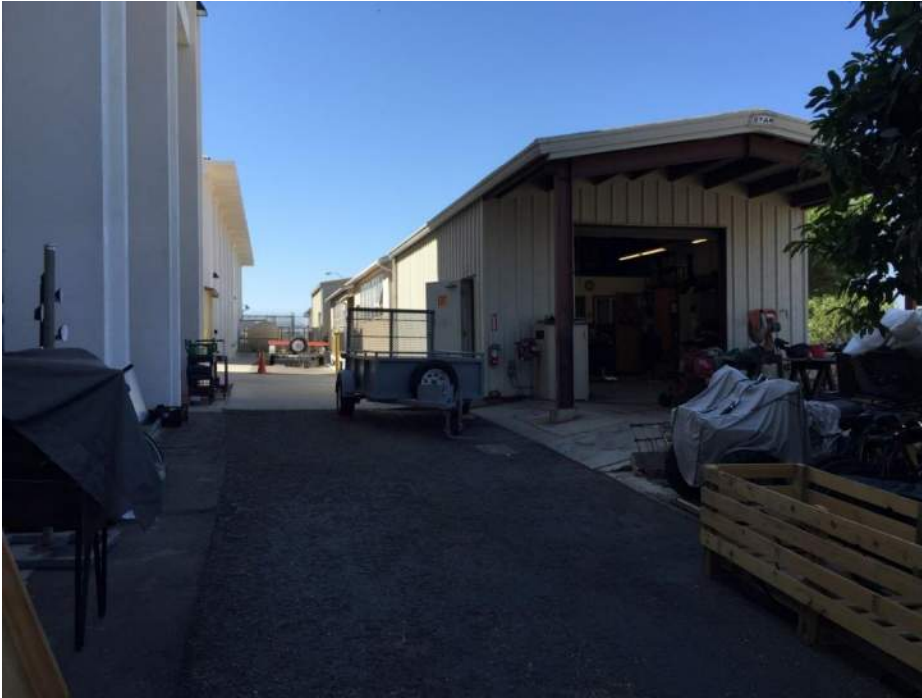
Photograph #13

Overview of the maintenance yard adjacent to the Northwest Building.

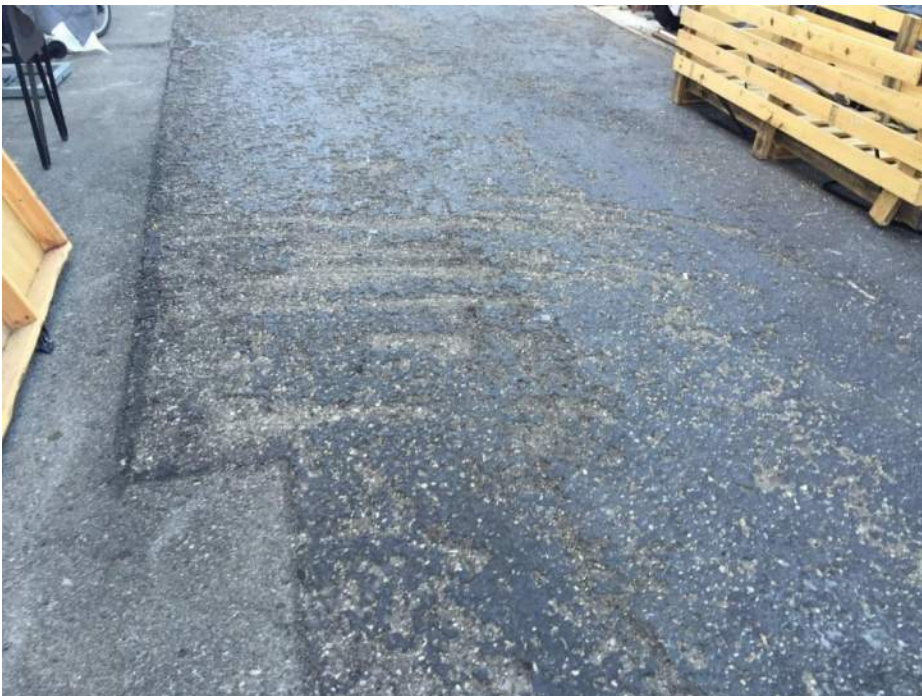
Photograph #14

Raveled asphaltic-concrete pavement was noted at the Northwest Building maintenance yard.

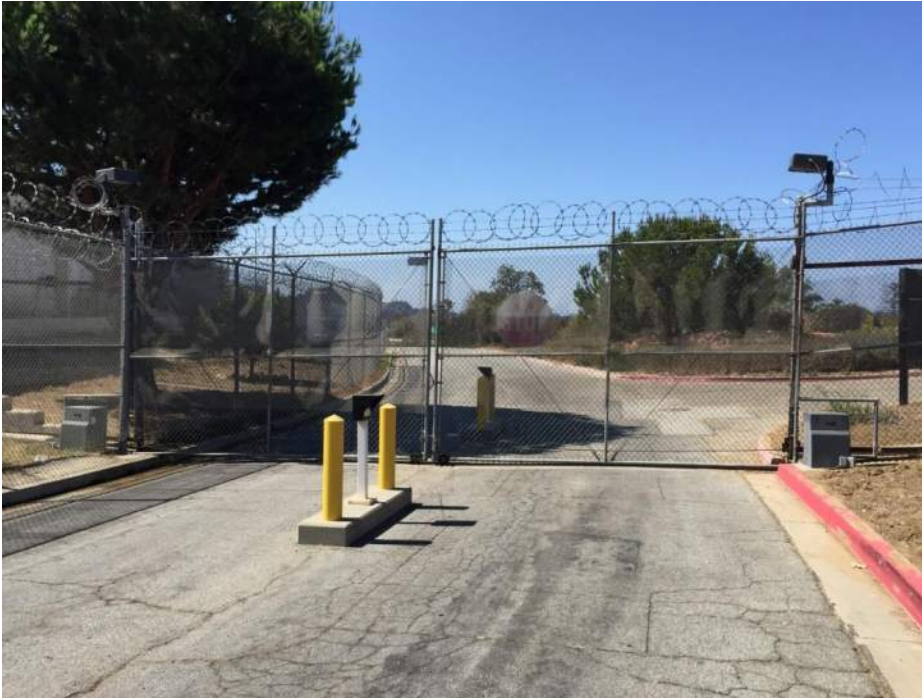
Photograph #15

Overview of the Northwest Building gate.

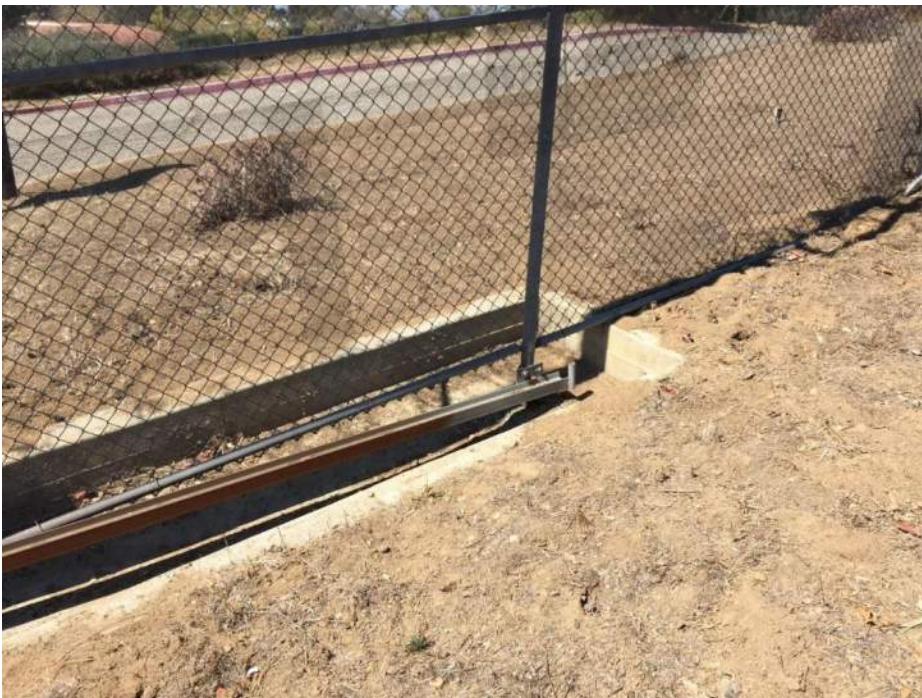
Photograph #16

A gap was noted near the Northwest Building gate should be addressed.

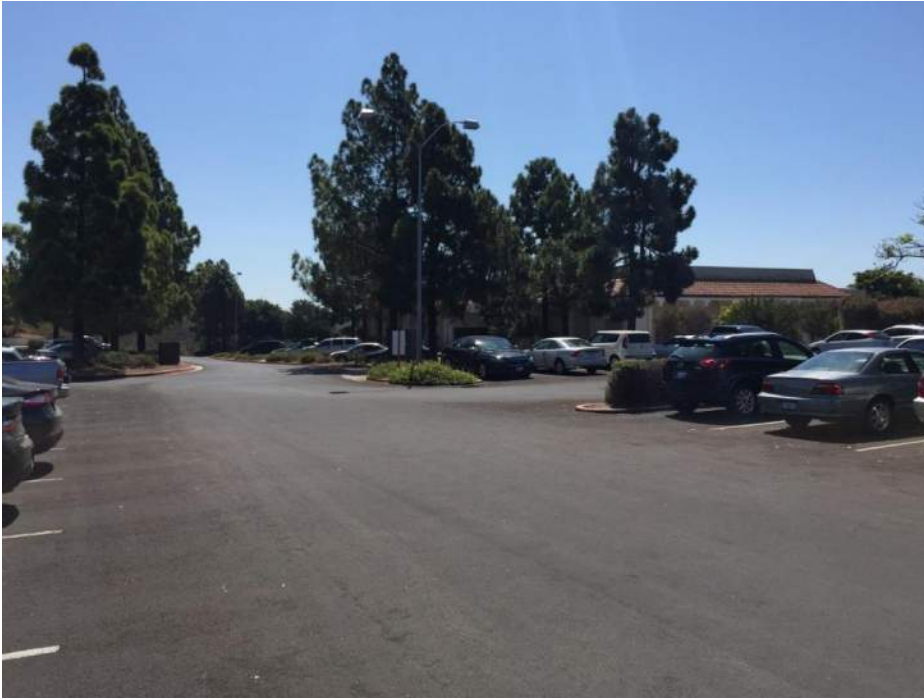
Photograph #17

Overview of the Main Jail parking lot, which was recently repaved.

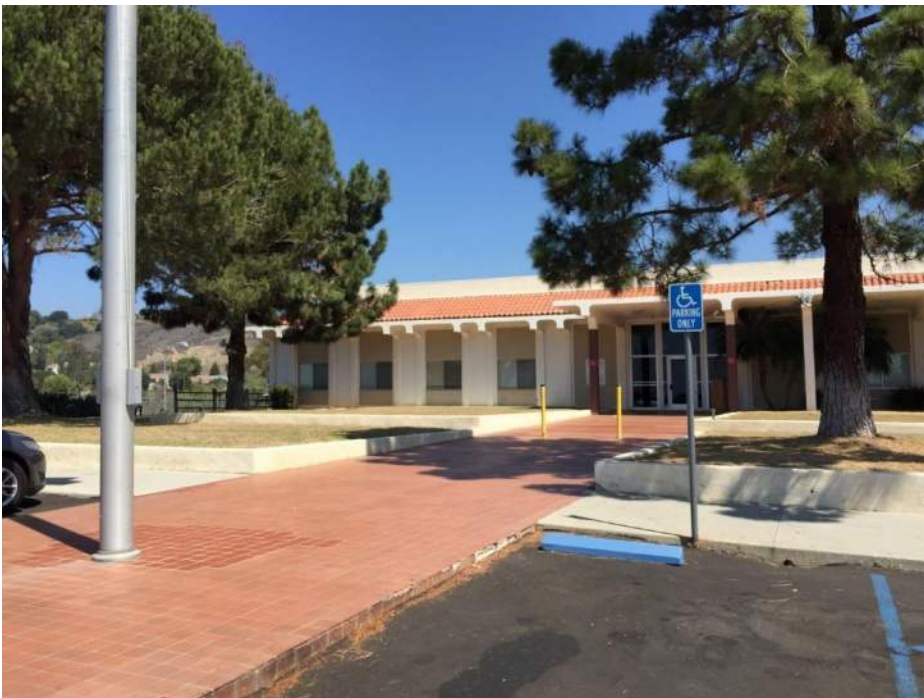
Photograph #18

Overview of the Main Jail entrance walk.

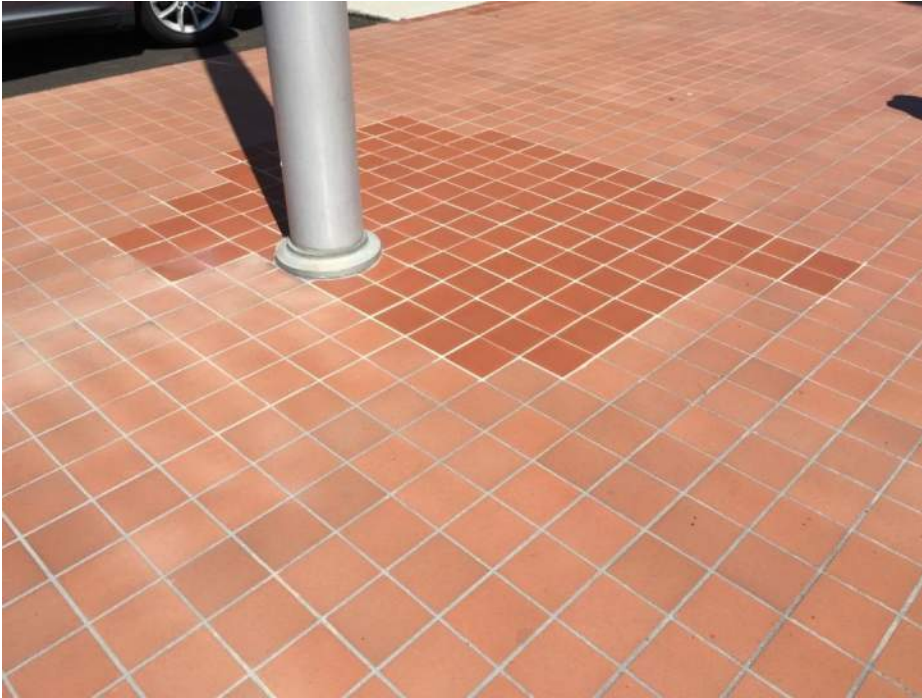
Photograph #19

Sections of the Main Jail entrance walk have been replaced due to failing tile. The area is planned for replacement per facility management.

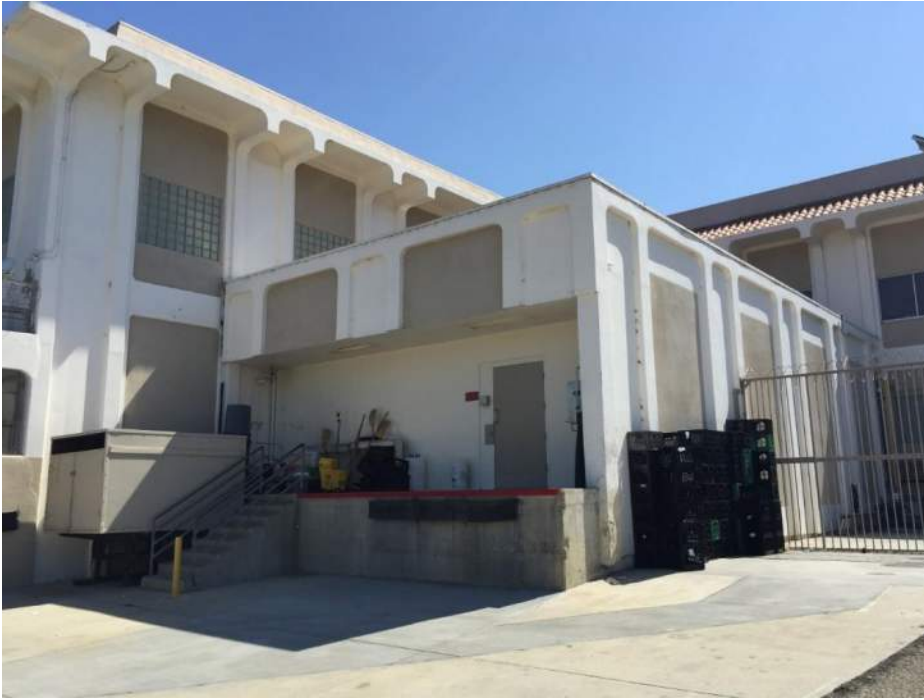
Photograph #23

Overview of the
Main Jail West Dock.

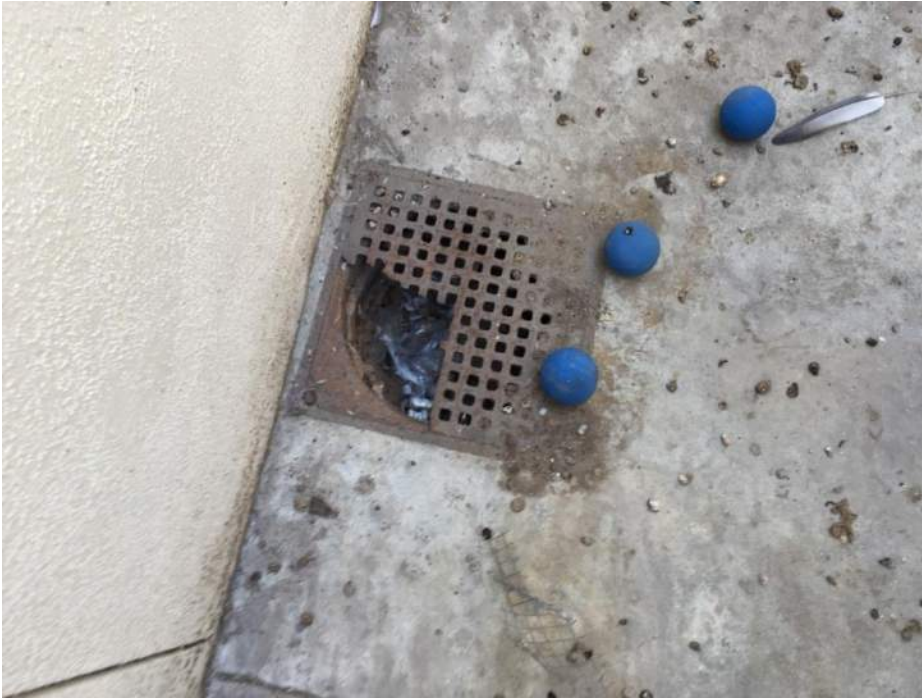
Photograph #25

Damaged or missing drain covers were noted at the Main Jail side yards and lots.

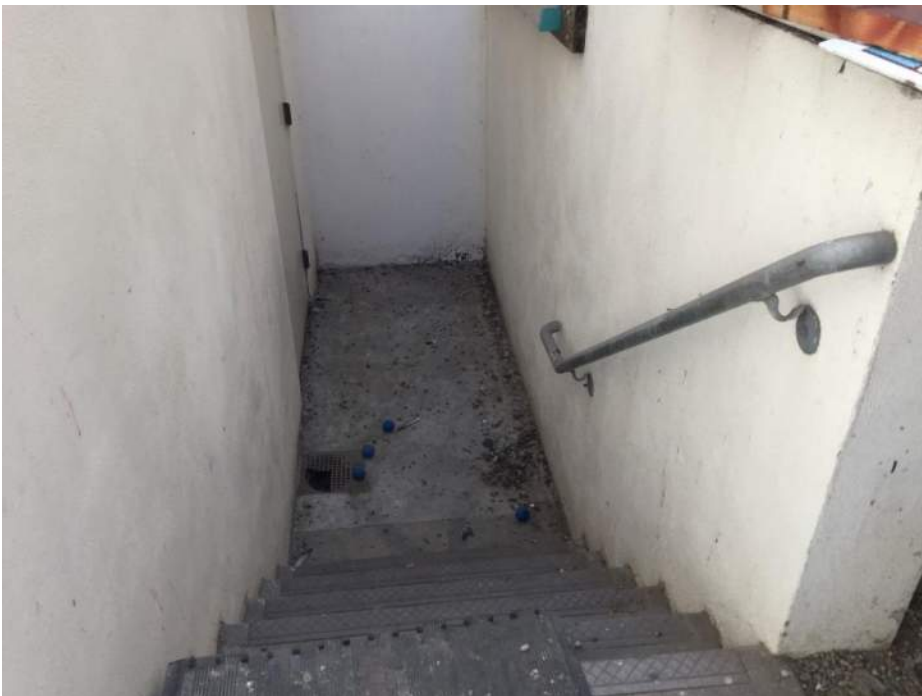
Photograph #26

Miscellaneous metal surfaces, including handrails, should be painted at the Main Jail within the term.

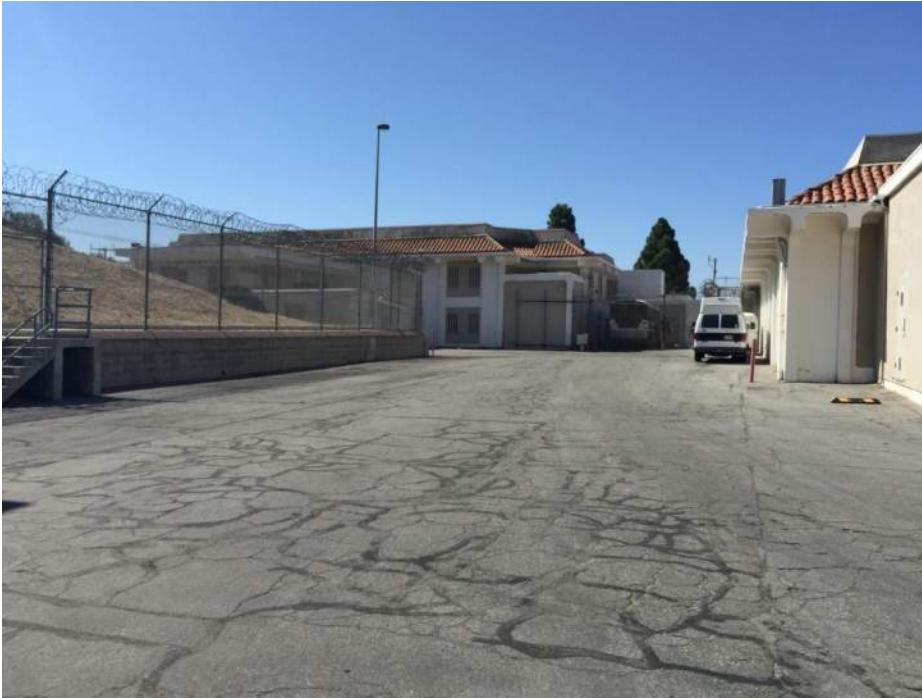
Photograph #27

Overview of the back lot from the Main Jail, looking south toward the IRC drop off. Note cracking and raveling in the asphaltic-concrete pavement.

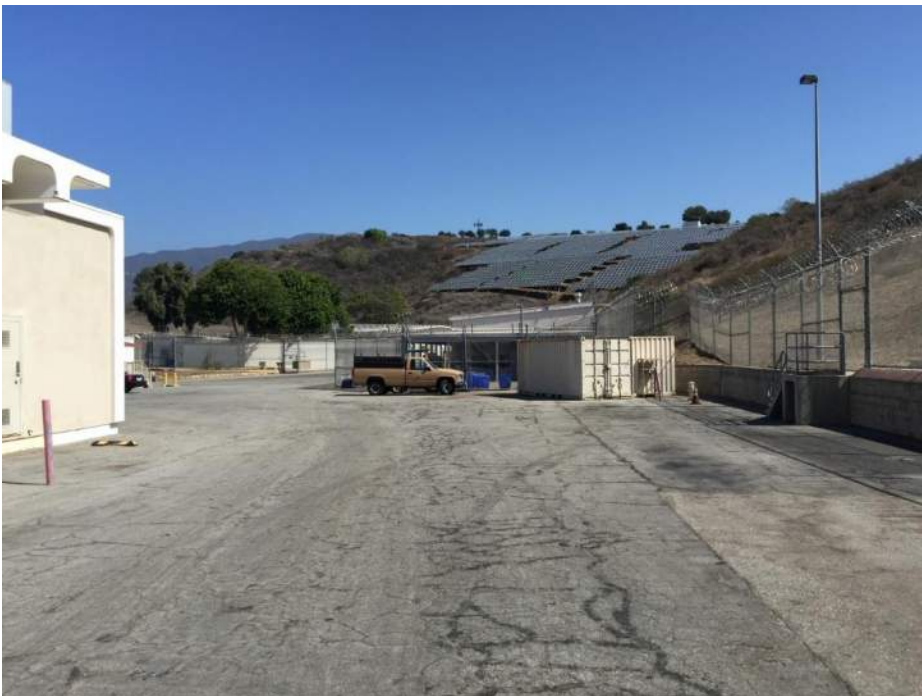
Photograph #28

Overview of the back lot at the Main Jail, looking north toward the Honor Farm.

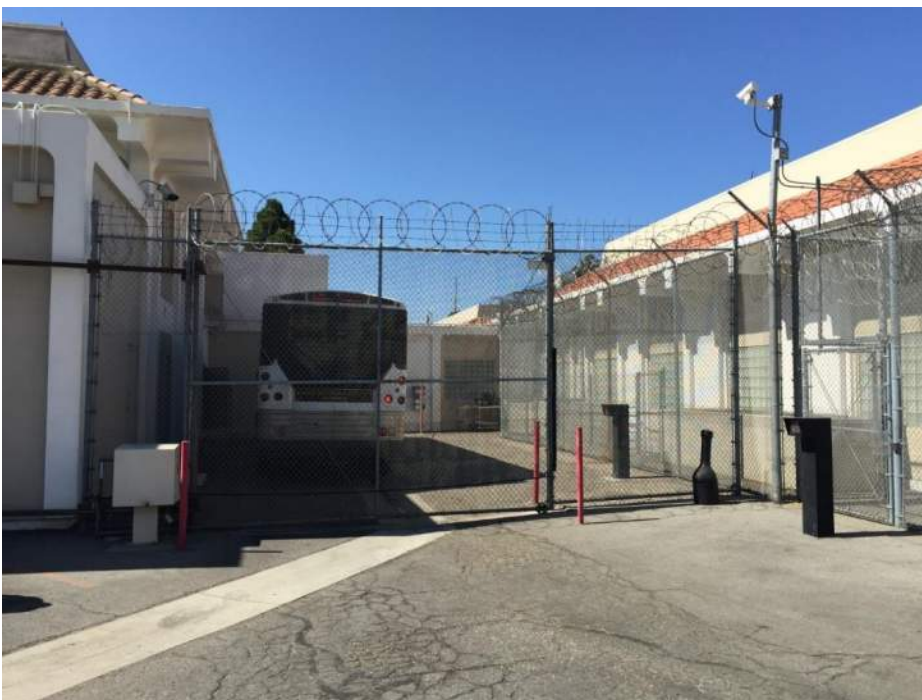
Photograph #29

Bus drop-off area
and gate operator at
the on the left at the
Main Jail.

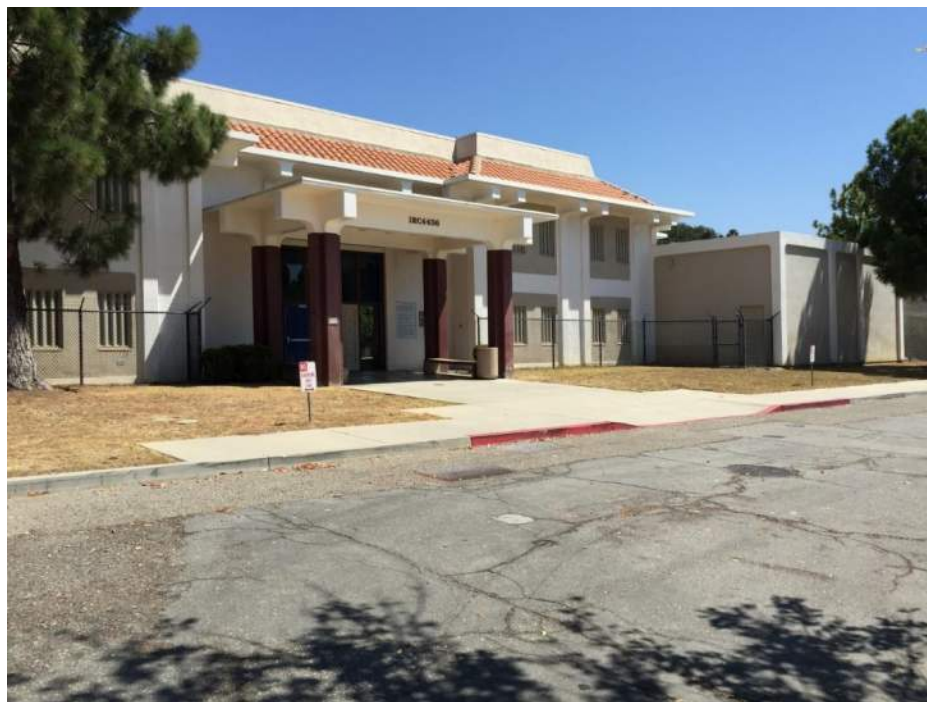
Photograph #31

Overview of the IRC parking lot and entrance.

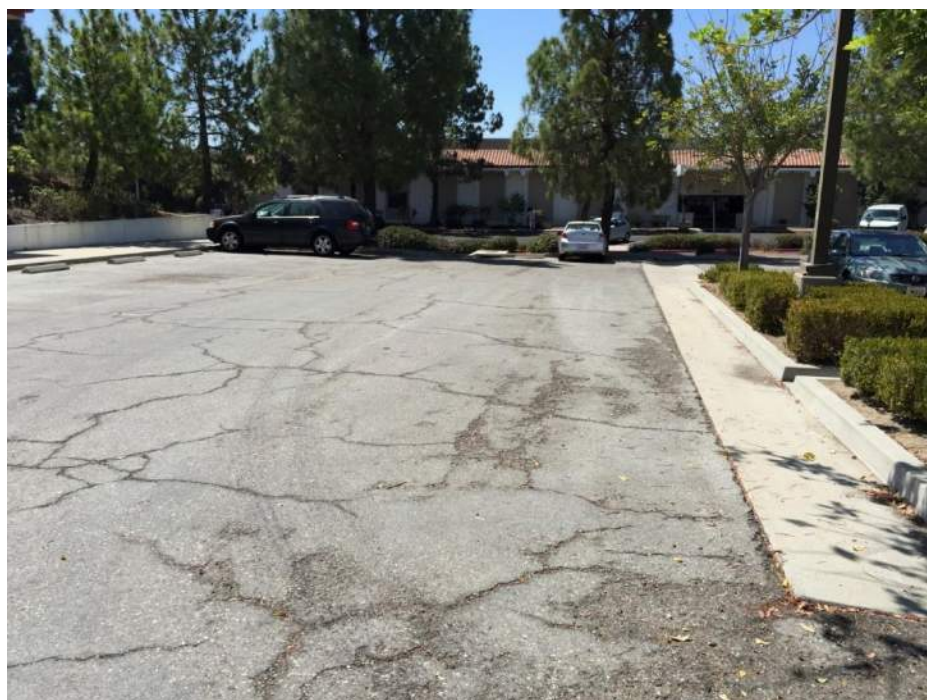
Photograph #32

Overview of the IRC parking lot.

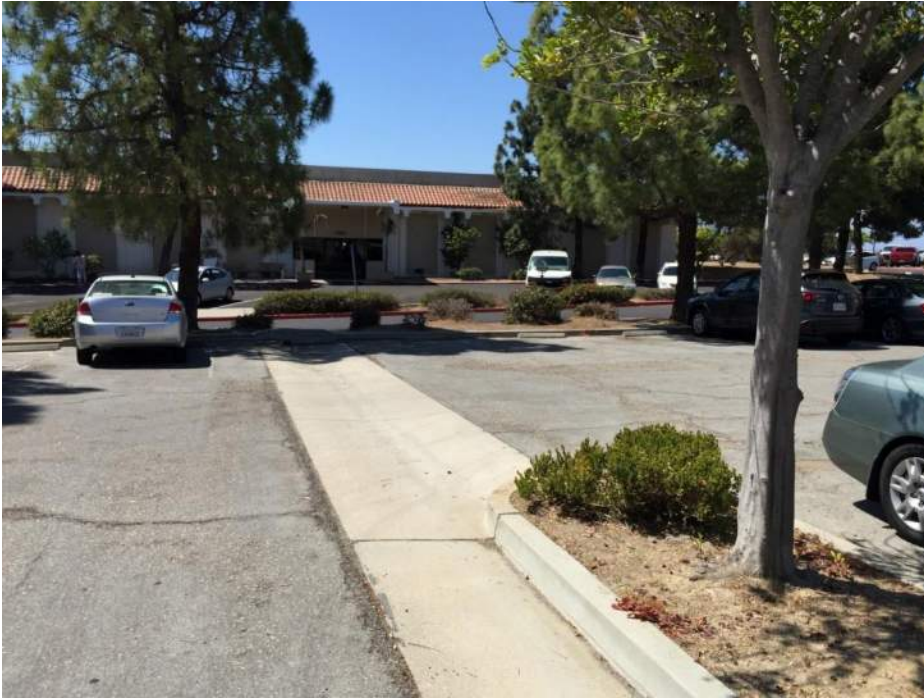
Photograph #33

The IRC parking lot is served by concrete v-gutters in the parking lot.

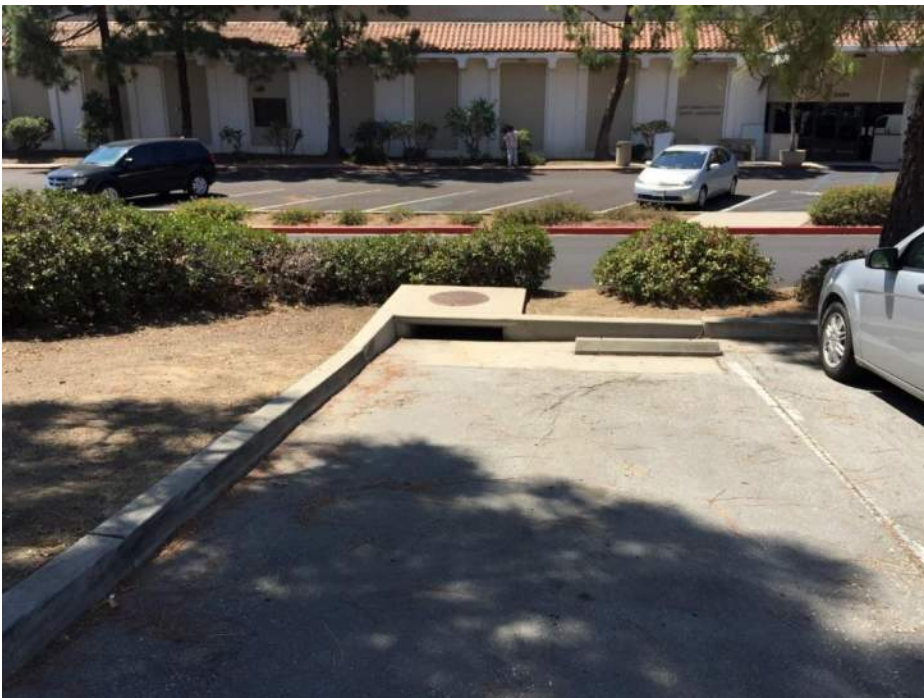
Photograph #34

The IRC parking lot is generally sloped to storm drain inlets at the perimeter.

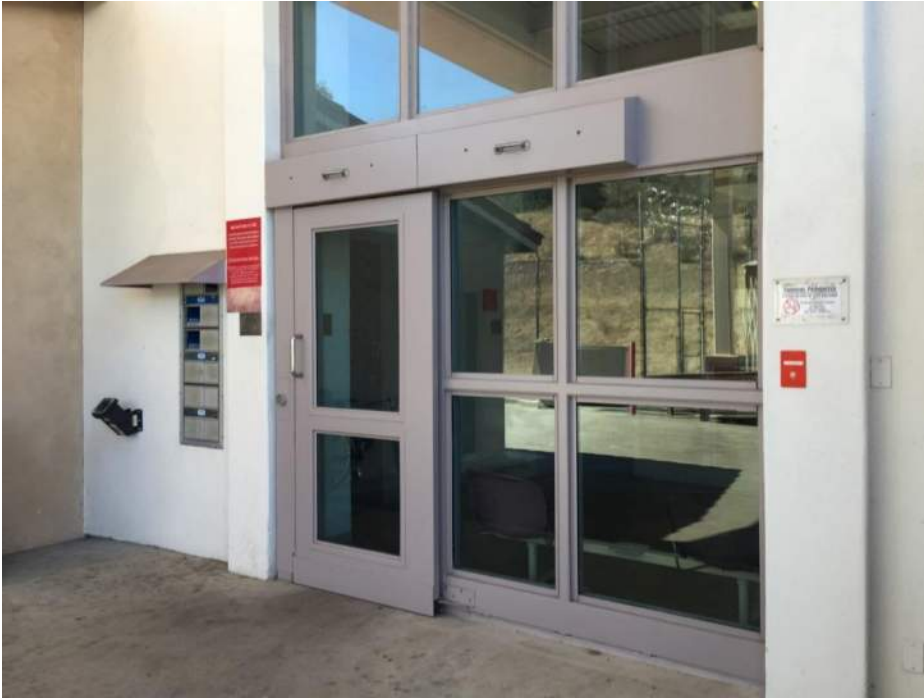
Photograph #35

The drop-off entrance at the IRC.

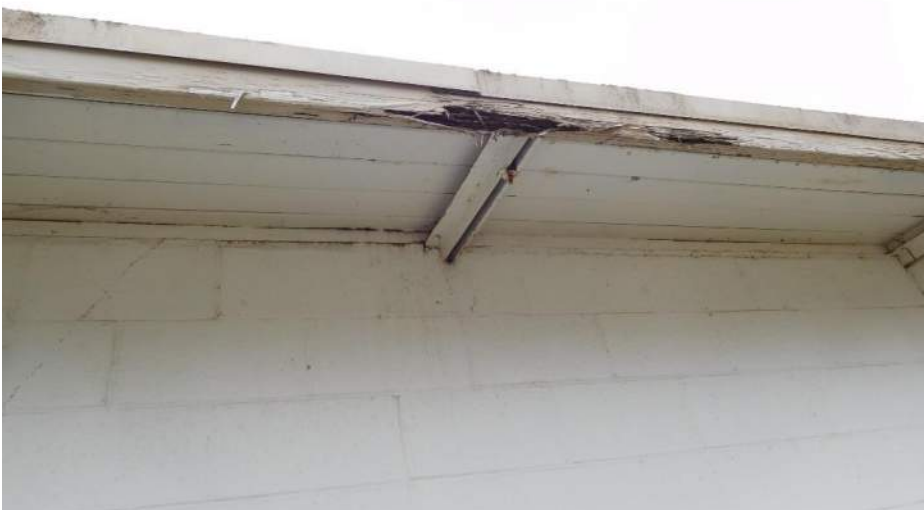
Photograph #36

Numerous areas where fascia's and soffits have significant dry rot requiring replacement at the Honor Farm.

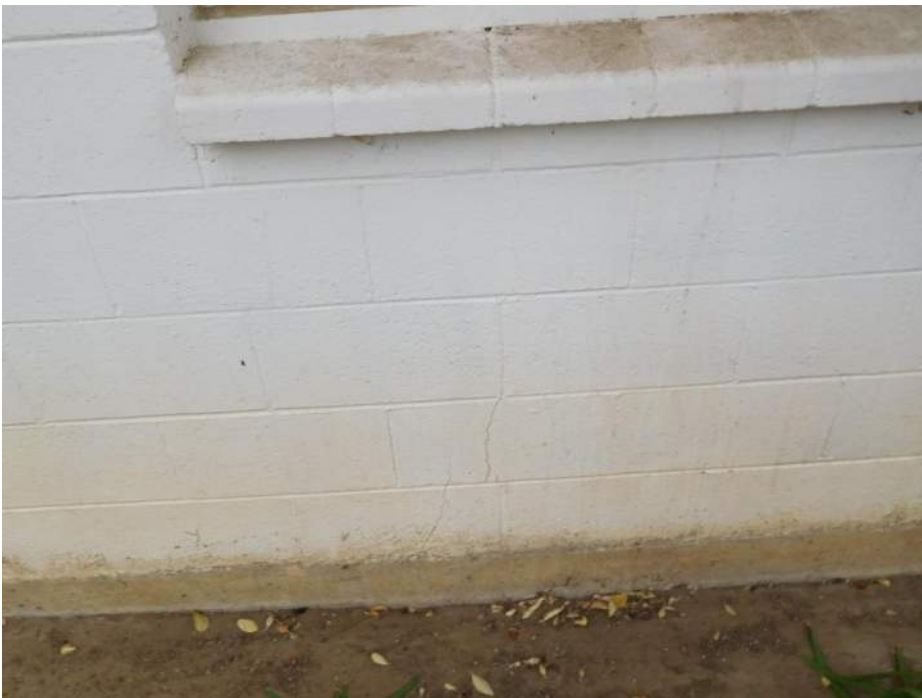
Photograph #38

Exterior walls with numerous cracks requiring repair and filling prior to painting at the Honor Farm.

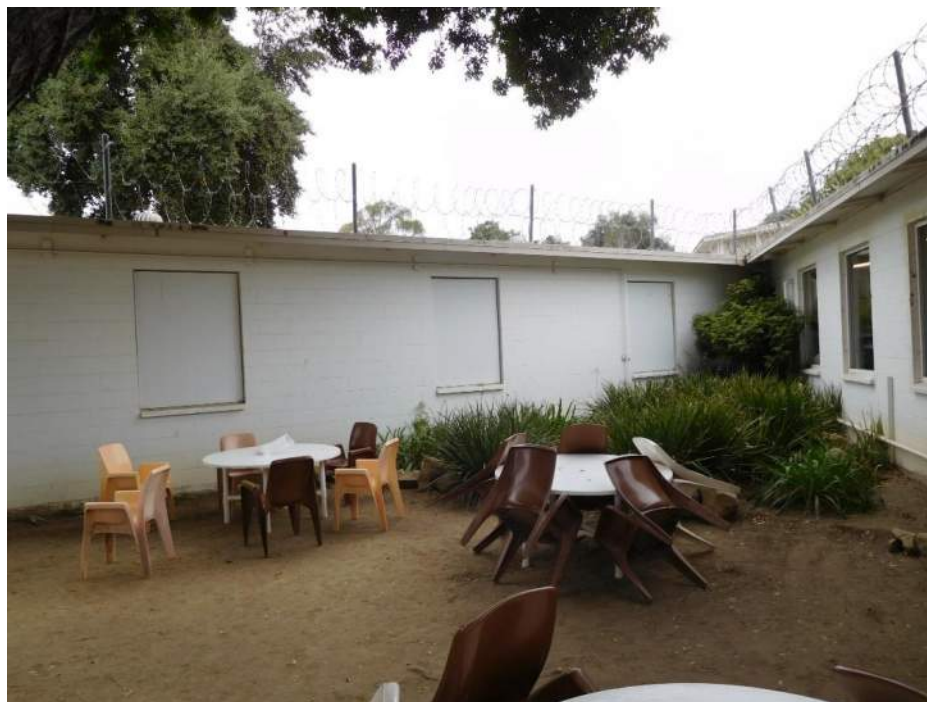
Photograph #39

Windows infilled with plywood at the Honor Farm.

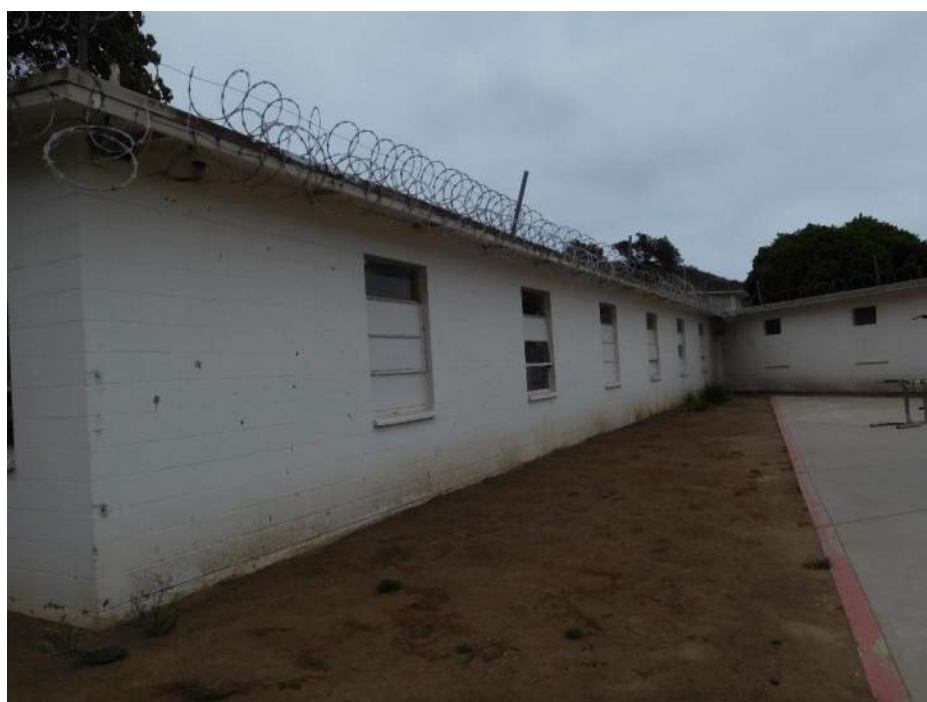
Photograph #40

Window panes painted and infilled with wood at the Honor Farm.

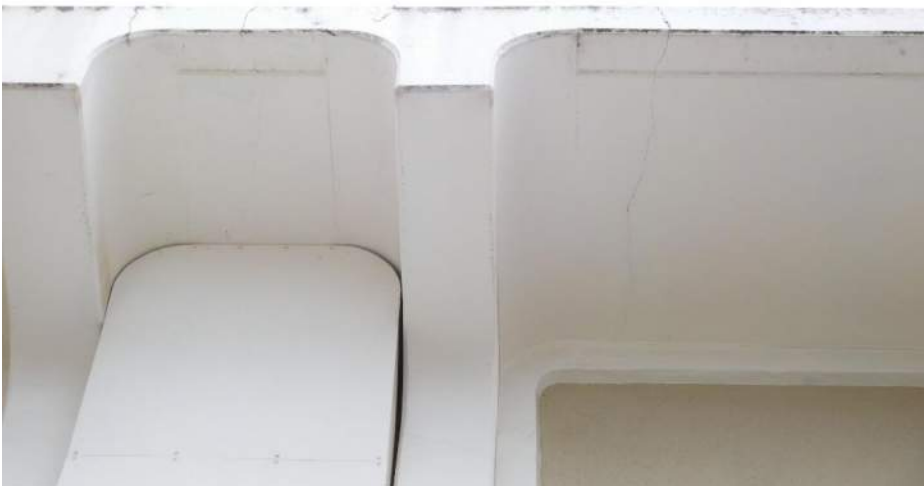
Photograph #48

Exterior concrete door canopies and roof slab reentrant corners have cracking, which will require epoxy repair at the Northwest Building.

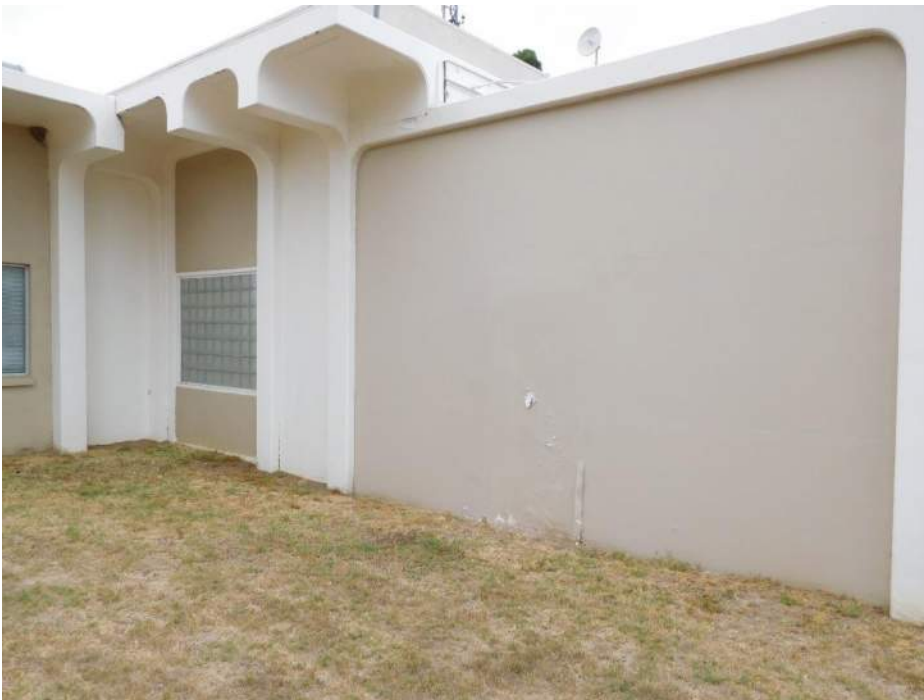
Photograph #54

South entry, women's section walls have one area that appears like a window or door opening was infilled with metal studs and plaster at the Main Jail.

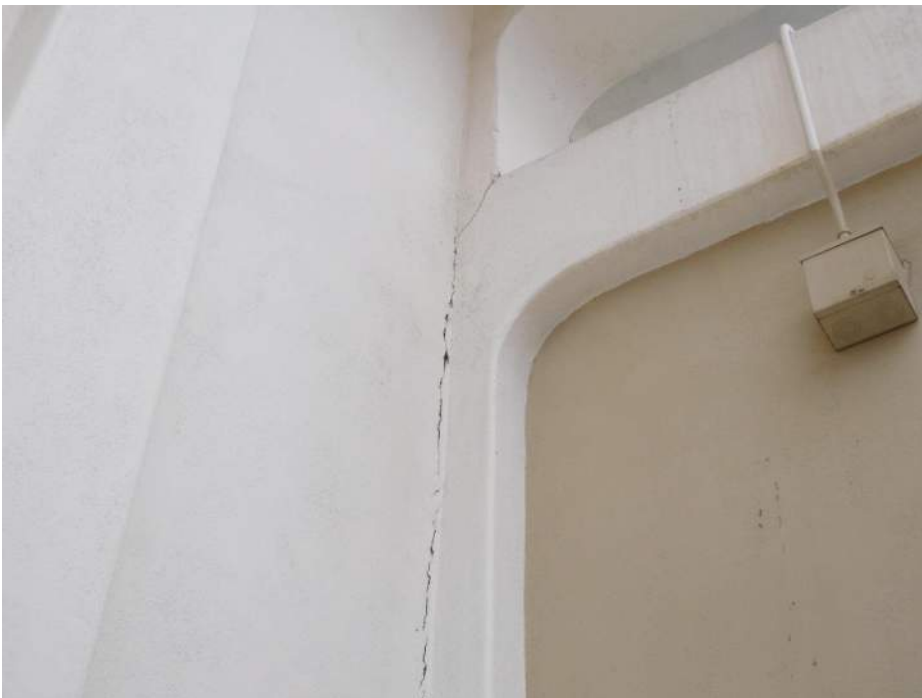
Photograph #56

The concrete exterior yard walls have numerous large cracks at interfaces with the main building, these will require epoxy repair and filling at the IRC.

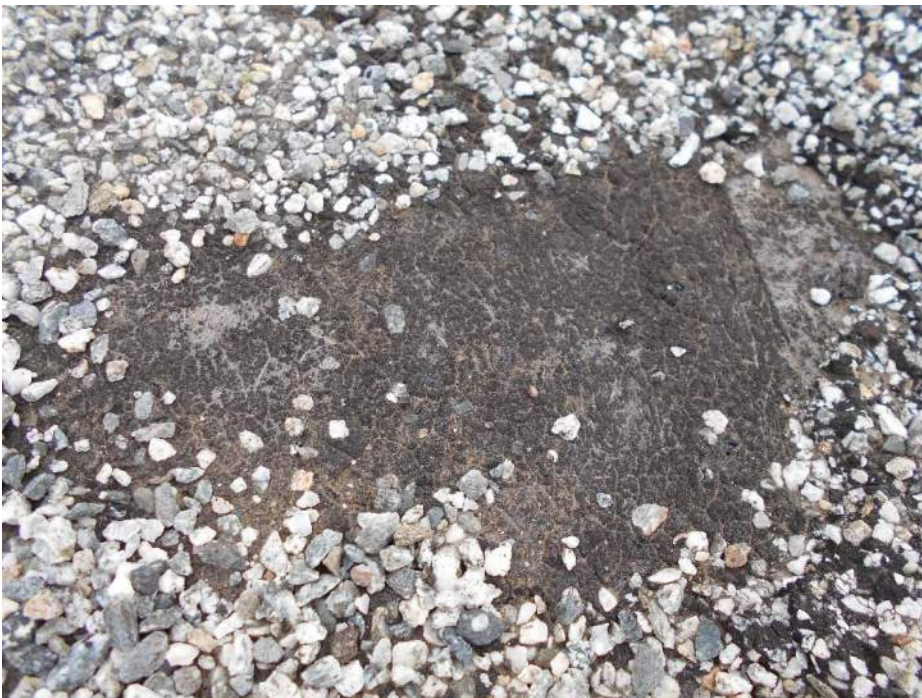
Photograph #62

Areas of roofing with missing gravel and exposed roof ply with cracking and deterioration at the Honor Farm.
