PROPERTY CONDITION ASSESSMENT

SANTA BARBARA COUNTY DETENTION CENTER

**4434 Calle Real
Santa Barbara, California**

October 29, 2015

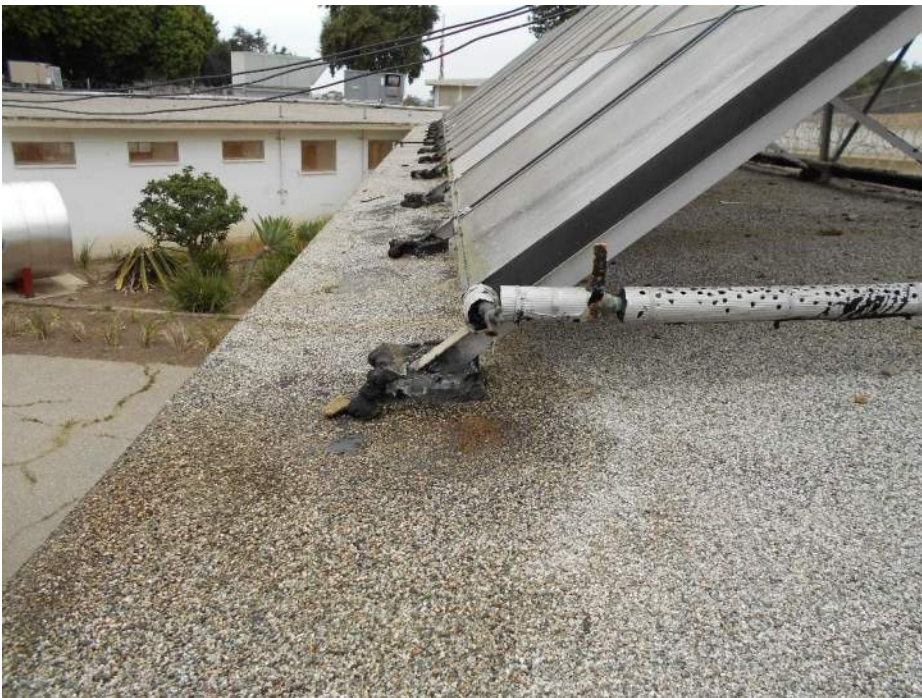
Photograph #66

Area of roofing at the base of the solar hot water modules where leaks have been reported and roof wood substrate at the Honor Farm is reported to have moisture damage.

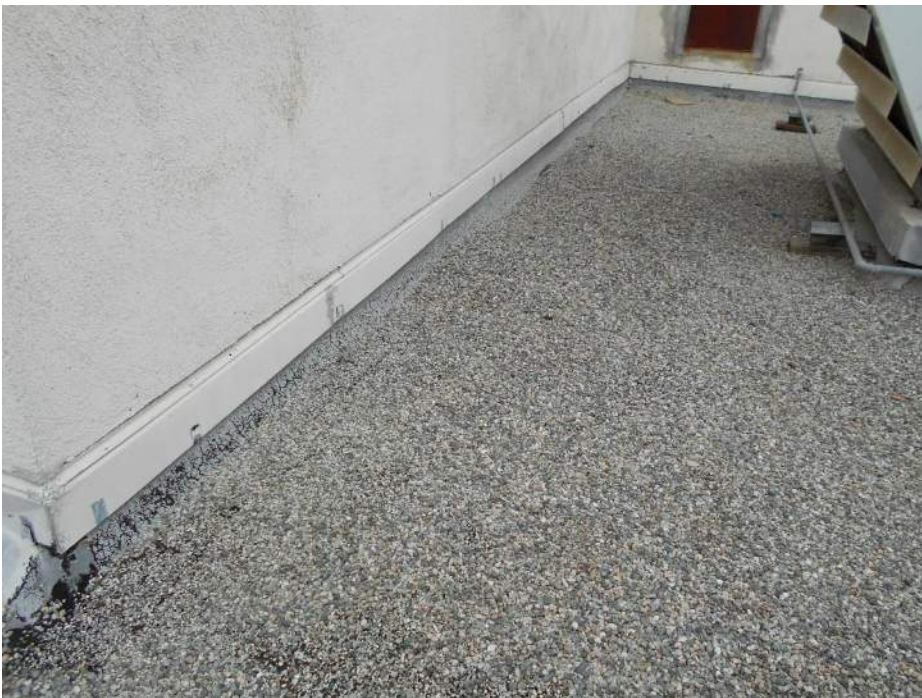
Photograph #68

Deterioration of the built-up roofing where it turns up and terminates at the parapet wall at the Northwest Building.

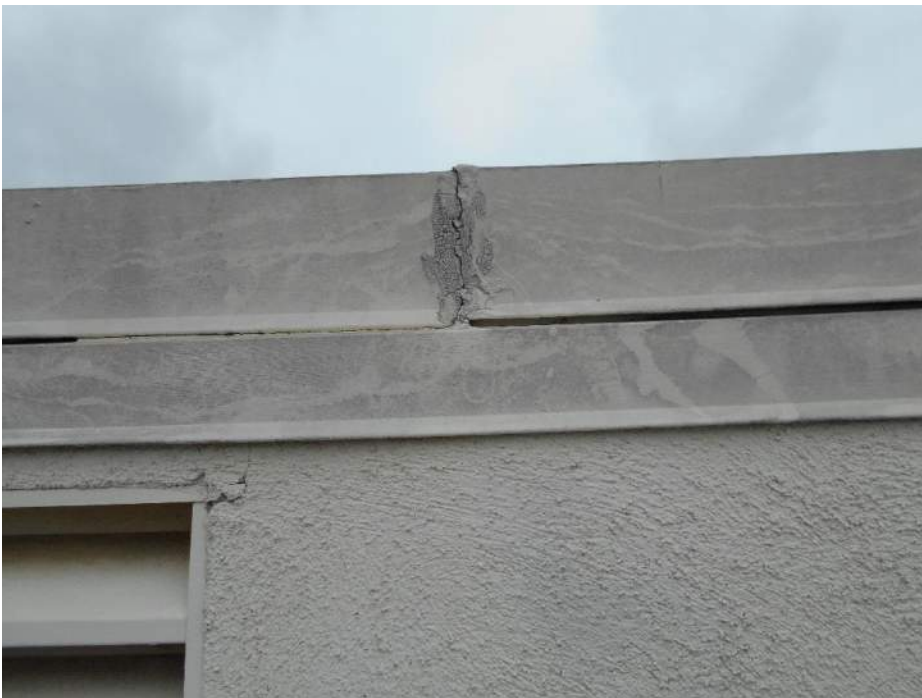
Photograph #72

Cracked sealant joints was noted at the sheet metal parapet coping cap at the Northwest Building.

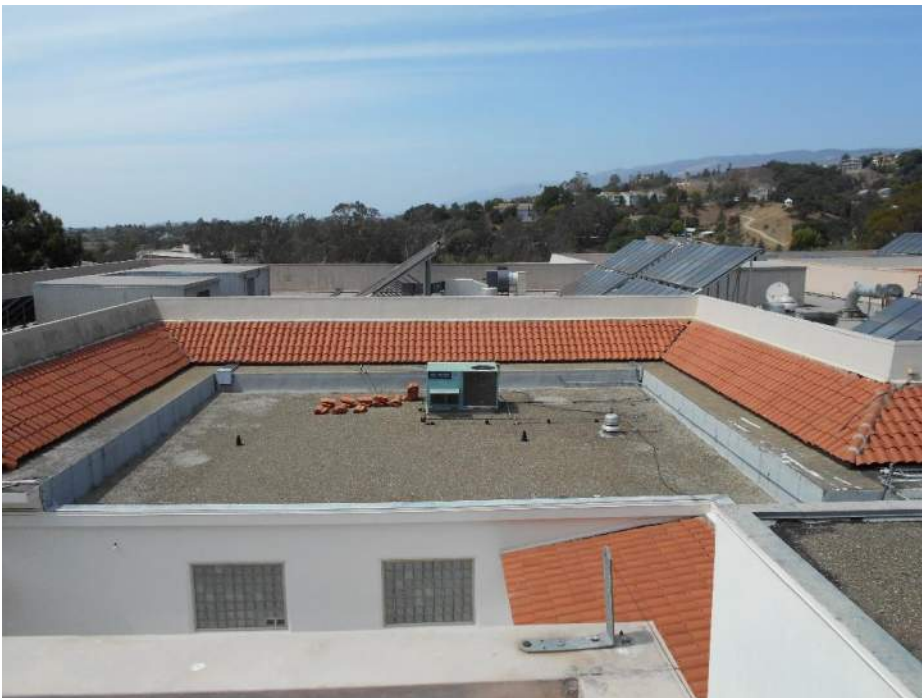
Photograph #84

Lower roof clay tile, built-up roofing, and parapet wall as viewed from the IRC building at the Main Jail.

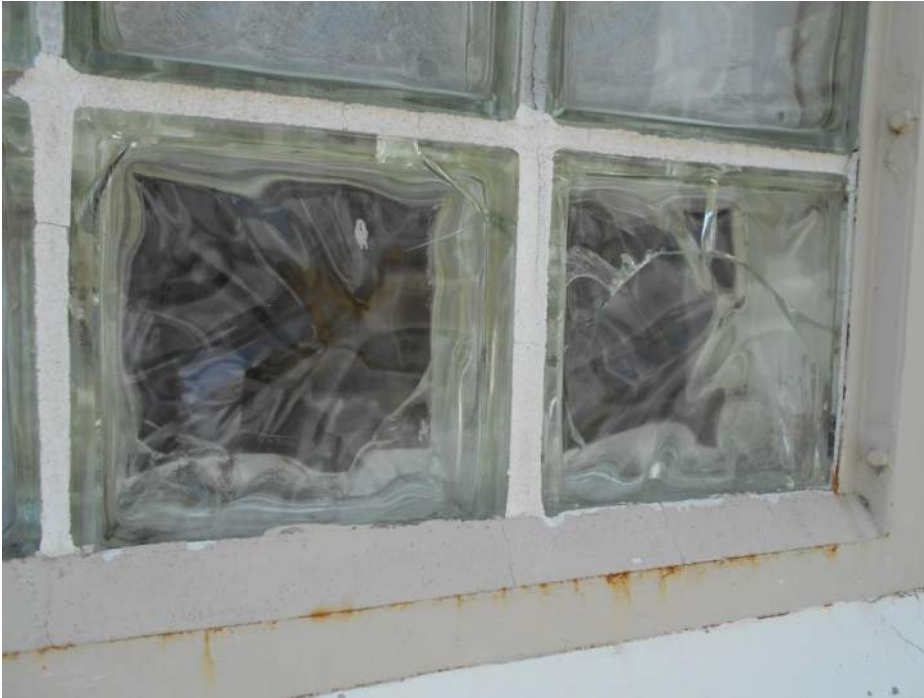
Photograph #101

Cracked glass block windows at the Main Jail.

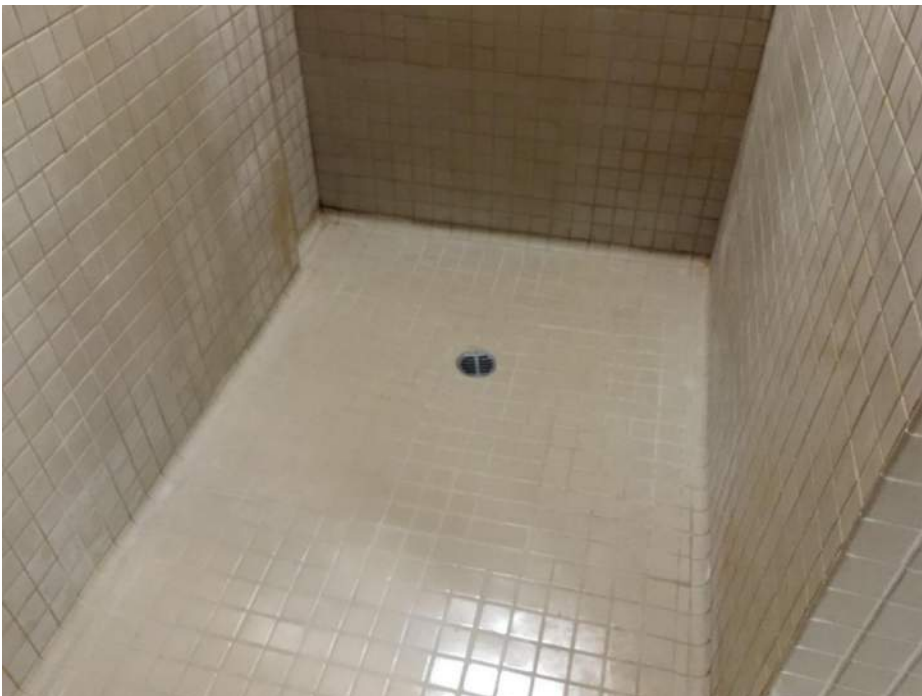
Photograph #106

Damaged tile was noted at the showers at the Honor Farm.

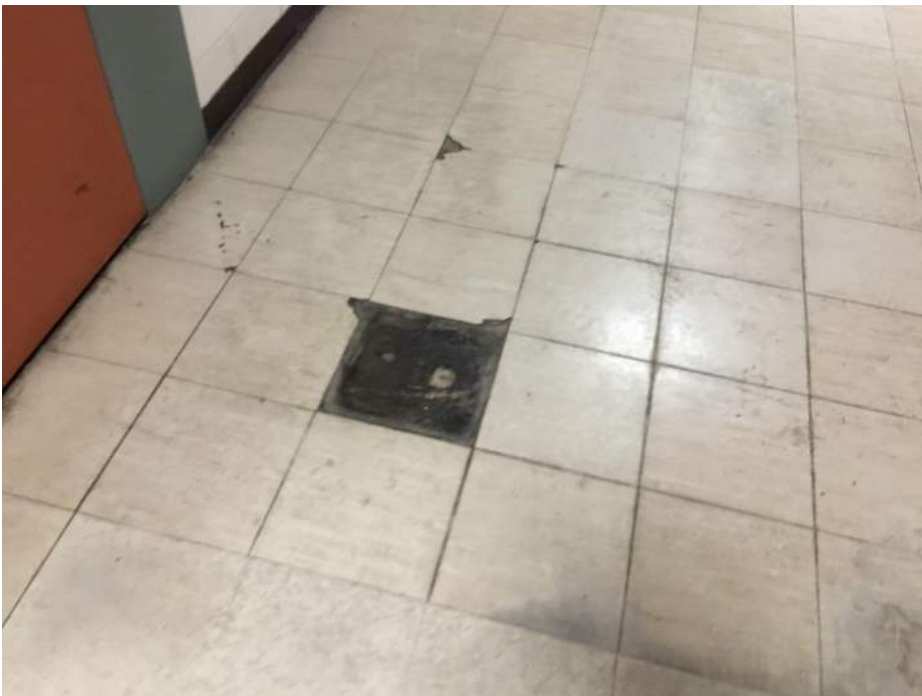
Photograph #116

Damaged vinyl tile was noted at the circulation areas at the Northwest Building.

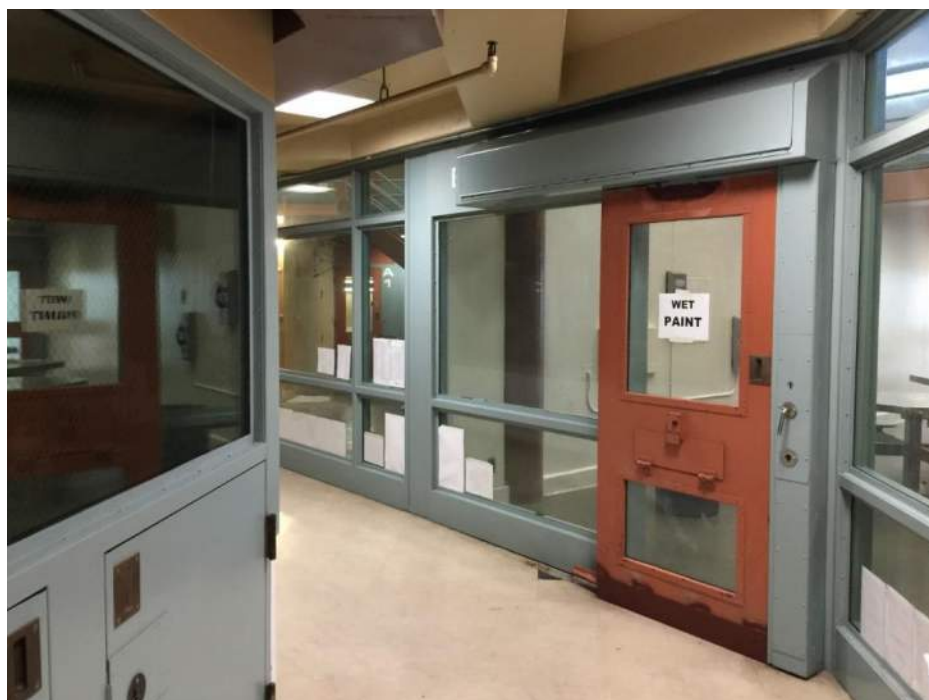
Photograph #118

Select cell block sliding doors were recently repainted and had operators refurbished at the Northwest Building.

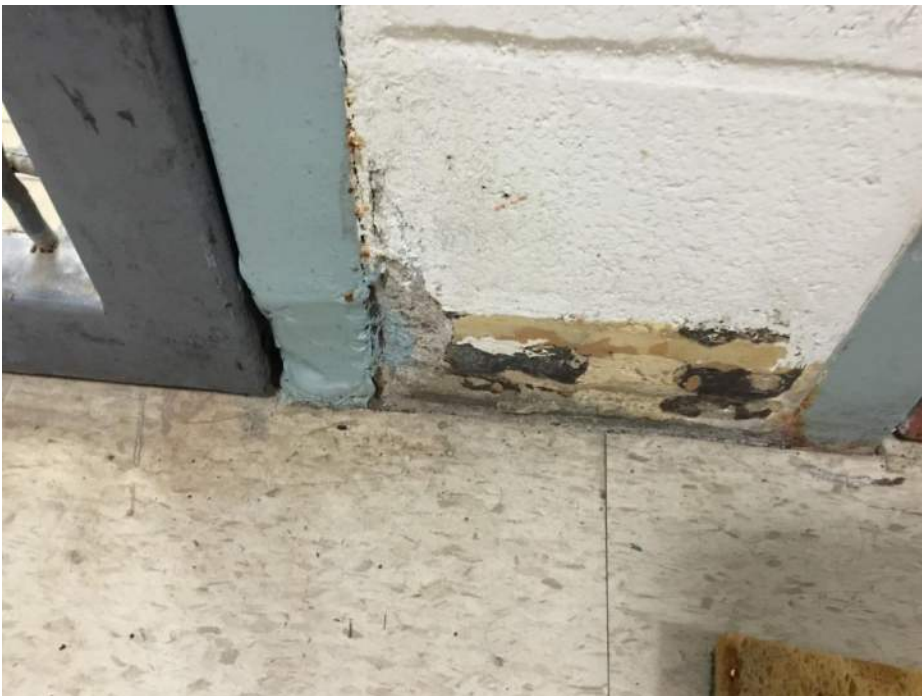
Photograph #122

Rust was noted at several doors and frames near wet areas and some cell doors at the Northwest Building.

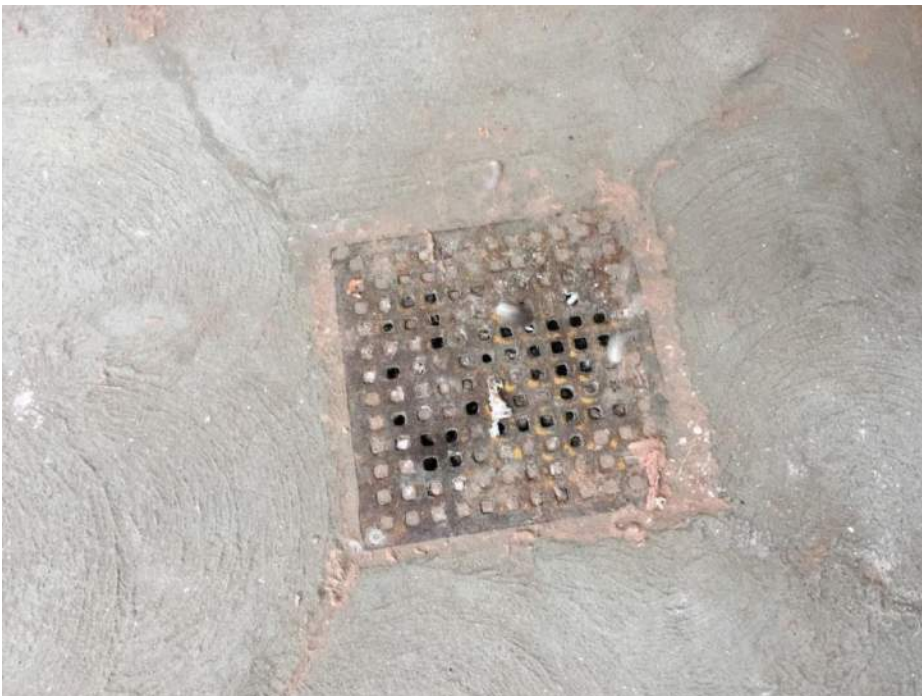
Photograph #124

Clogged drain covers were noted at the enclosed recreation yards at the Northwest Building.

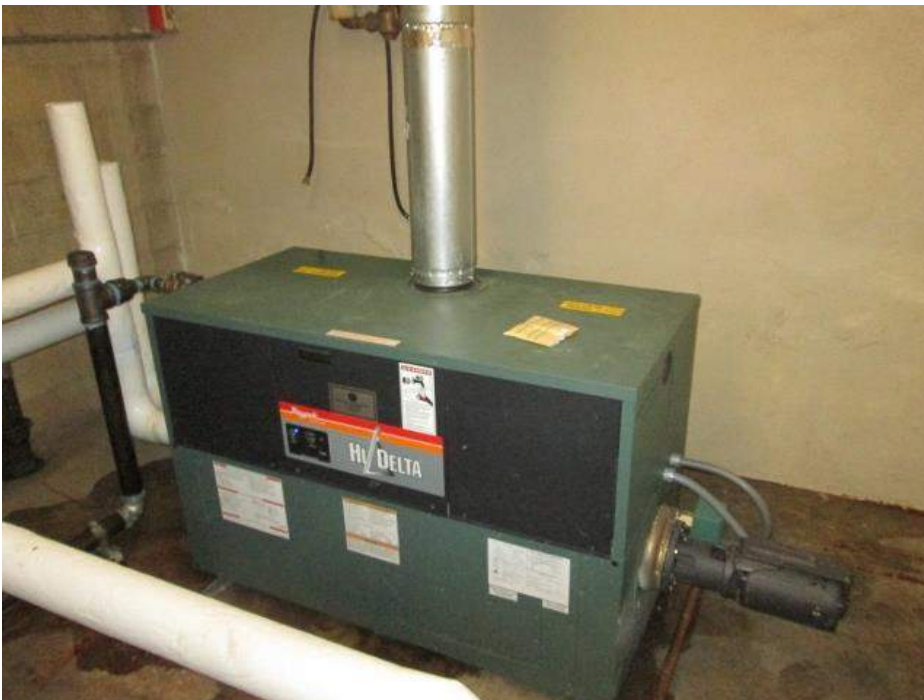
Photograph #156

Domestic hot water boiler at the Northwest Building.

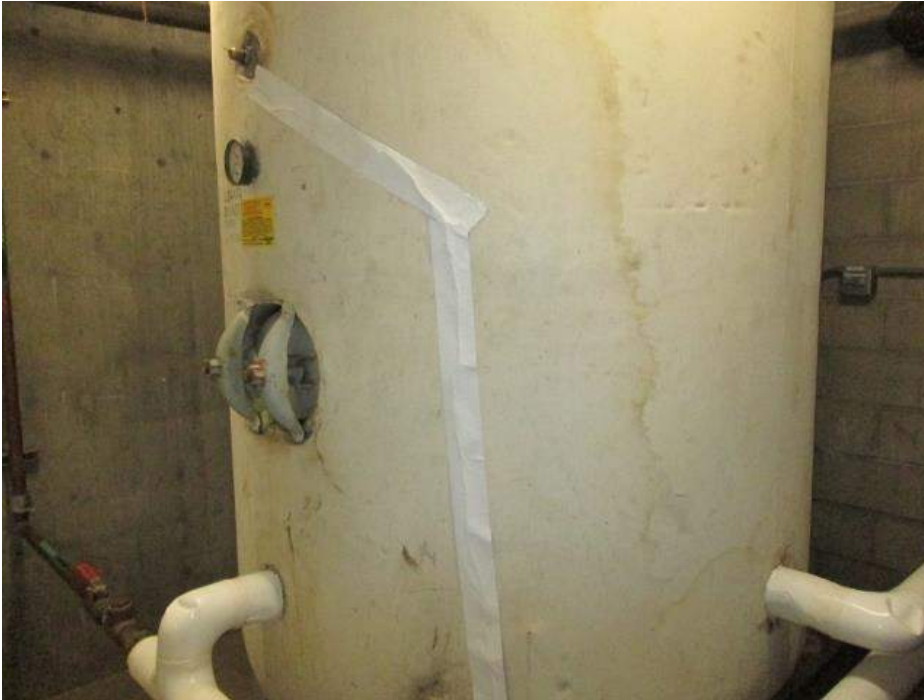
Photograph #157

Domestic hot water storage tank that serves the Northwest Building.

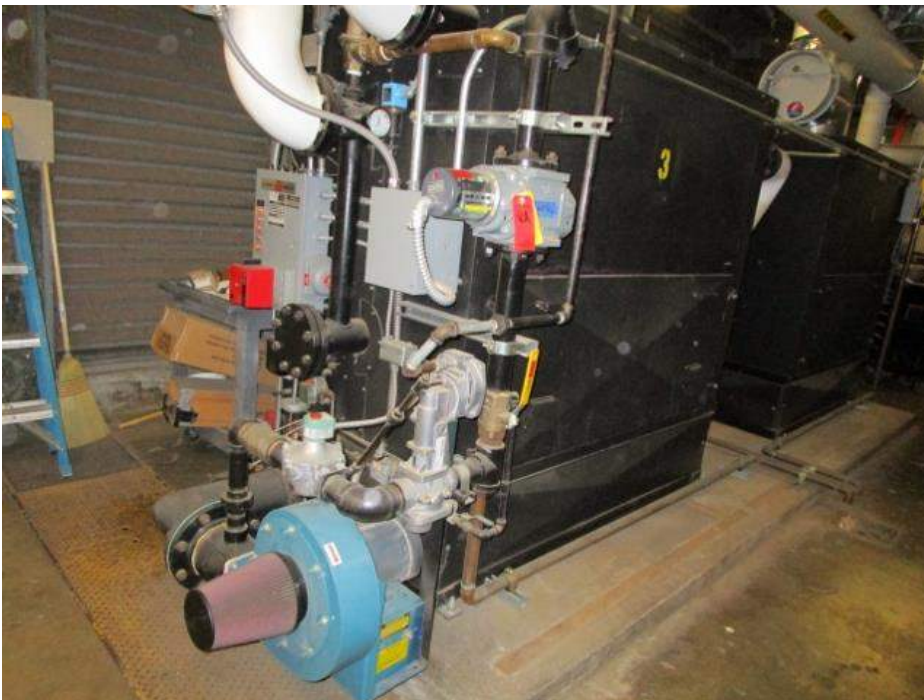
Photograph #158

Heating and domestic hot water boiler that serves the Mail Jail.

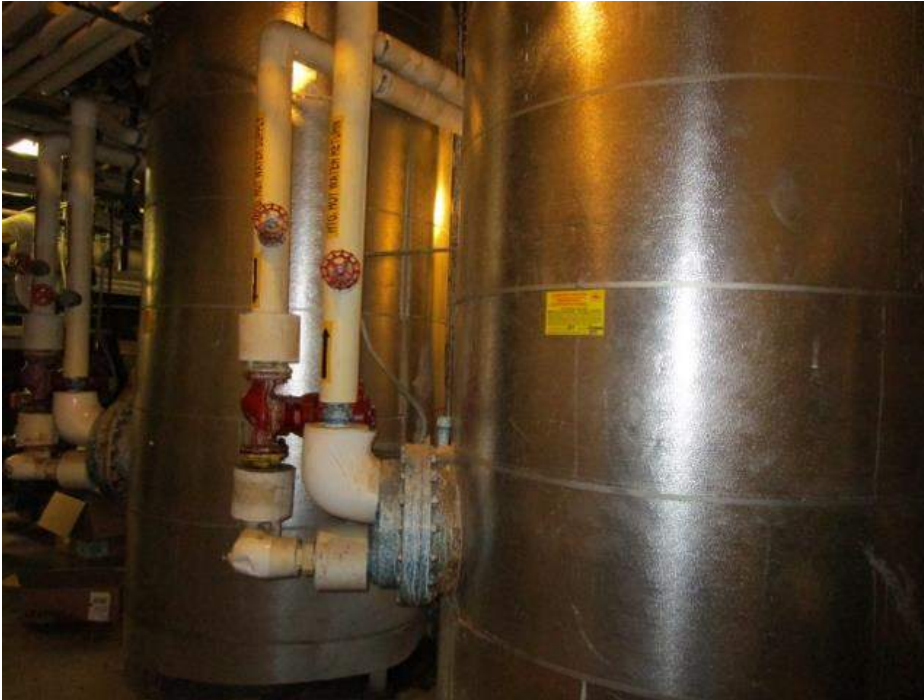
Photograph #159

Heating and domestic hot water storage tanks for the Mail Jail.

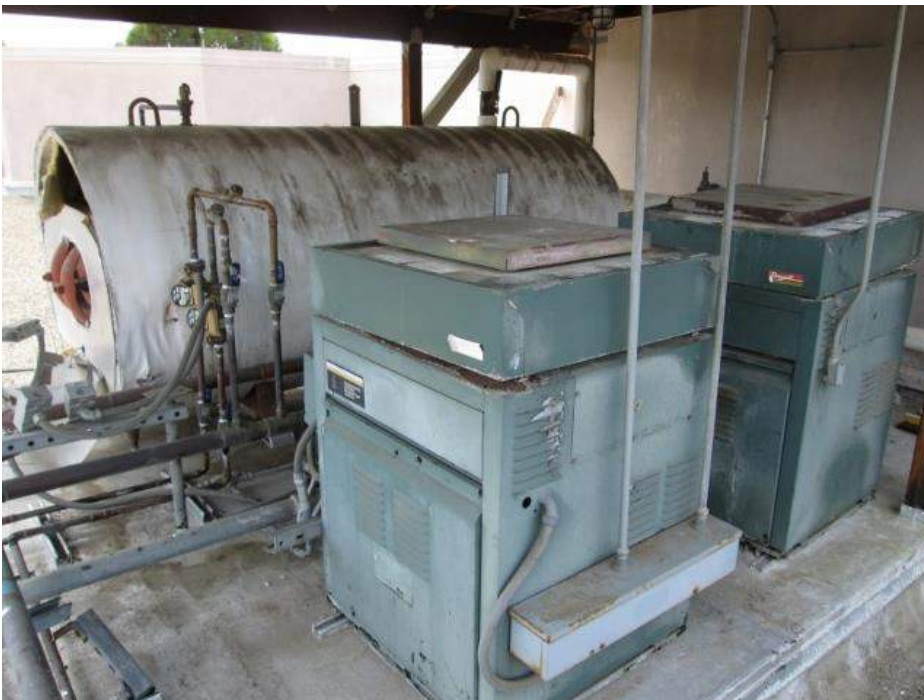
Photograph #160

Domestic hot water boilers and storage tank serving the IRC.

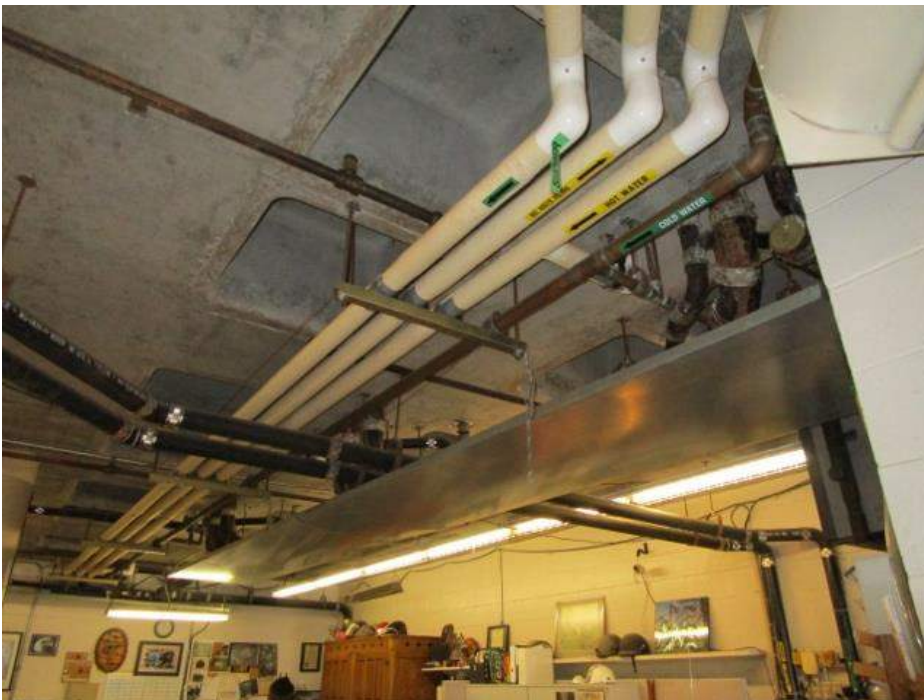
Photograph #162

Part of the plumbing chase in the basement area near the receiving area of the Northwest Building. Metal pan is used to prevent leaks to the area below.

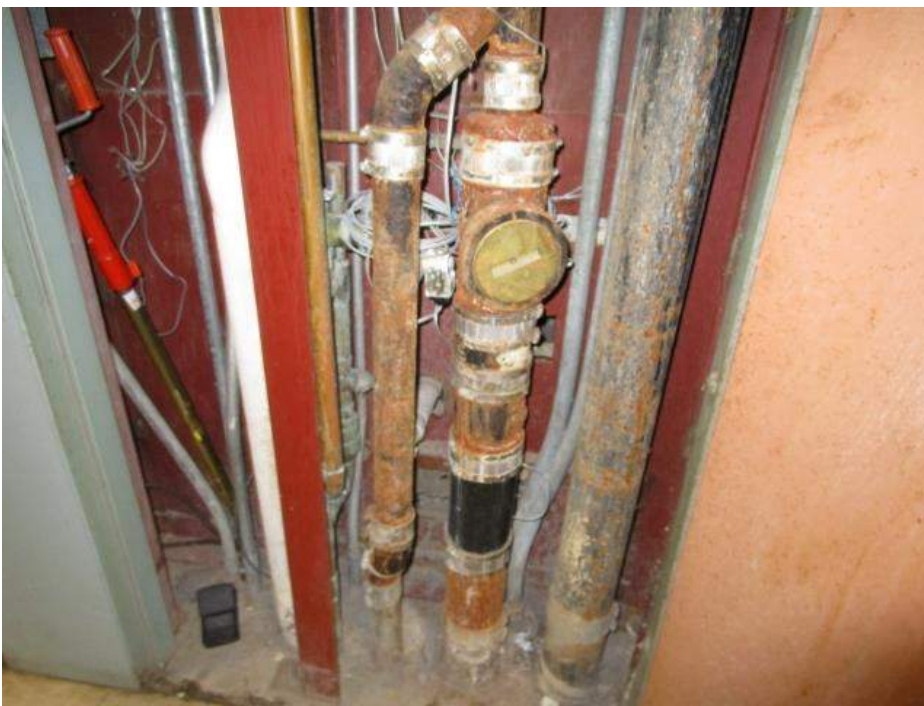
Photograph #163

Waste plumbing chase at one cell in the Northwest Building area.

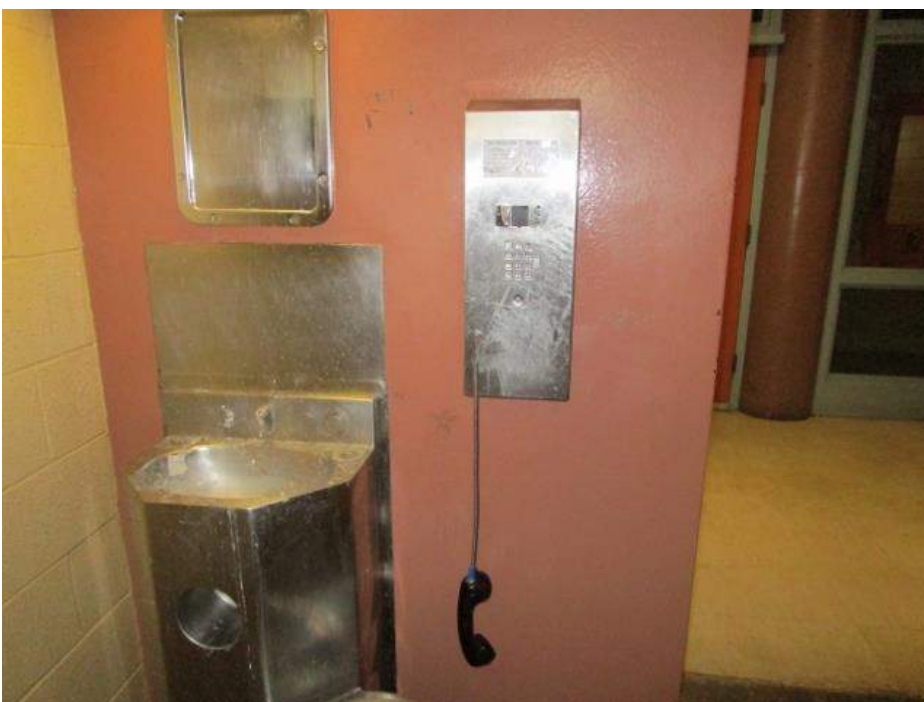
Photograph #164

View of a sink and toilet in the Northwest Building area.

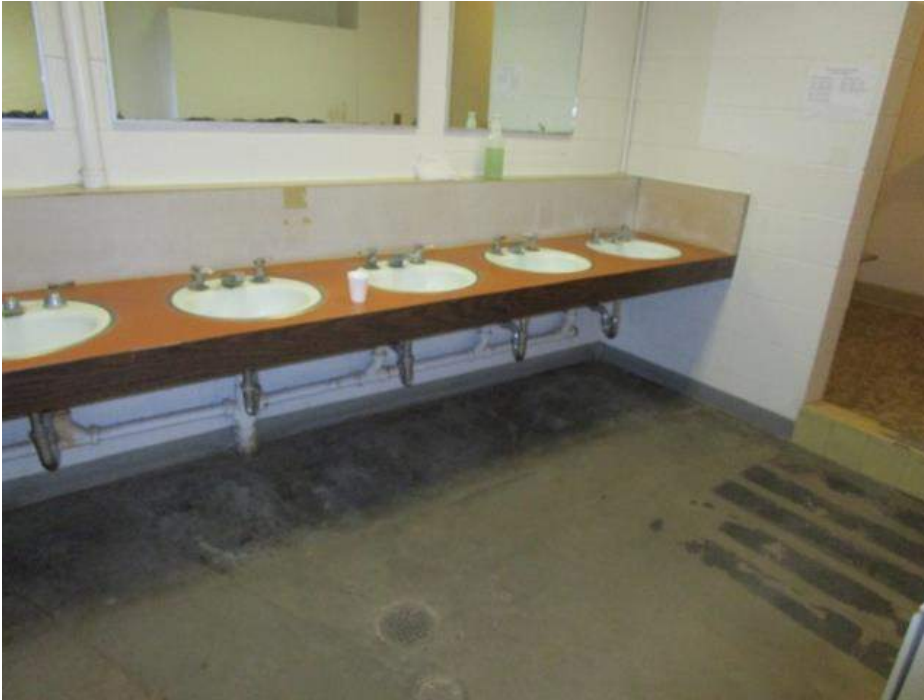
Photograph #165

Sinks at the women's
Honor Farm.

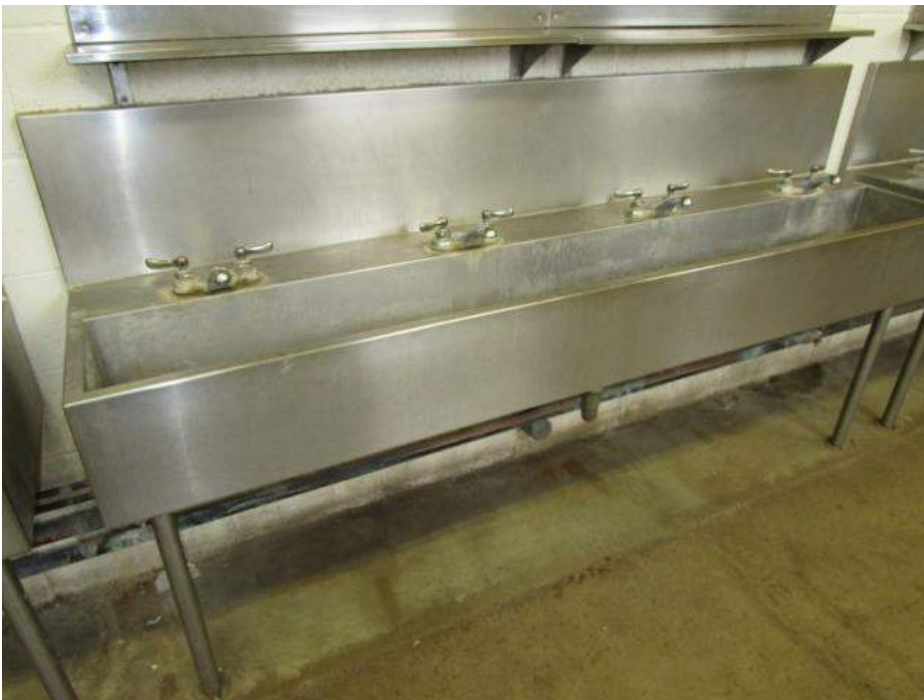
Photograph #166

Sinks at the men's
Honor Farm.

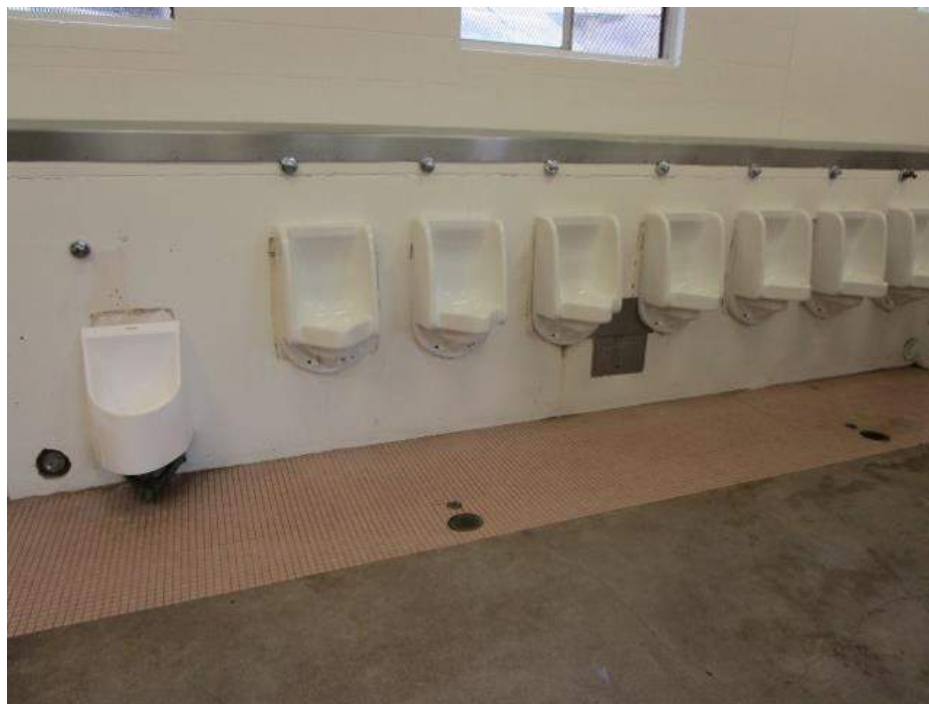
Photograph #167

Urinals at the men's
Honor Farm.

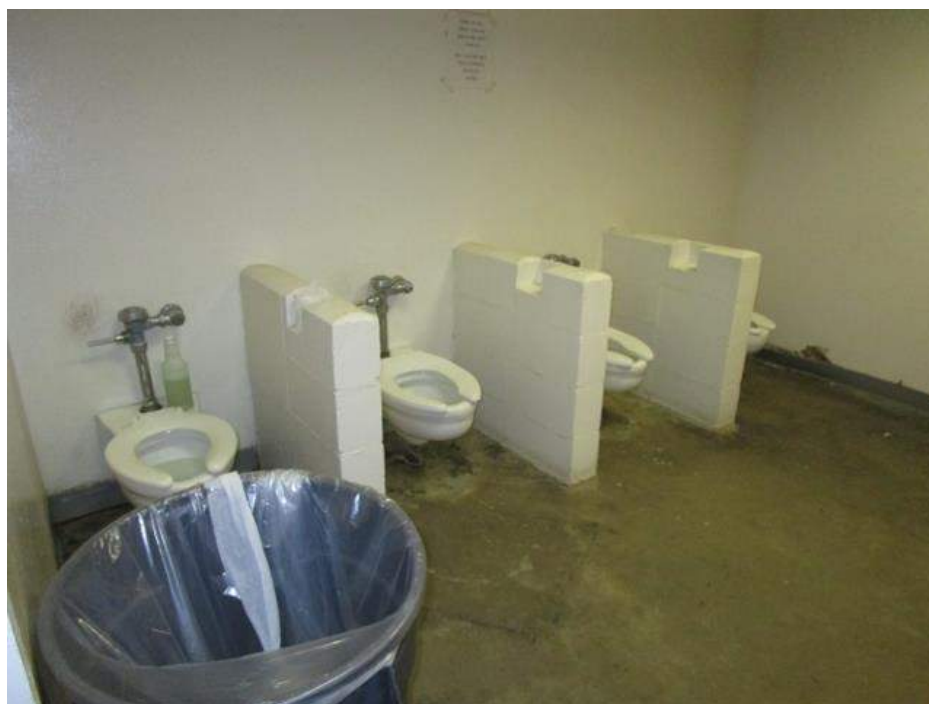
Photograph #168

Water closets at the
women's Honor
Farm.

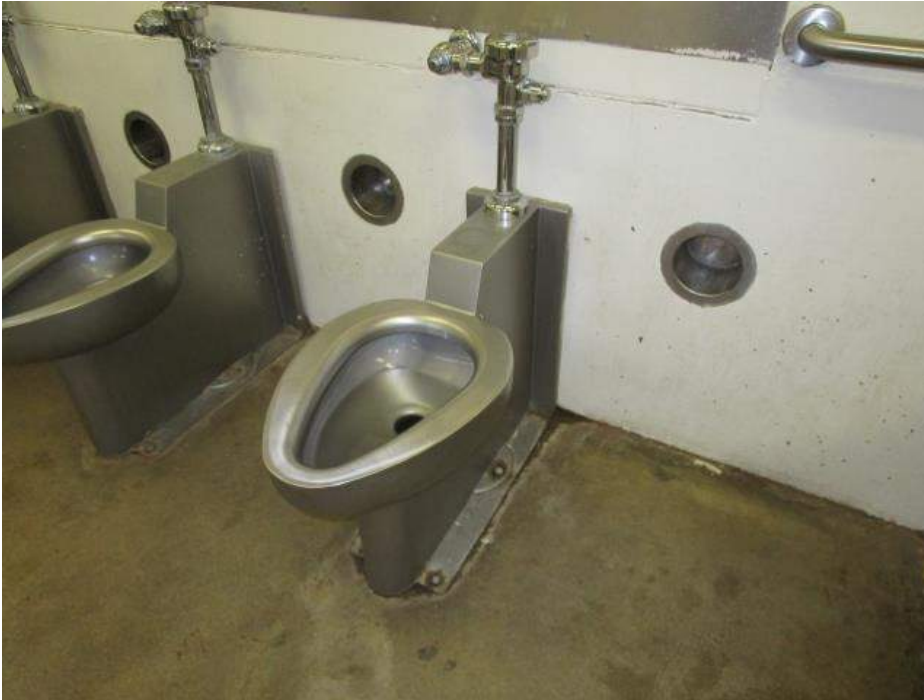
Photograph #169

Water closets at the men's Honor Farm.

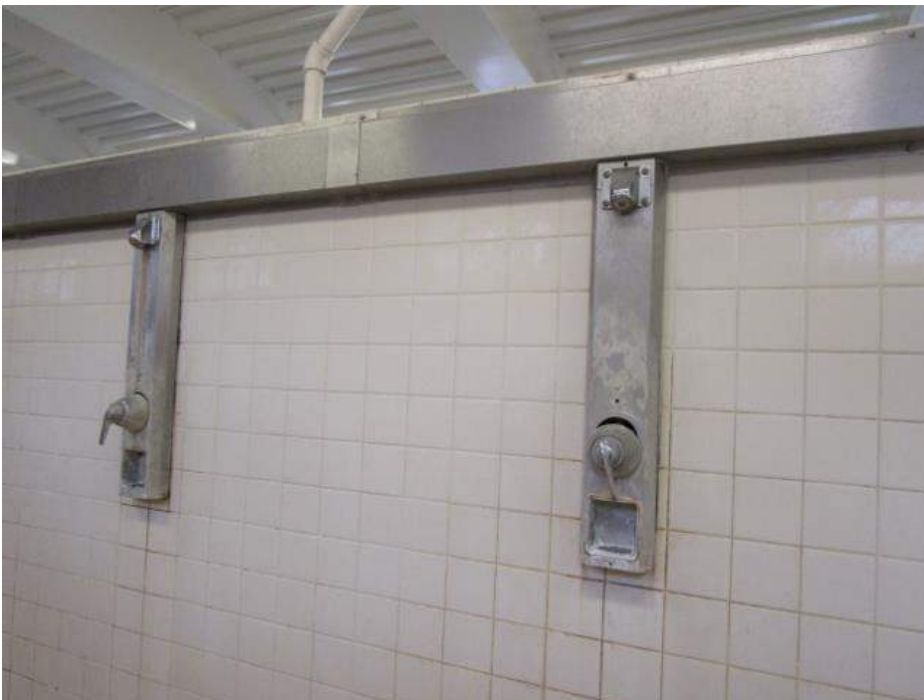
Photograph #170

Shower controls at the men's Honor Farm.

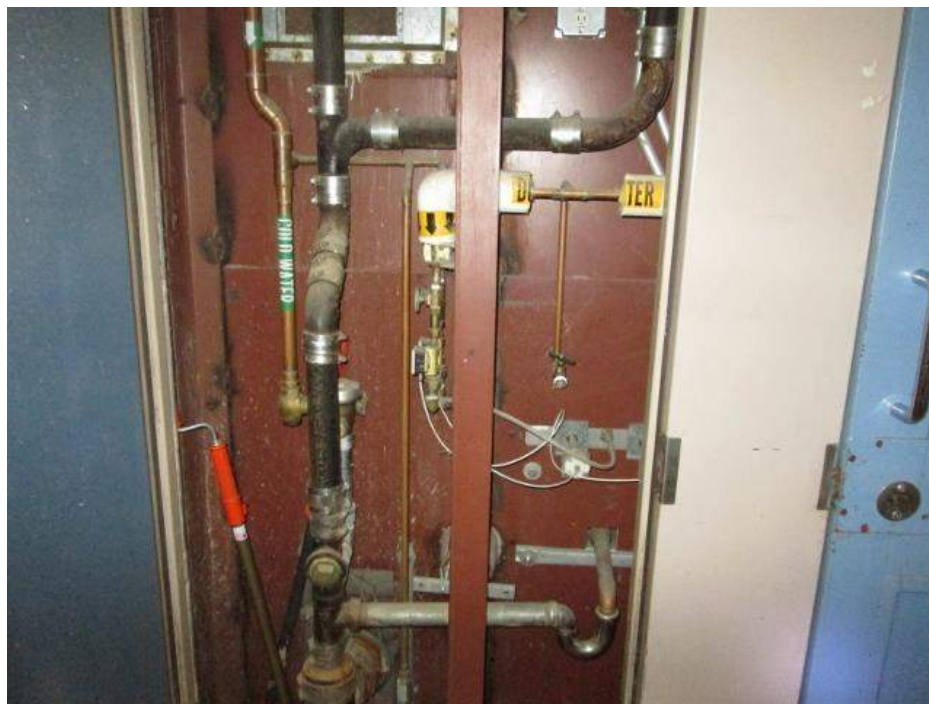
Photograph #171

Plumbing chase for a cell at the IRC.

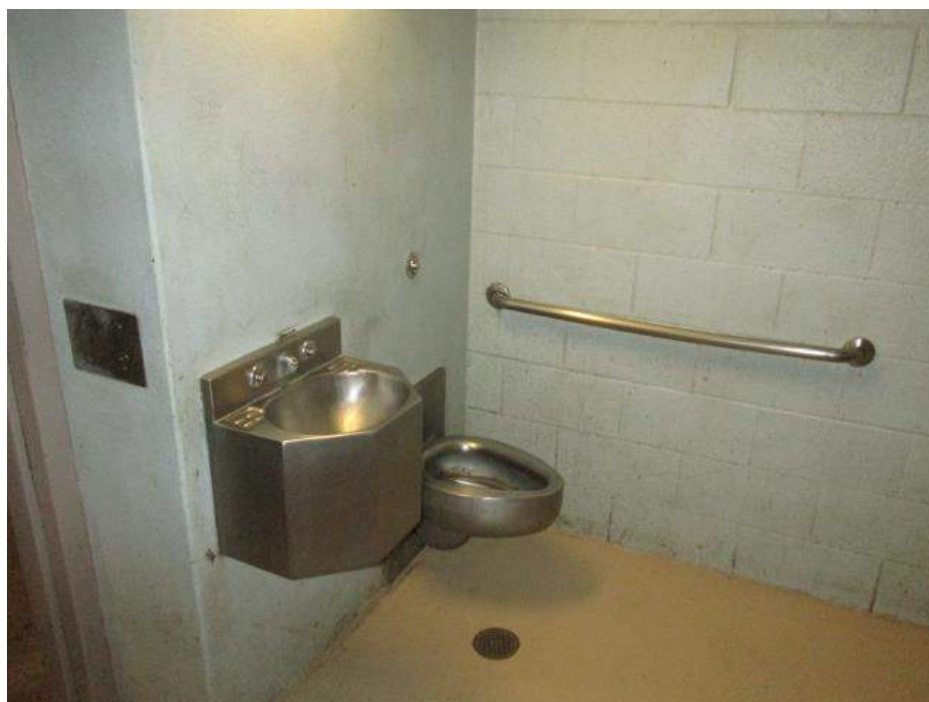
Photograph #172

Sink and toilet for a cell at the IRC.

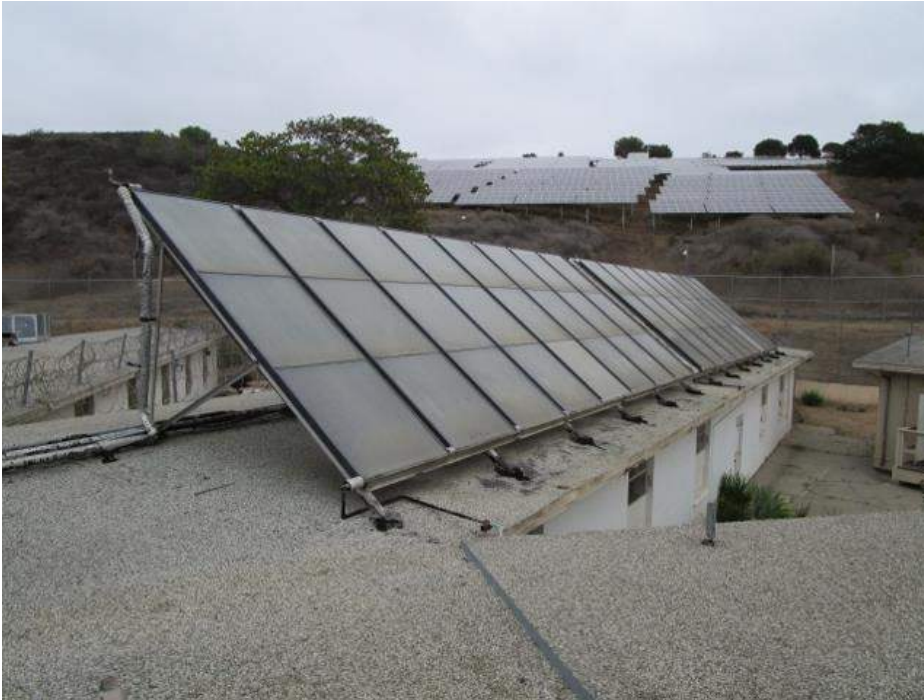
Photograph #173

Solar-powered hot water system at the Honor Farm.

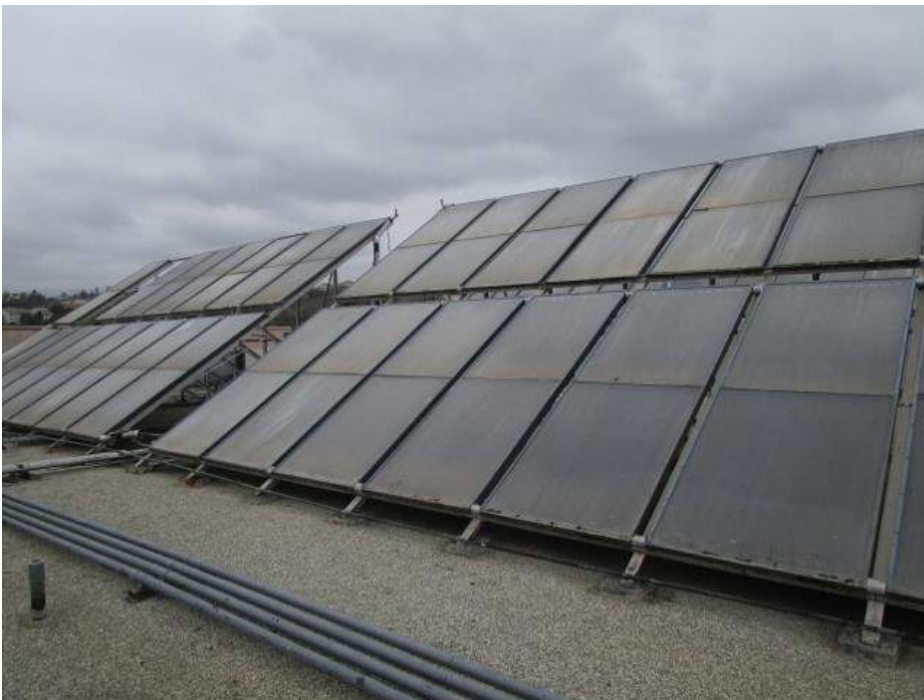
Photograph #174

Partial view of the solar-powered hot water system at the Main Jail.

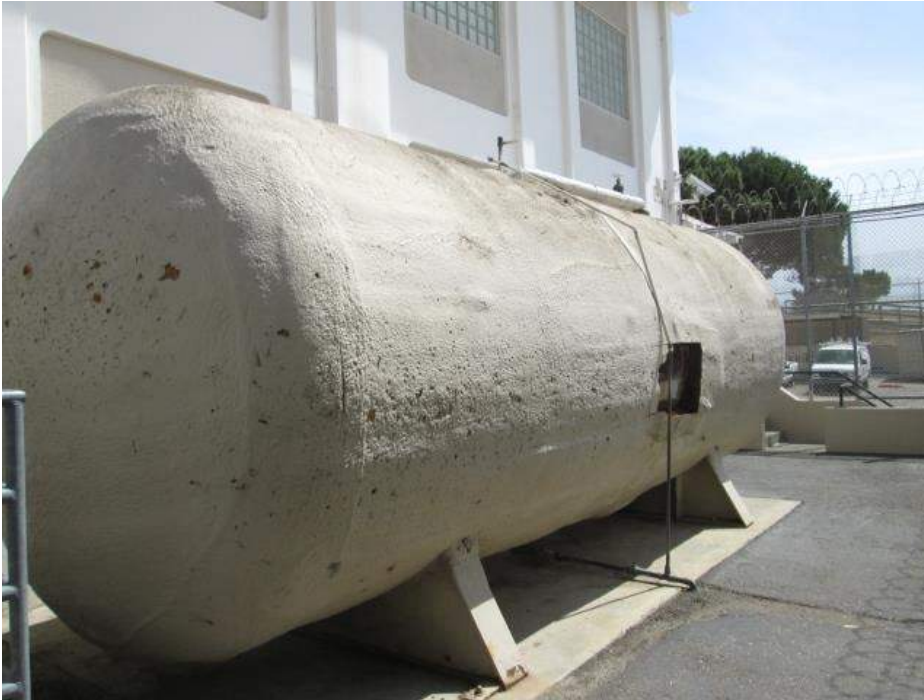
Photograph #175

Storage tank for the solar-powered water heating system at the Main Jail.

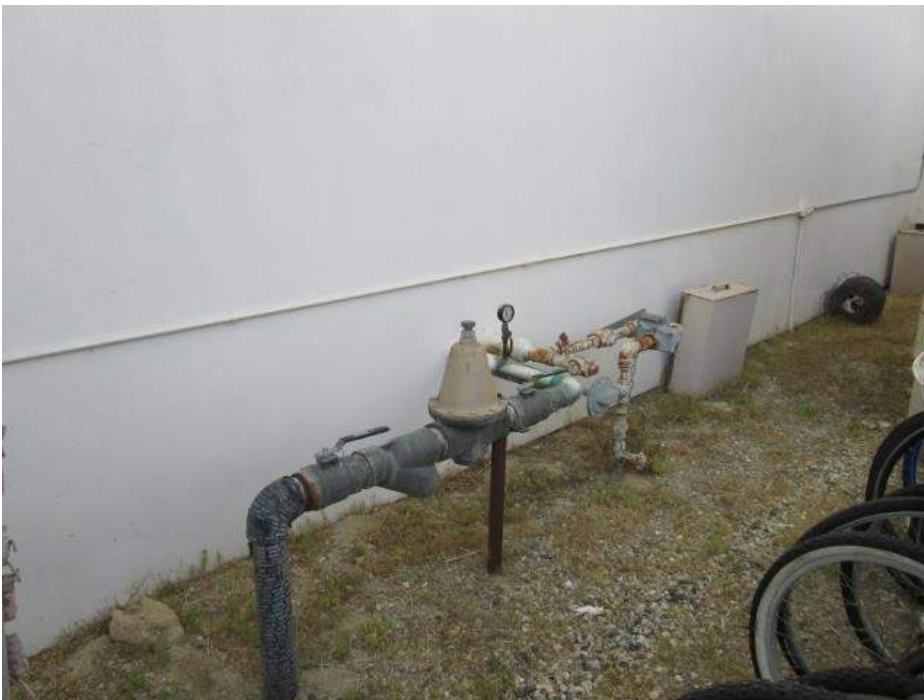
Photograph #176

Representative domestic water and natural gas service at the Main Jail.

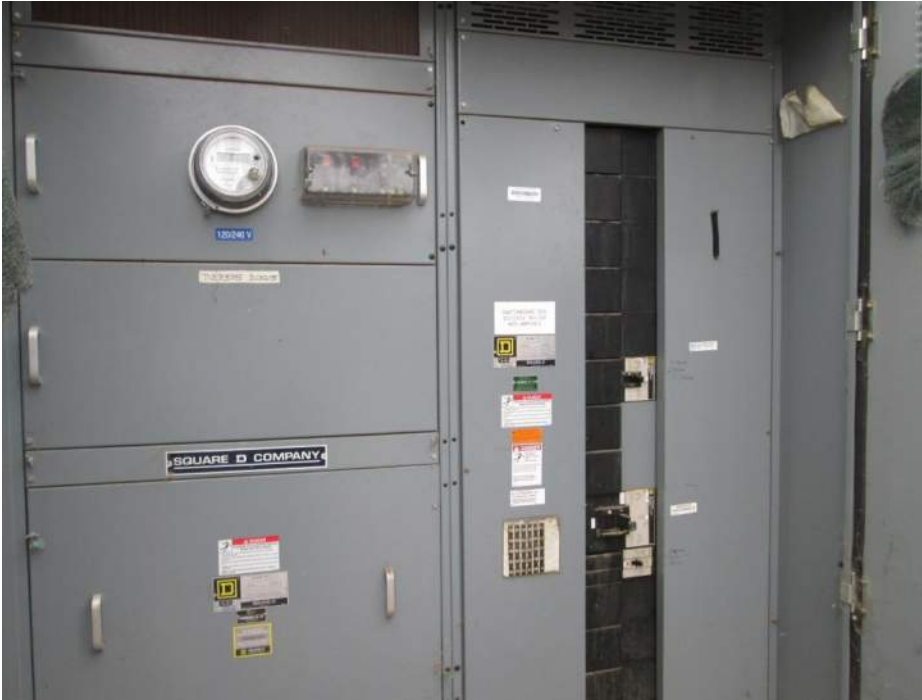
Photograph #177

Main switchboard at
the Honor Farm.

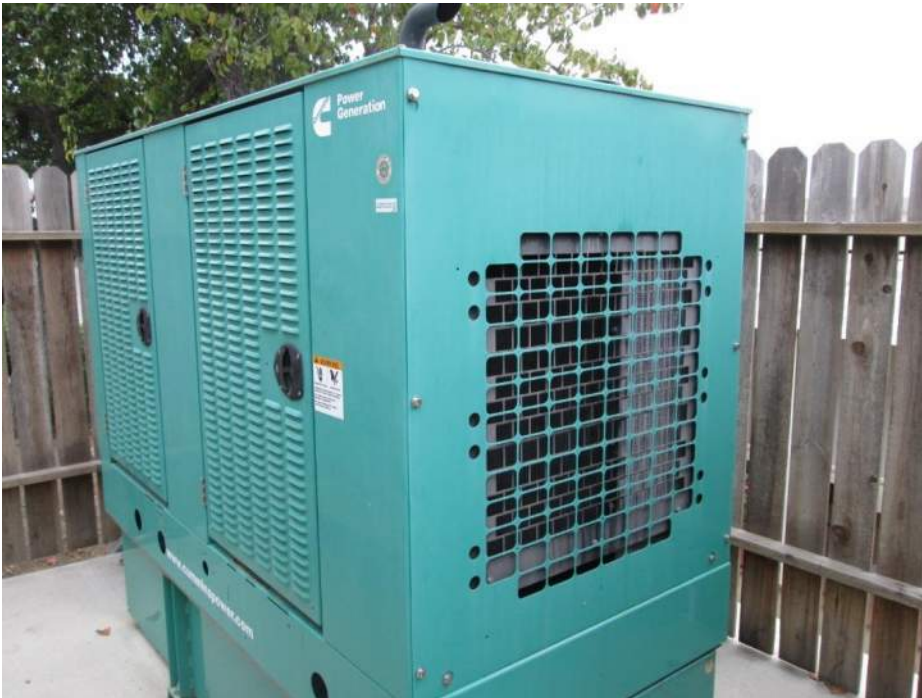
Photograph #178

Emergency
generator installed in
2009 at the Honor
Farm.

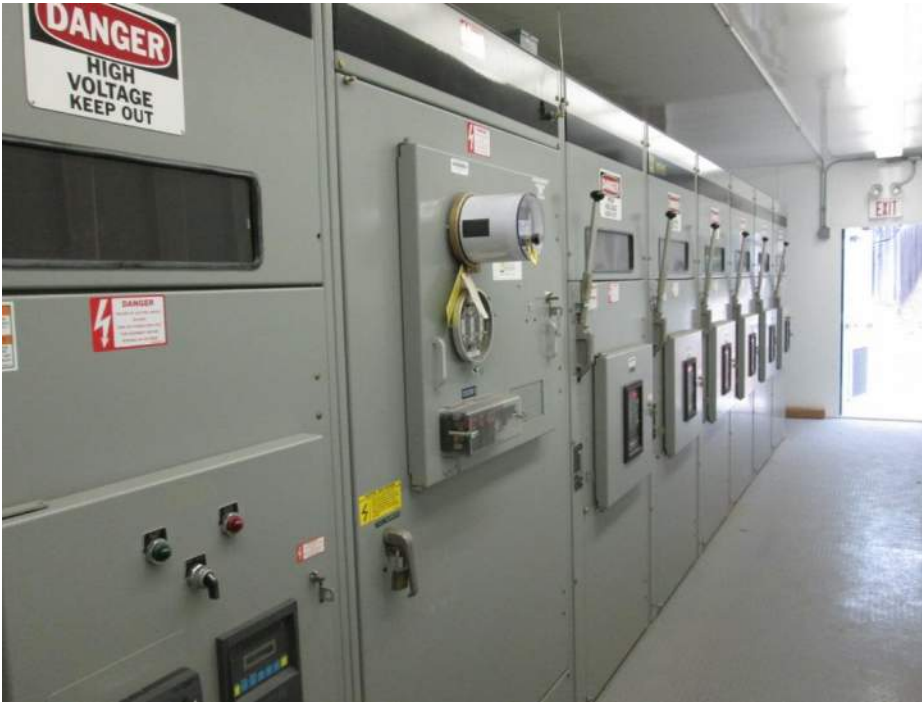
Photograph #179

High-voltage electric service for detention center and other county buildings.

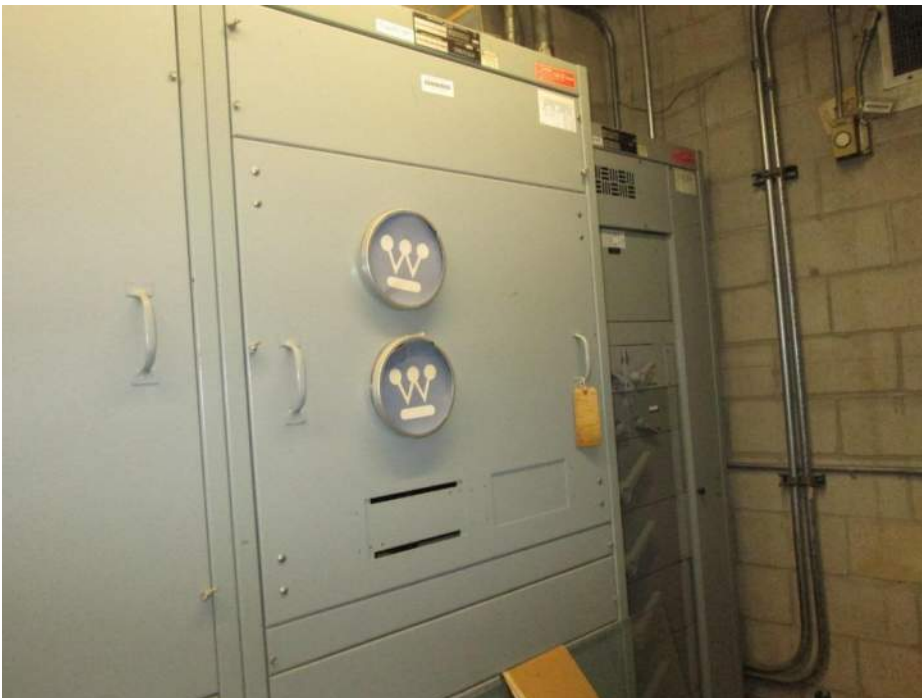
Photograph #180

Main switchboard for Northwest Building fed from Main Jail.
