PROPERTY CONDITION ASSESSMENT

SANTA BARBARA COUNTY DETENTION CENTER

**4434 Calle Real
Santa Barbara, California**

October 29, 2015

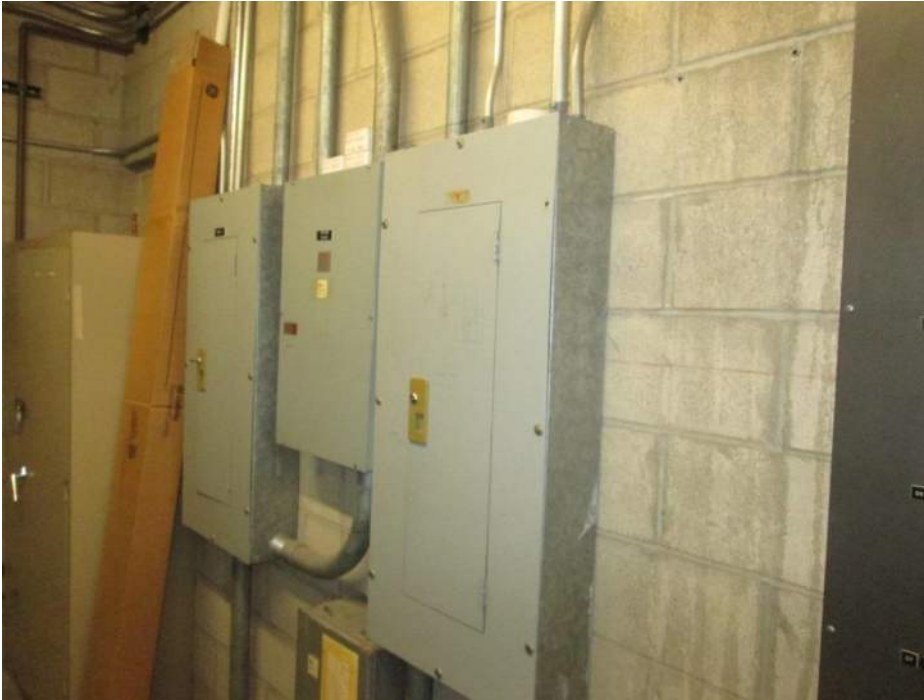
Photograph #181

Distribution panels
for Northwest
Building.

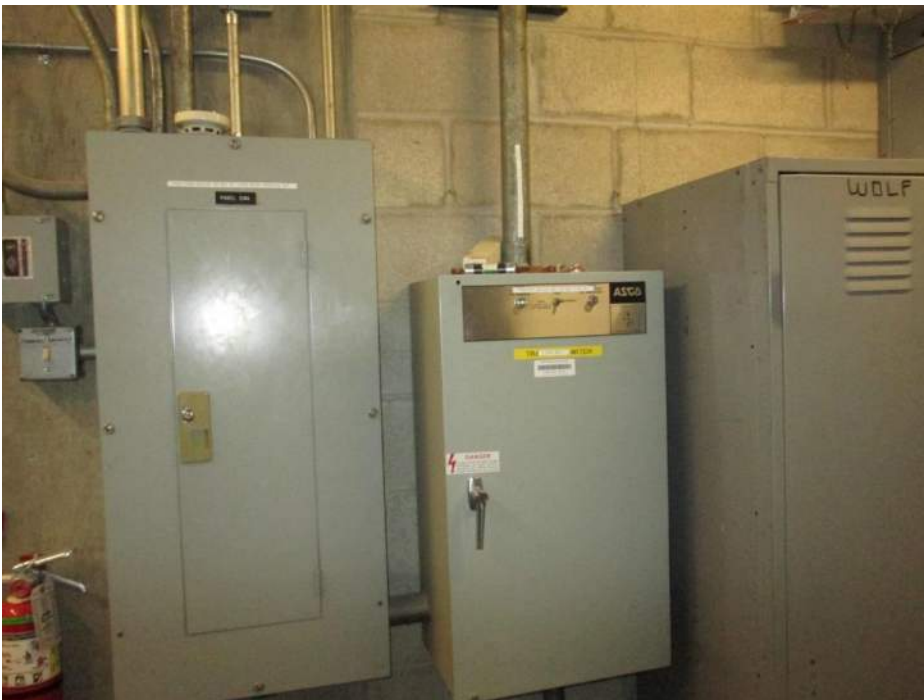
Photograph #182

Automatic transfer
switch and
emergency
switchboard for
Northwest Building
fed from the Main
Jail.

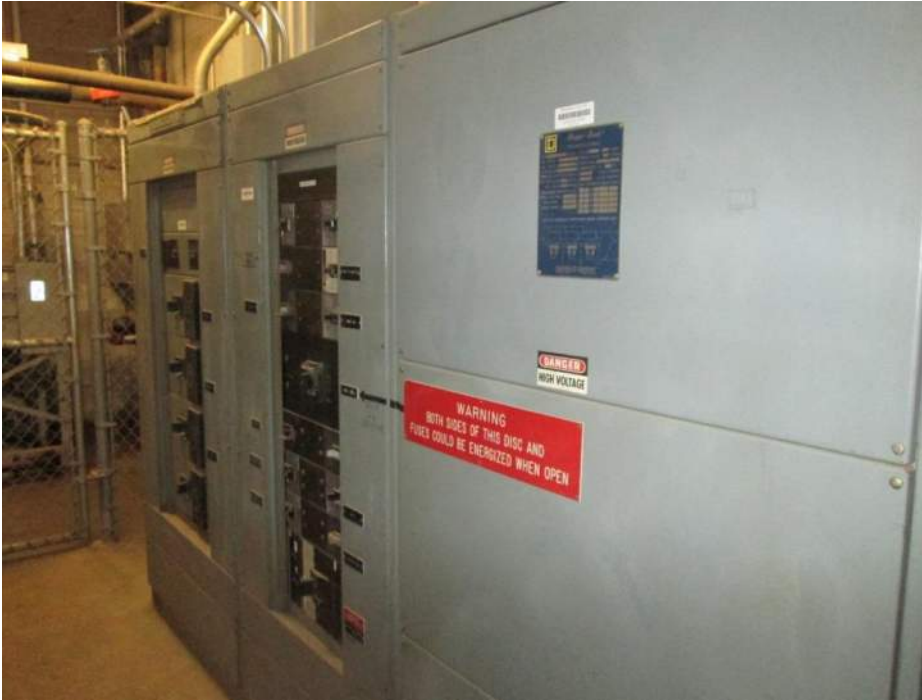
Photograph #183

Transformer and main switchboard for the Main Jail.

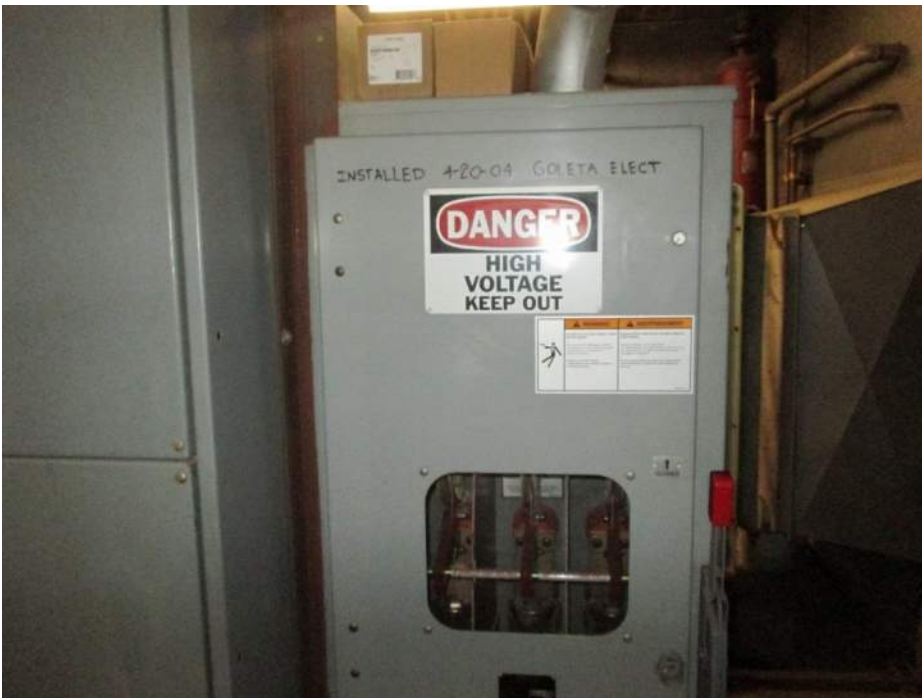
Photograph #184

High-voltage disconnect for the Main Jail that has been replaced.

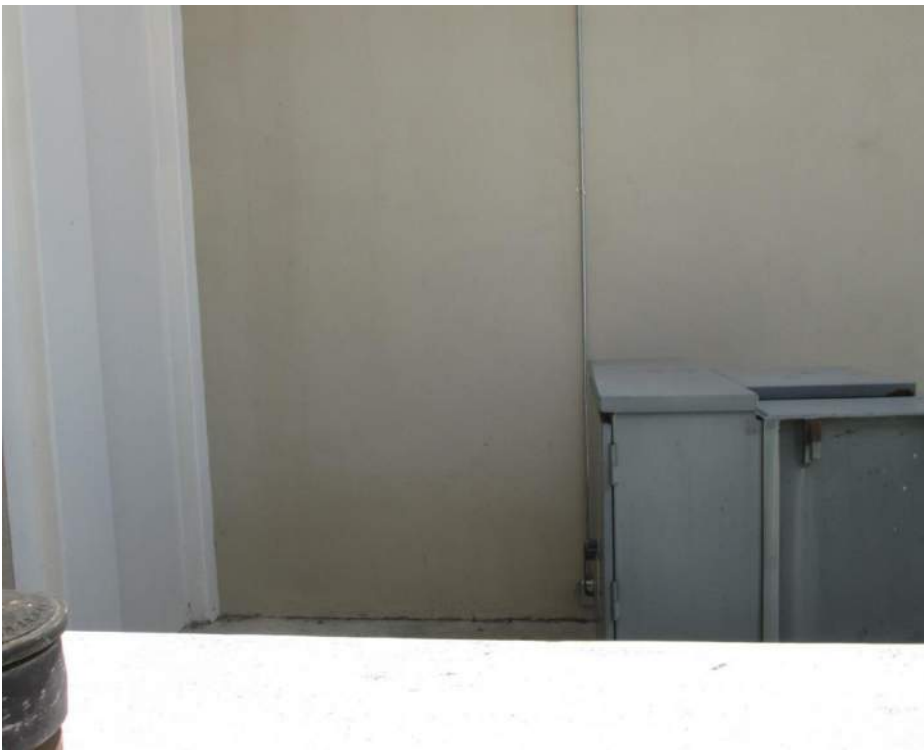
Photograph #186

Pad-mounted transformer for the IRC.

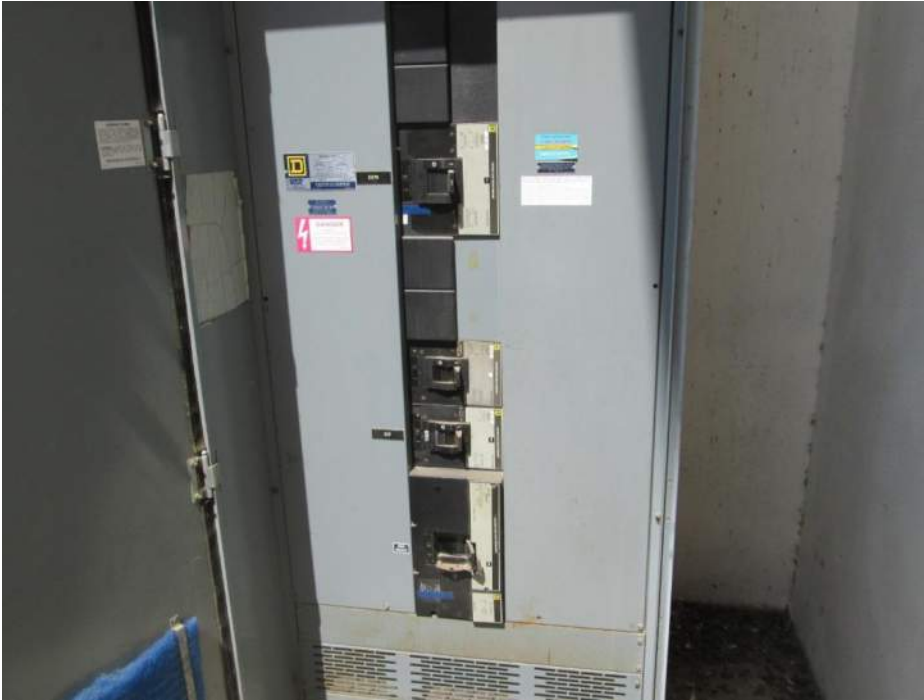
Photograph #187

Main switchboard
for the IRC.

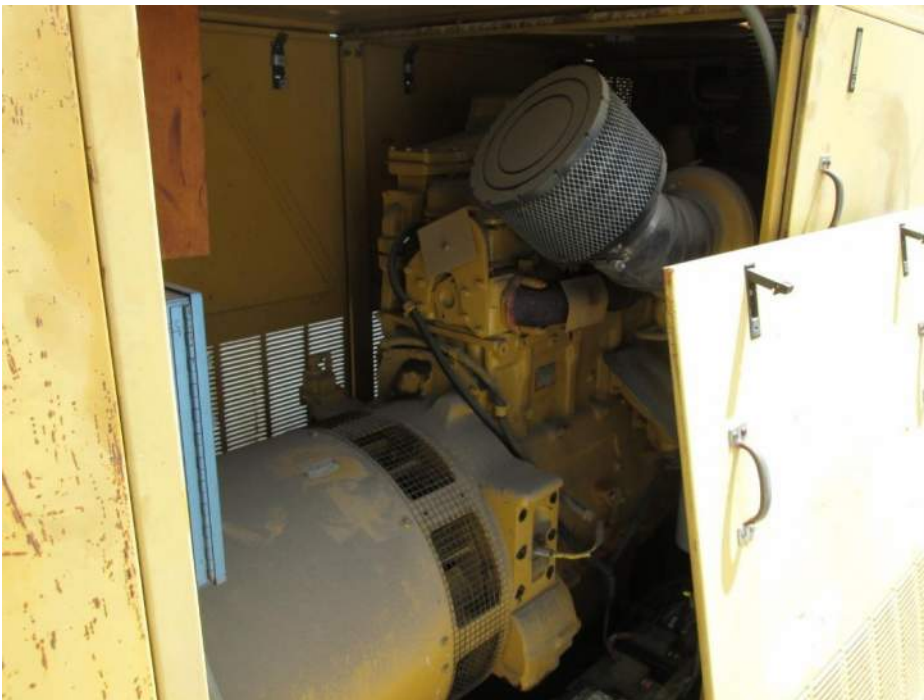
Photograph #188

Emergency
generator for the
IRC.

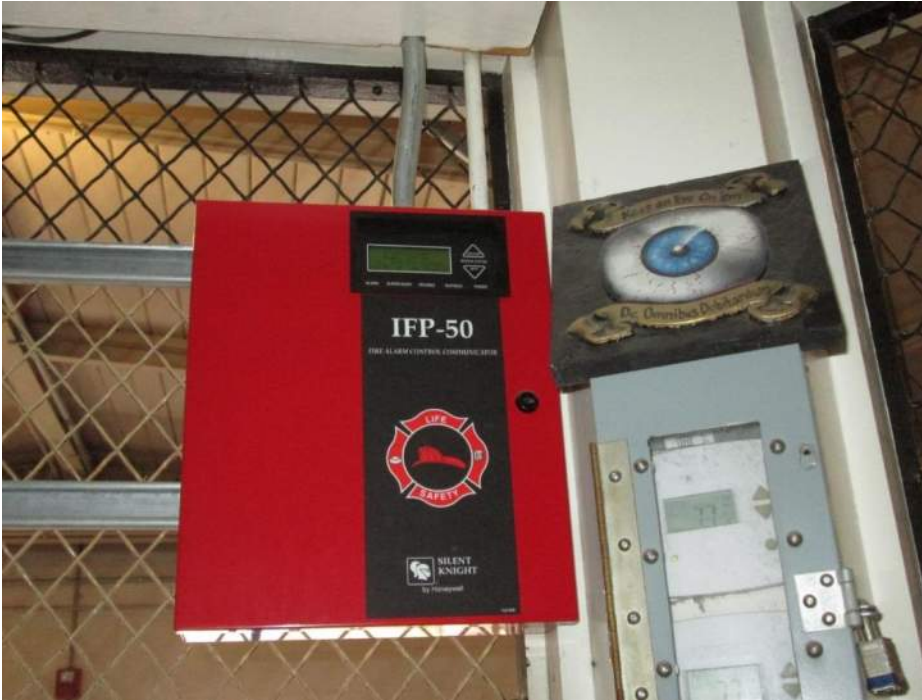
Photograph #189

Fire alarm control panel for the Honor Farm.

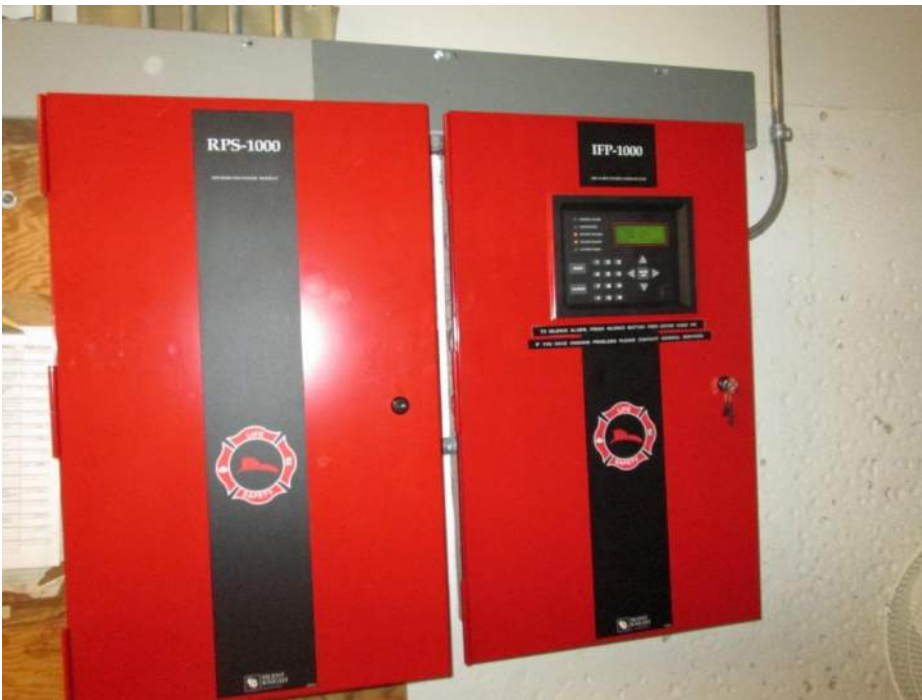
Photograph #190

Fire alarm control panel for the Main Jail.

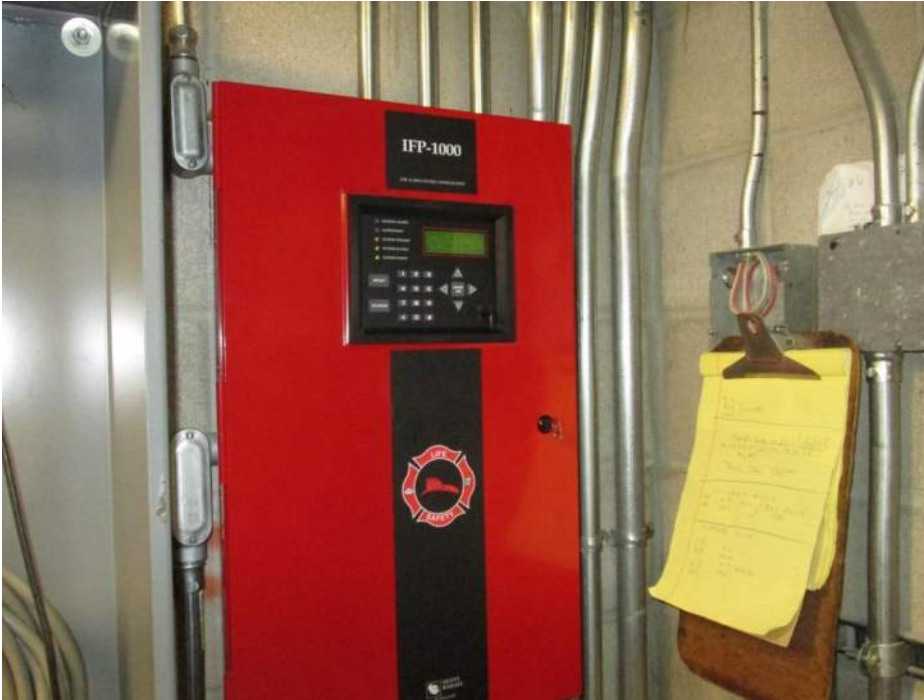
Photograph #191

Fire alarm control panel for the IRC.

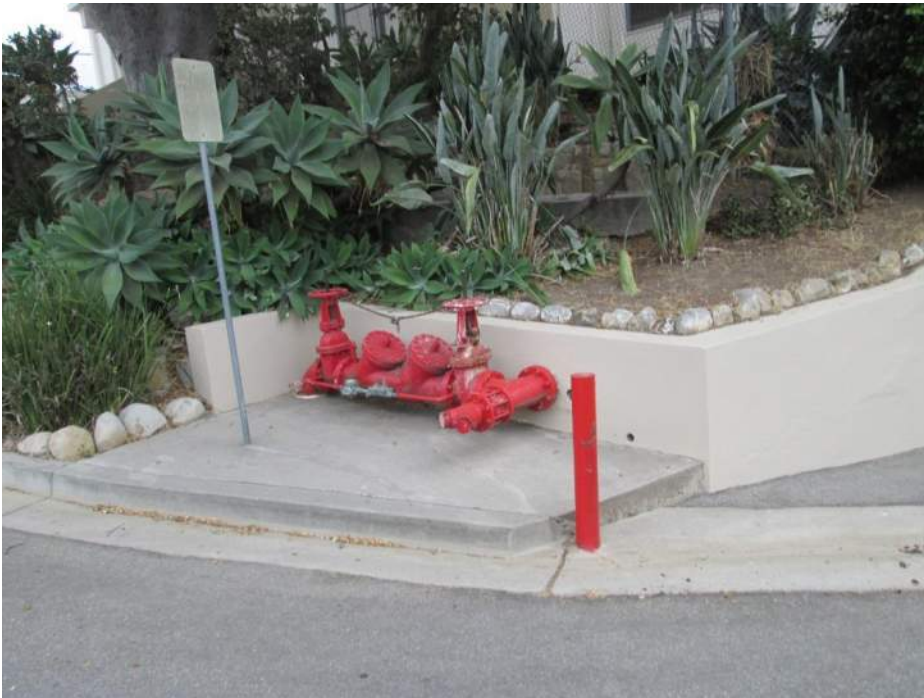
Photograph #192

Fire water service for the Northwest Building.

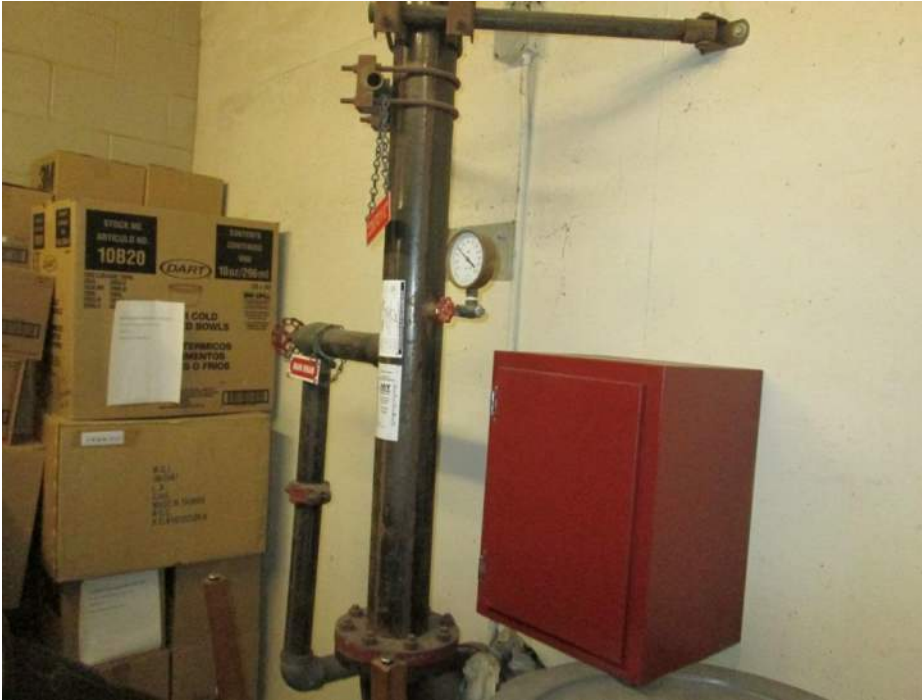
Photograph #193

Fire sprinkler riser
for the Northwest
Building.

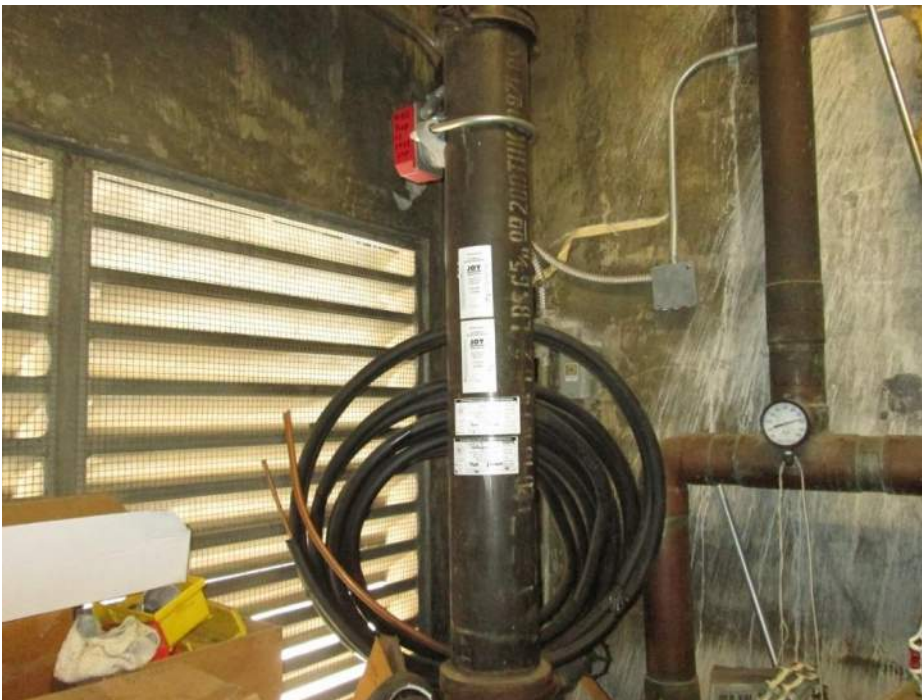
Photograph #194

Fire sprinkler riser
for the Main Jail.

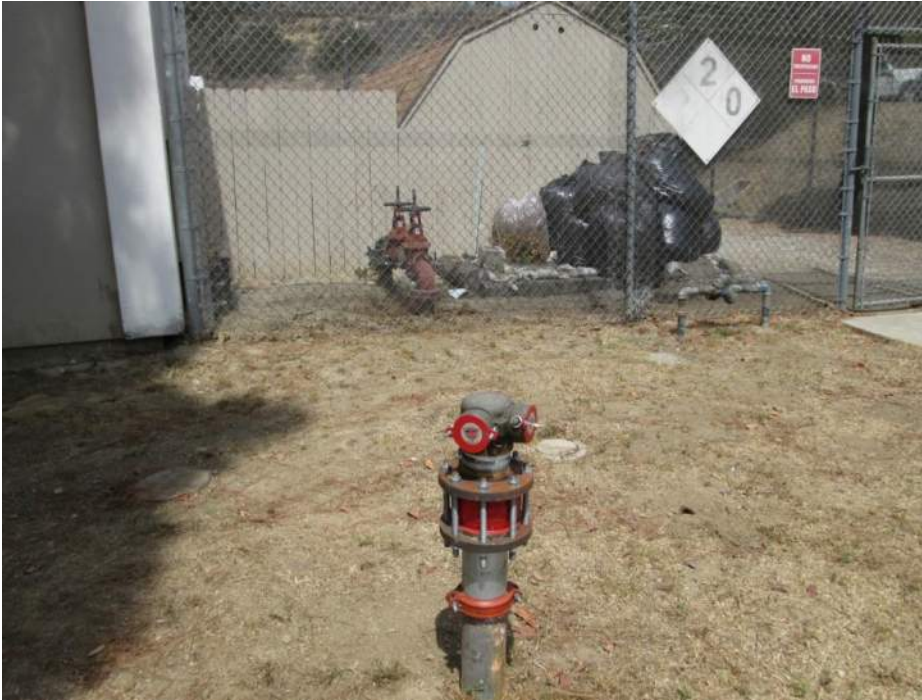
Photograph #195

Fire department connection and fire water service for the IRC.

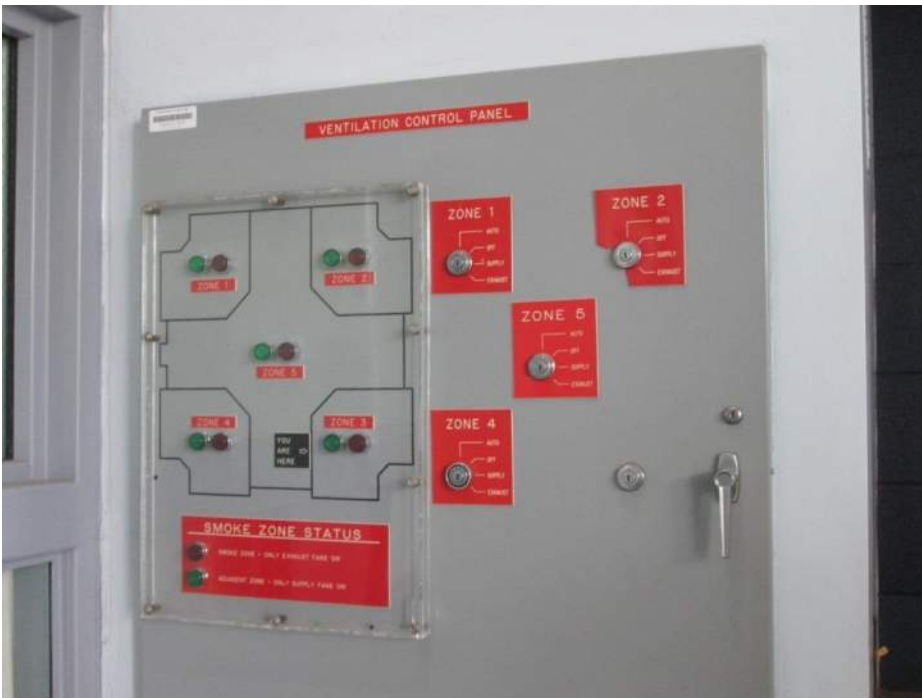
Photograph #196

Smoke control panel for the IRC.

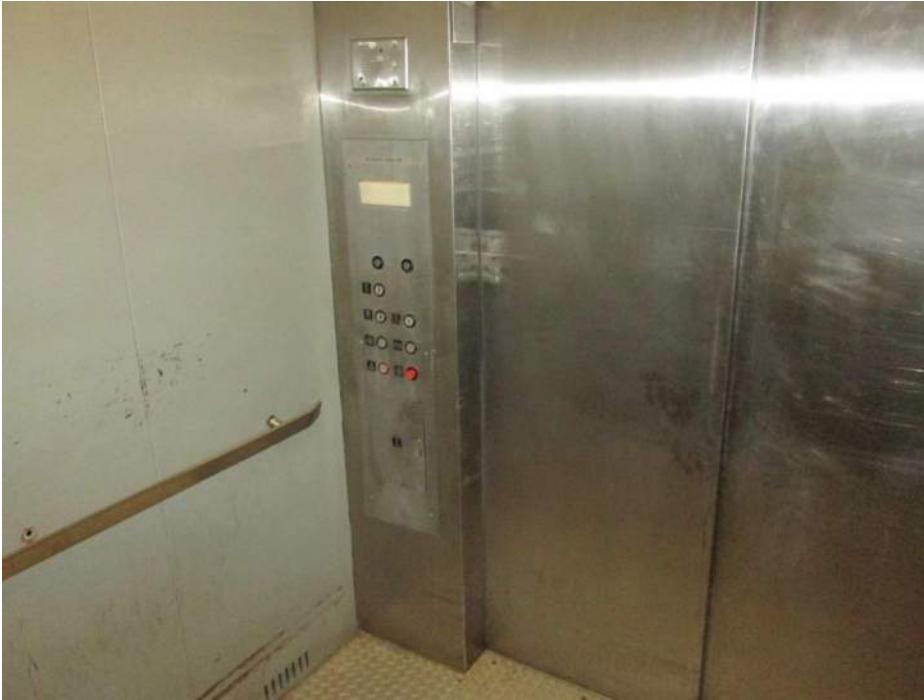
Photograph #197

The Northwest Building elevator cab interior and control panel.

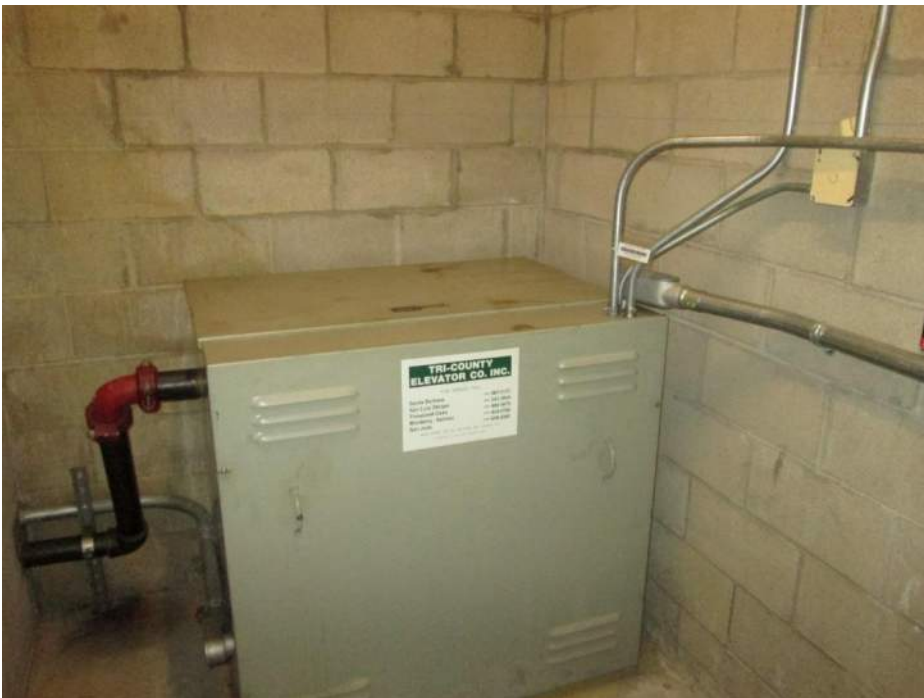
Photograph #198

Elevator equipment for The Northwest Building elevator.

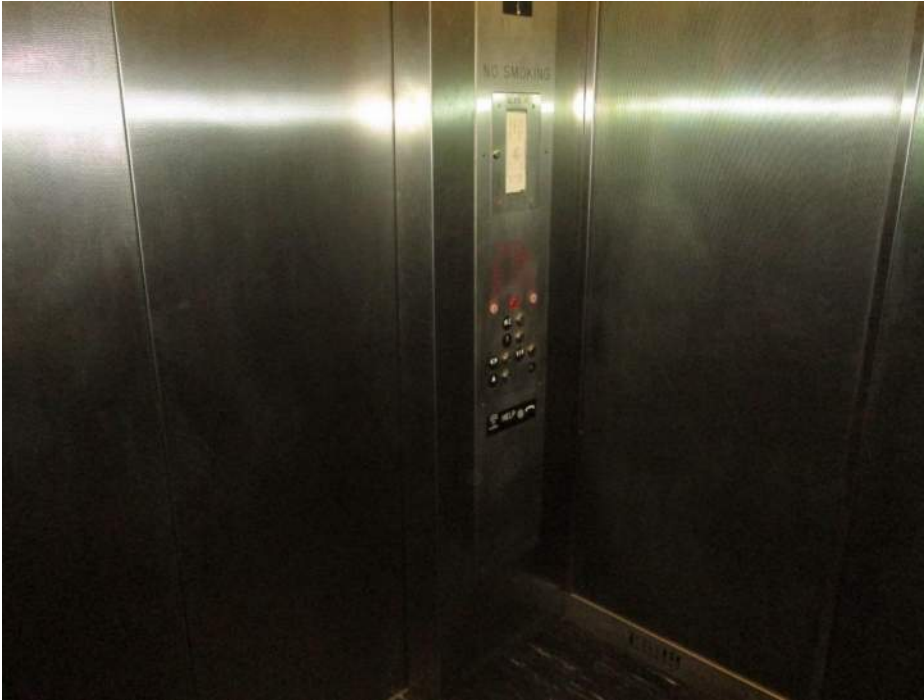
Photograph #199

The Main Jail service elevator cab interior and control.

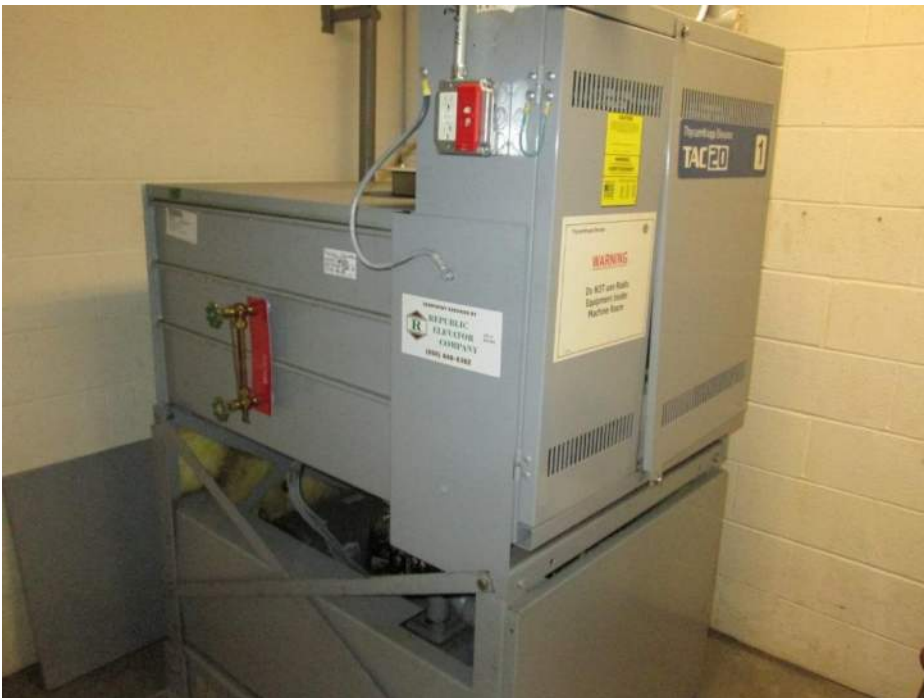
Photograph #200

The Main Jail elevator equipment with new control panel and hydraulic valve.
