PHASE 2 CULTURAL RESOURCES STUDY
HISTORIC RESOURCES
461 SAN YSIDRO ROAD
MONTECITO, CALIFORNIA
APN 009-060-049

Prepared for
AB Design Studio
27 East Cota Street
Santa Barbara, CA 93101

Prepared by
Alexandra C. Cole
Preservation Planning Associates
519 Fig Avenue
Santa Barbara, CA 93101

May 2010

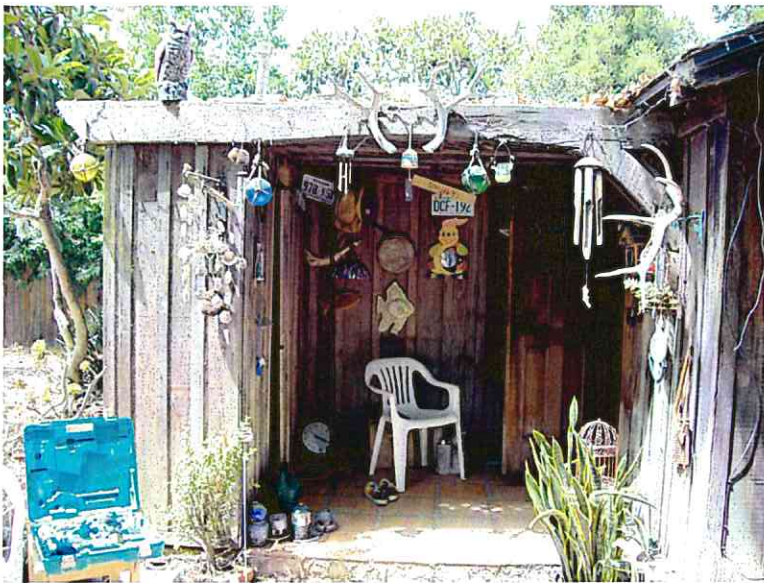
VIEW OF COVERED ENTRY PORCH

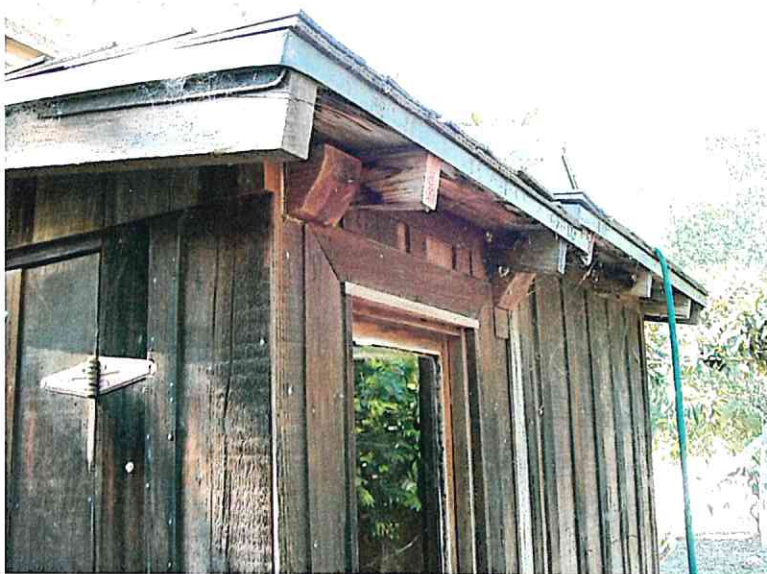
NORTHWEST VIEW OF BATHROOM WING
